**MAINTENANCE
INFORMATION**

MI13-06

DATE :	MAY 2013	SECTION :05-Cooling System
SUBJECT :	HOSE CLAMP FOR COOLING SYSTEM CONNECTION

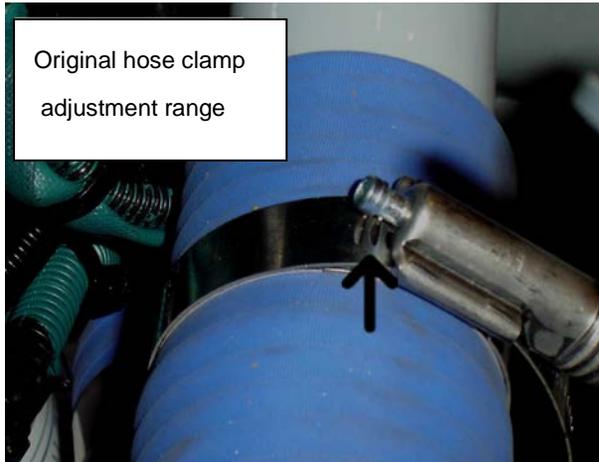
Hose clamps with a smaller diameter are available to increase the adjustment range at the upper and lower radiator flexible connections and at the oil cooler connections located under the turbocharger.

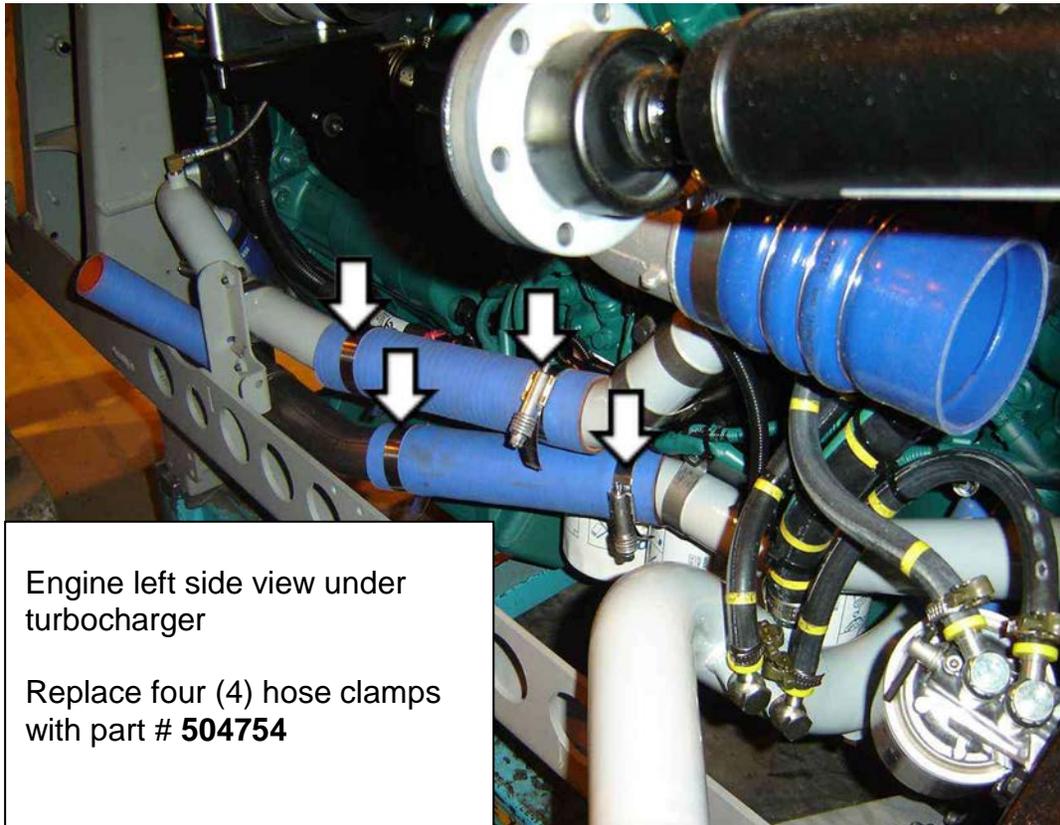
- 5- Replace the four (4) hose clamps on the blue flexible hoses located under the turbocharger with four (4) new hose clamps (part # **504754**).

NOTE: All clamps must be tightened to 100 lbs-in.

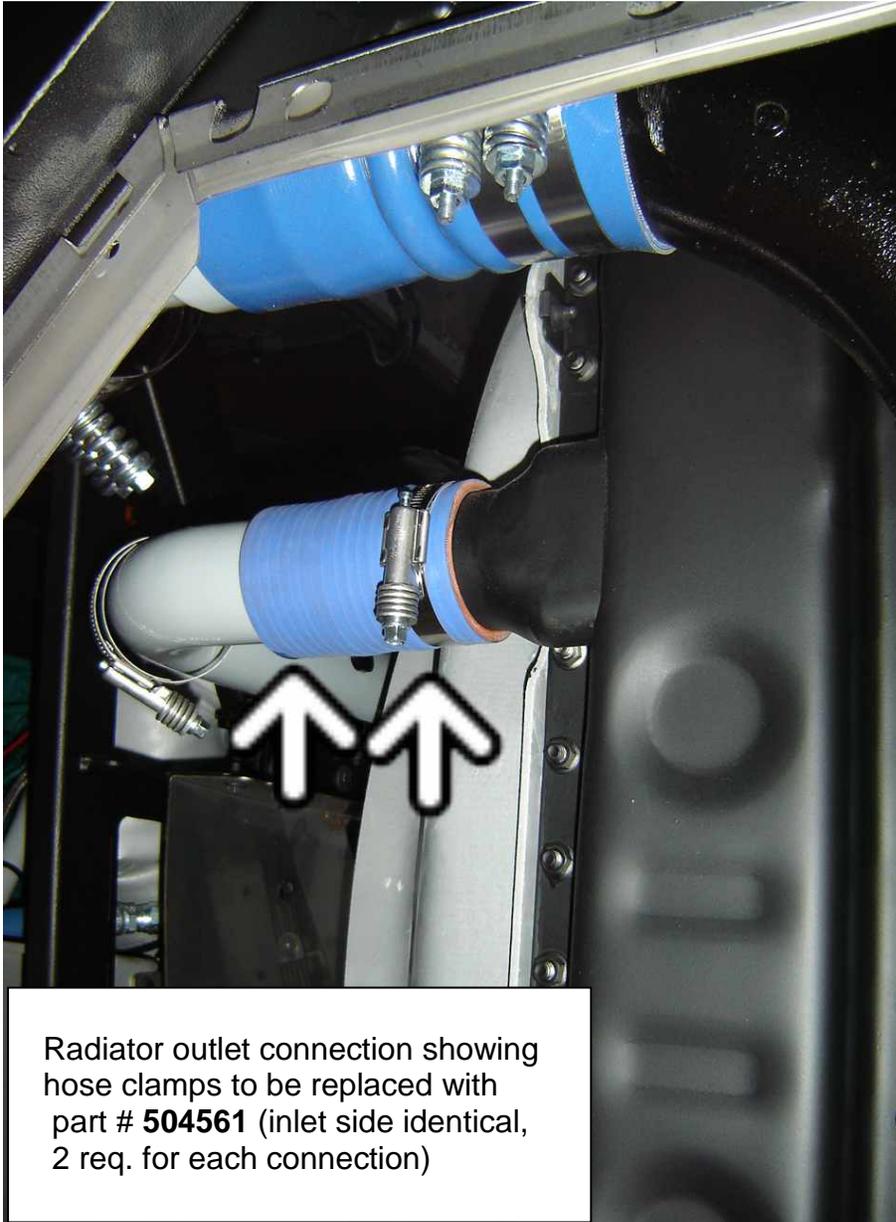
- 7- Replace the four (4) hose clamps on the blue flexible hoses located at the radiator inlet and outlet connection with four (4) new hose clamps (part # **504561**).

NOTE: Clamps replaced at the previous step can be reused on the radiator hoses if they are in good condition.

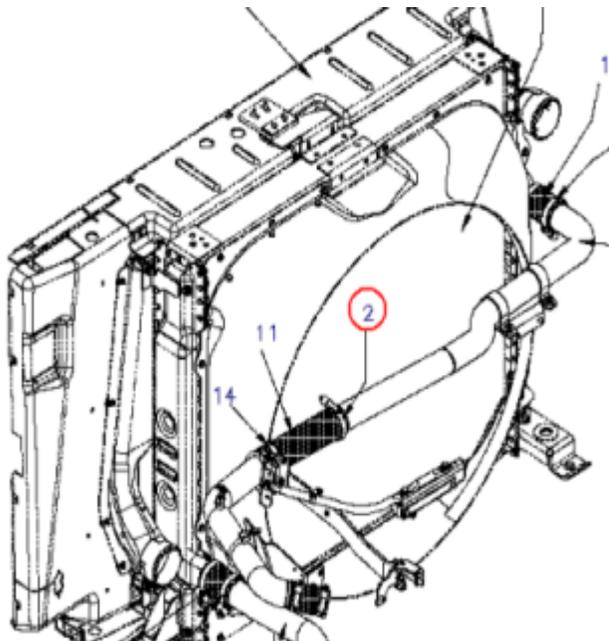
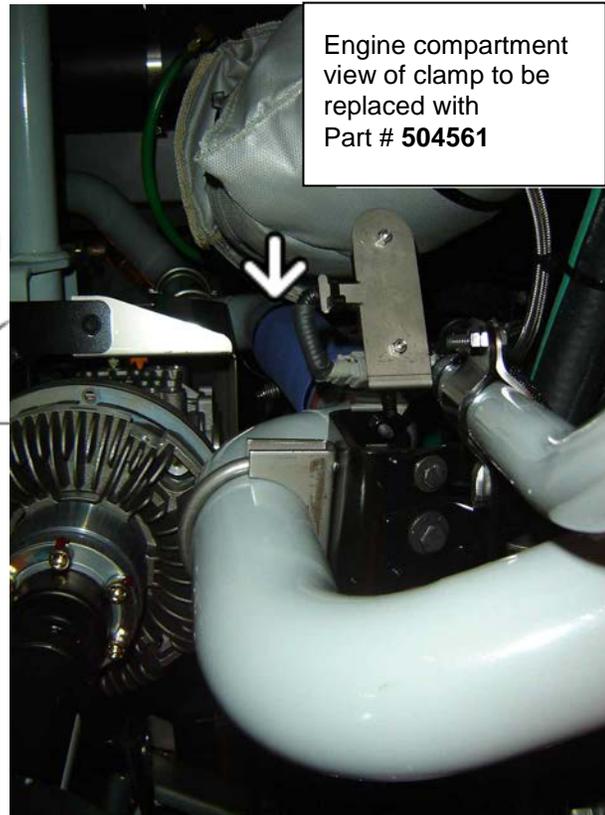
Figure 1

8- On the radiator connecting hose near the turbocharger, replace the hose clamp nearest to the radiator outlet (number 2 on figure 1) with a new hose clamp (part # **504561**).
