PREVOST

MAINTENANCE INFORMATION

Mi98-39

DATE : February 1999	SECTION : 16
SUBJECT : PNEUMATIC DIAGRAM ERROR

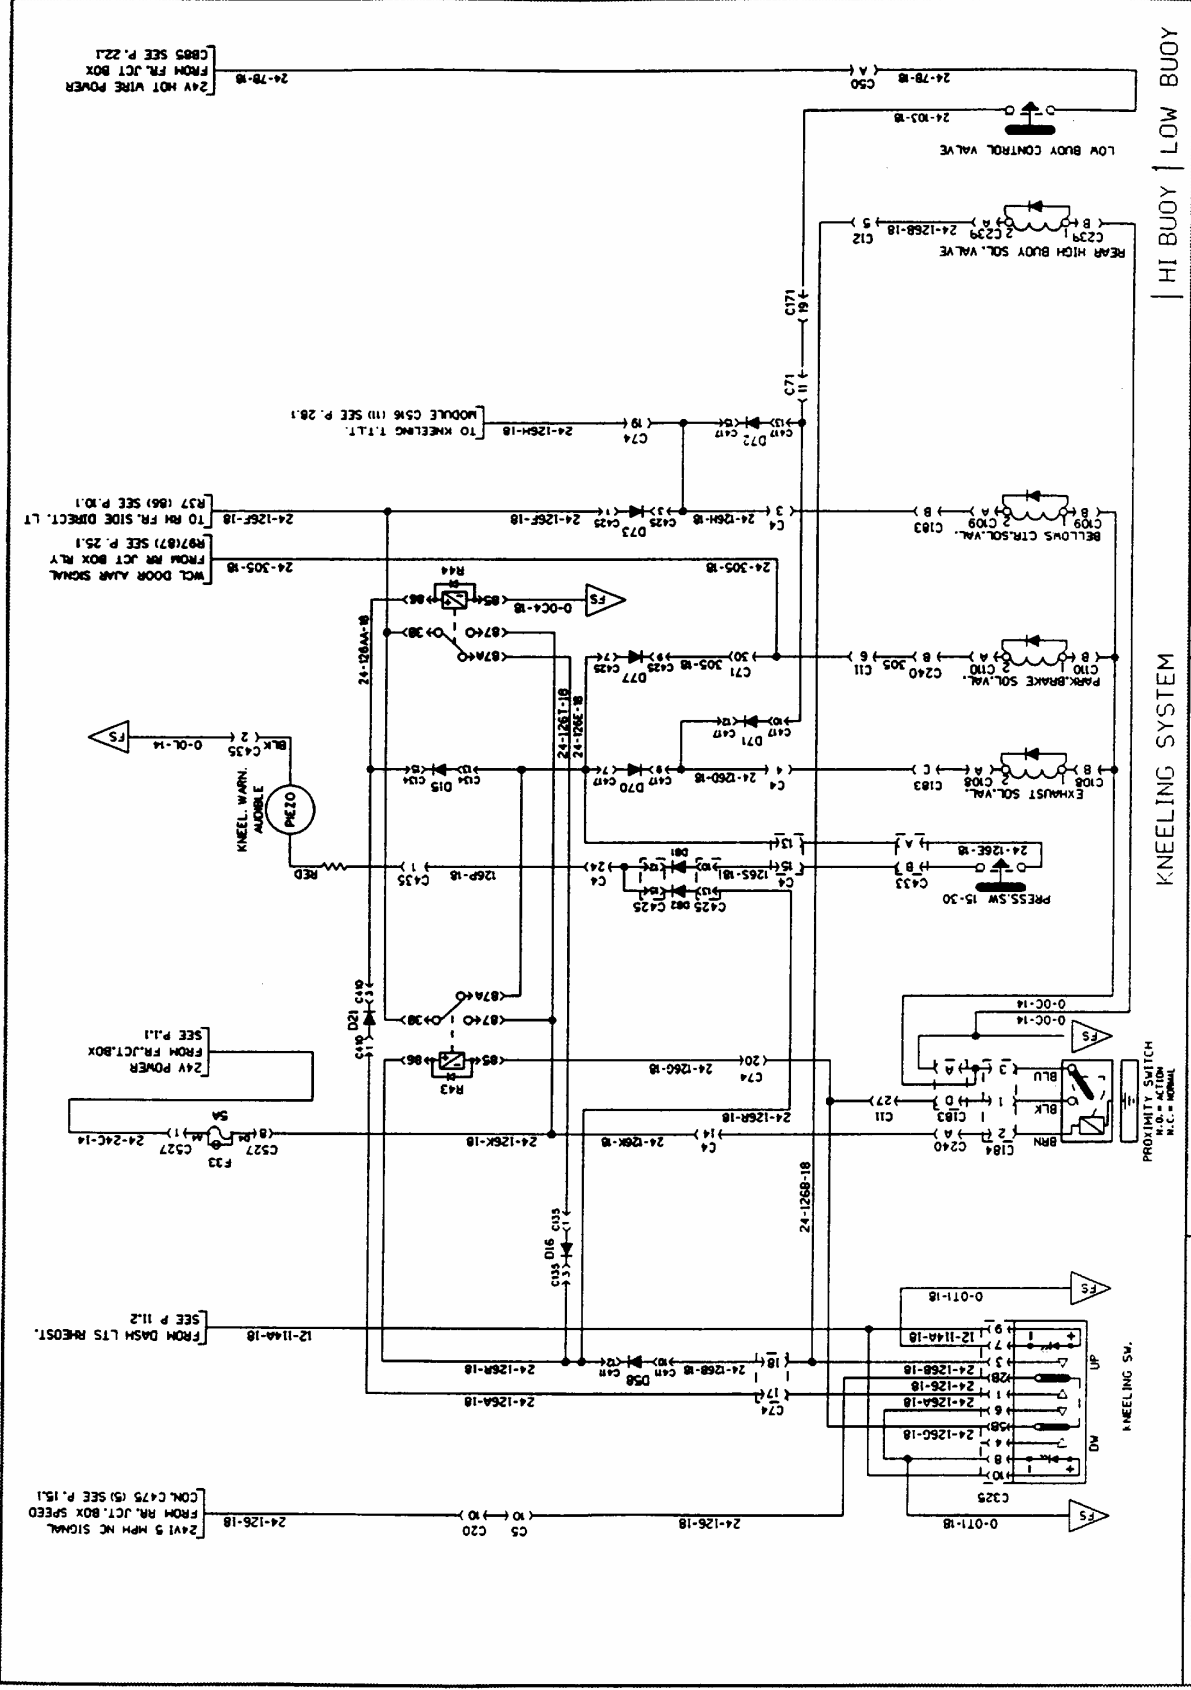
Note: Pneumatic diagram D140219 rev. M and electrical diagram D060902 page 18.1 are included with this maintenance information.

On the above-mentioned vehicles equipped with "Kneeling" option, a mistake occurred between the pneumatic diagram and the electrical diagram. Pneumatic diagram should indicate that C-108 connector is connected to exhaust solenoid valve while C-109 connector is connected to bellows control solenoid valve.

Note: No vehicle modification is necessary, only write down a note on the pneumatic diagram about connector hooking.
