SAFETY RECALL

Sr06-10

DATE : OCTOBER 2006	SECTION : 12
SUBJECT : BENDIX® SR-7™ SPRING BRAKE MODULATING VALVE

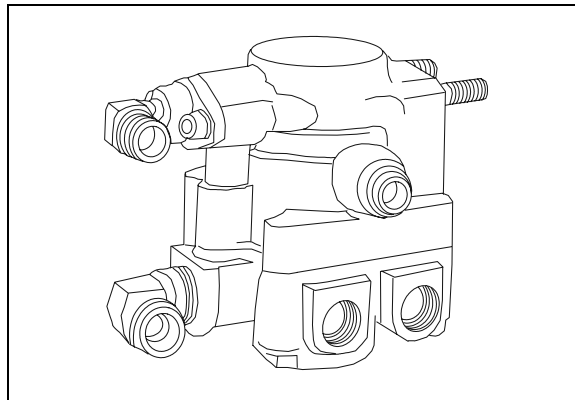
FIGURE1: SR-7 VALVE

Bendix has determined that a check valve inside the Bendix® SR-7™ spring brake modulating valve may not properly seat, causing internal valve leakage. The leakage can result in delayed application of the spring brakes to park the vehicle upon pulling of the dash valve button. The delay, which could last up to three minutes, may be accompanied by secondary air leakage, such that the secondary reservoir is depleted. During this time, there is a risk that the vehicle can roll away. This issue does not affect the operation of the vehicles service brakes, however it could affect the emergency stopping distance in the event of a primary air system failure application of parking brakes.

3. Remove the L.H. side hinged rear fender or raise the vehicle to access the spring brake valve.
4. Identify all lines before disconnecting then disconnect the lines and hoses from the spring brake valve.
5. Remove the two mounting nuts that secure the valve to the frame rail then remove the valve.

1. Align the mounting studs with the mounting holes on the vehicle frame rail. Tighten the mounting nuts to 180-220 inch-lbs.
2. Install the valve (642015) onto the vehicle ensuring all ports are connected as marked during disassembly.

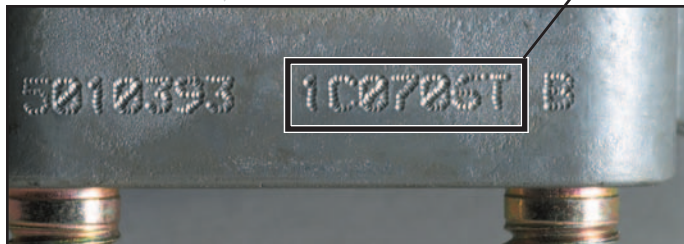
Step 2: Identify the date of manufacture.
(Date code located on the top of the valve as shown.)

SR-7™ valves with the casting code "Bendix 1" manufactured between April 1, 2006 and May 24, 2006 are subject to the recall campaign and must be replaced.

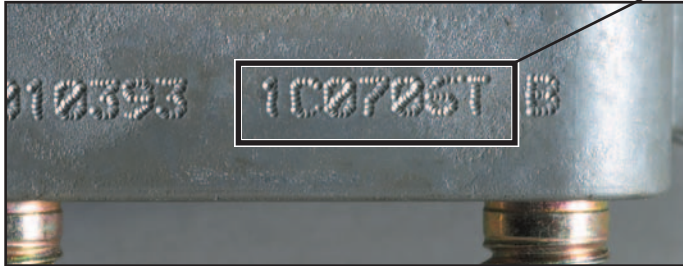
Date Code Location

The key date code characters used for identification are the 2nd through the 6th alphanumeric characters; all others can be disregarded.

The second character in the date code is an alpha character representing the month of manufacture (A through M skipping the letter I) corresponding to January through December (D = April and E = May). The next four characters are numbers representing the two digit day of the month followed by the two digit year. For example the date code 1C0706T, key characters C0706, indicates the valve was manufactured 3-07-06 or March 7, 2006.

D0106 (April 1, 2006) through _E2406_ (May 24, 2006) inclusive.
