PREVOST

**SAFETY
 RECALL**

Sr09-09

DATE : JUNE 2009	SECTION : 14-STEERING
SUBJECT : INSPECTION AND REPLACEMENT OF DRAG LINK SPHERICAL PLAIN BEARING ROD END

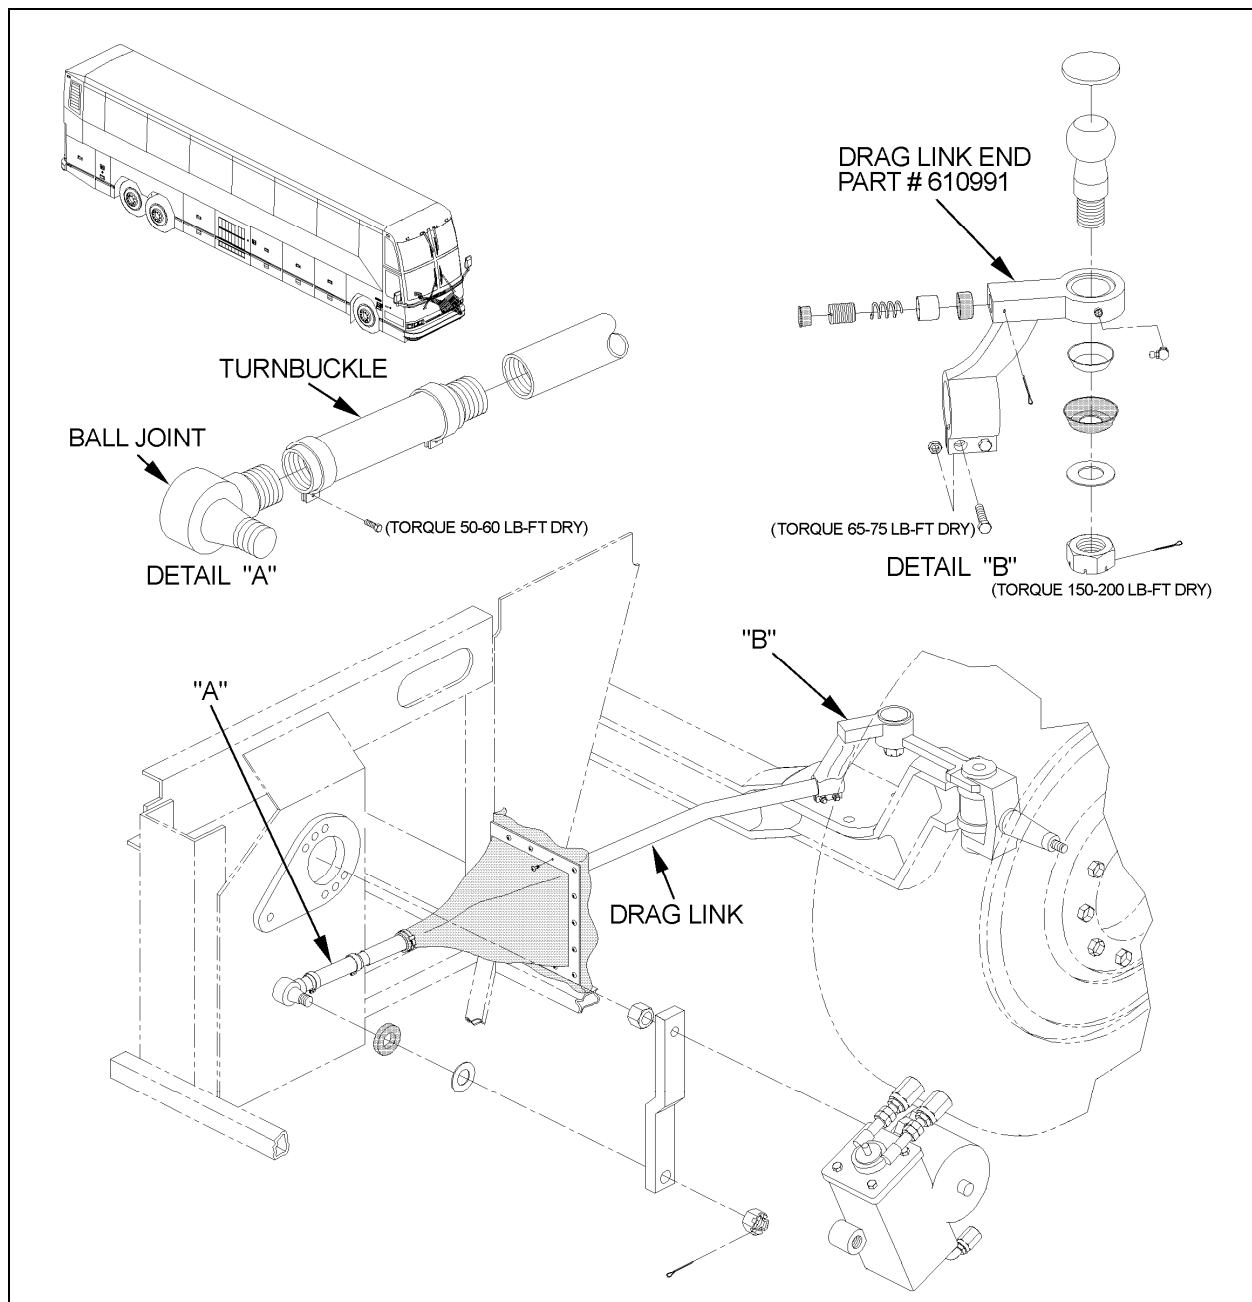
FIGURE 6

1. At drag link spherical plain bearing rod end remove cotter pin from castle nut then remove castle nut (Refer to figure 6).
2. Separate L.H. steering arm from ball joint.
3. Unfasten two pinching bolts from drag link end.
4. Unfasten drag link end from drag link.

5. Install new drag link end (610991). Fasten drag link end onto drag link the same number of turns as previously removed.

6. Reconnect steering arm to ball joint, torque tighten castle nut to 150-200 lb-ft dry.
7. Install new cotter pin (502104).
8. Torque tighten two drag link end pinching bolts to 65-75 Lb-Ft dry.

If this is not the case, unfasten turnbuckle collar nuts on drag link and turn turnbuckle in order to center steering wheel. Retighten collar nuts to 50-60 Lb-Ft dry (Refer to figure 6).

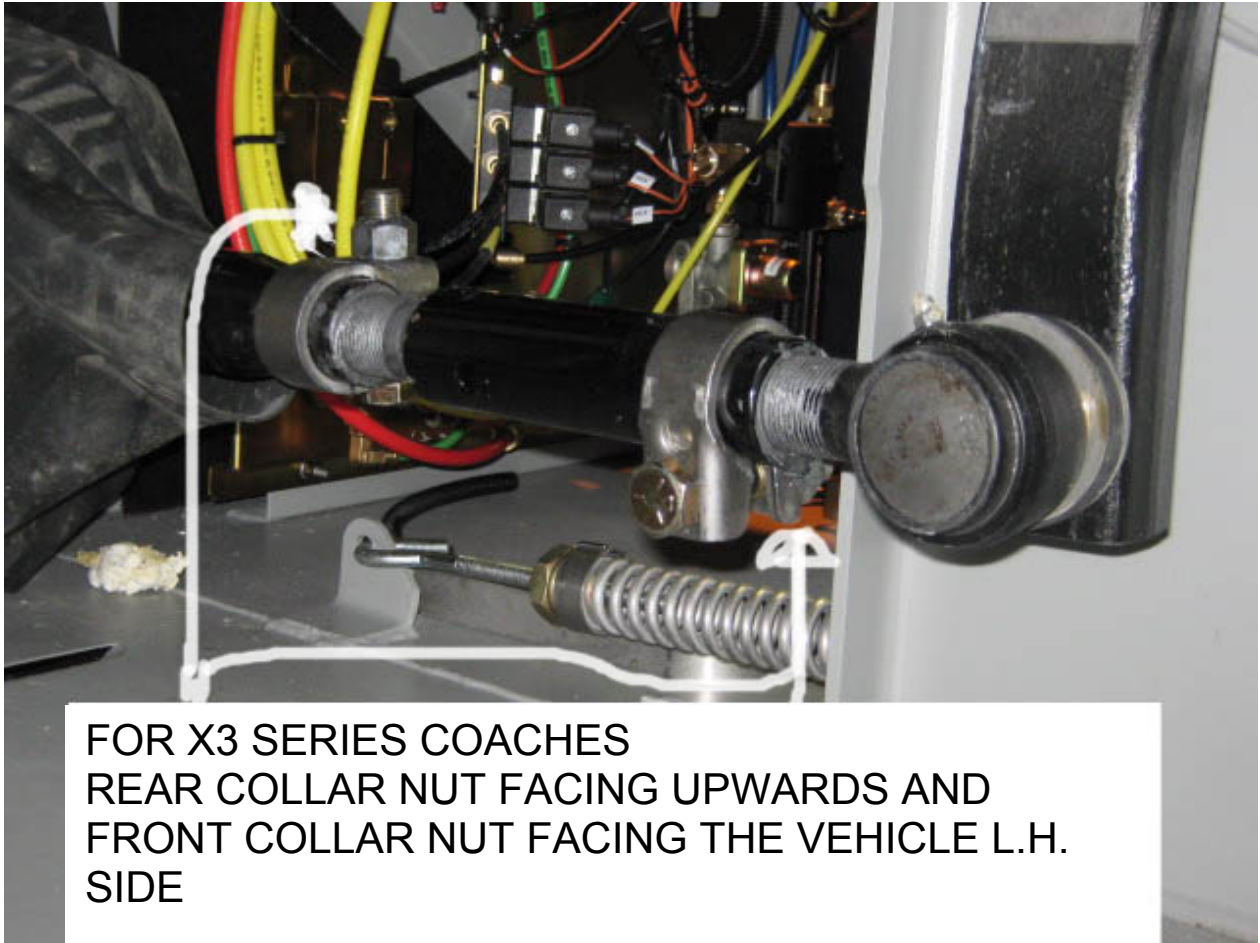
FOR X3 SERIES COACHES
REAR COLLAR NUT FACING UPWARDS AND
FRONT COLLAR NUT FACING THE VEHICLE L.H.
SIDE

To prevent interference when reaching maximum steer angle, make sure to properly reposition turnbuckle collars.

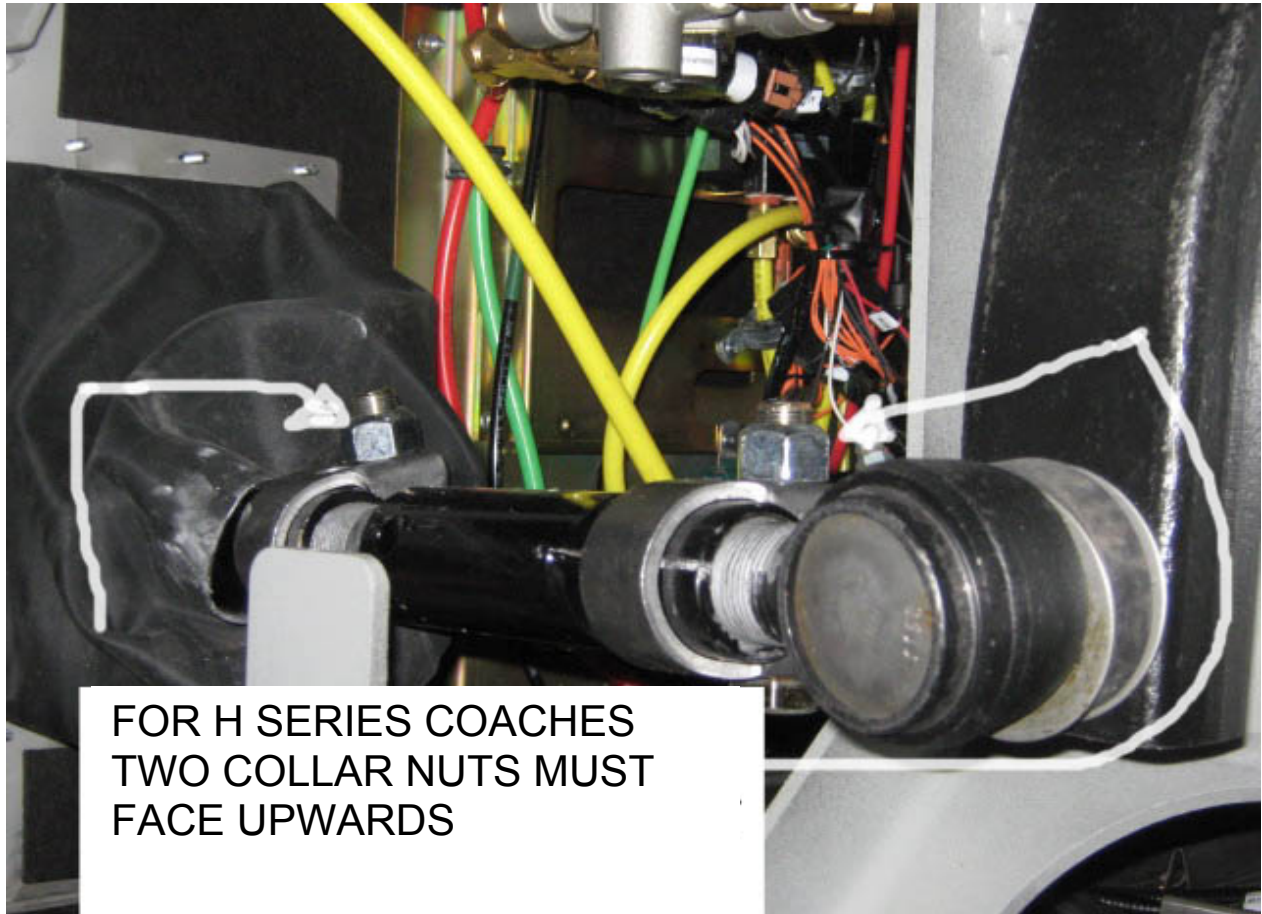
FOR H SERIES COACHES
TWO COLLAR NUTS MUST
FACE UPWARDS
