PREVOST

**SAFETY
RECALL**

Sr12-26

DATE : JULY 2012	SECTION : 06-ELECTRICAL
SUBJECT : POWER CABLE RUBBING PROTECTION

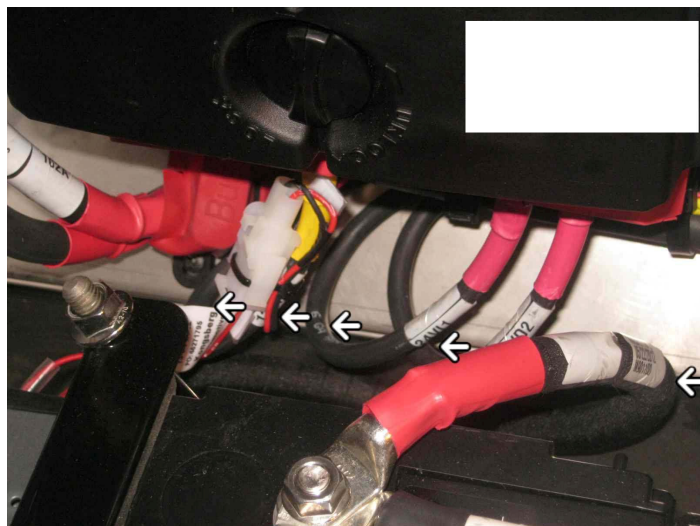
2. No cable should touch this edge even if it is rounded.

Along the complete edge, make sure that no cable touches it.

If required, use cable ties to route cables away from the edge.

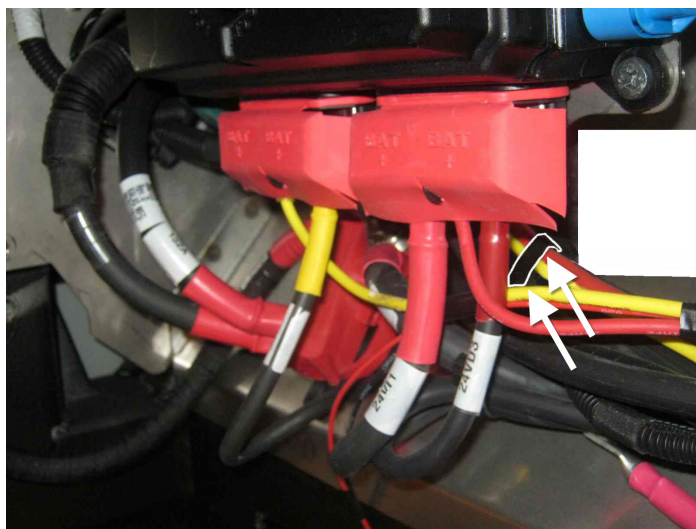
3. Make sure this cable tie is tight (arrows). It is mounted on a cable tie base.

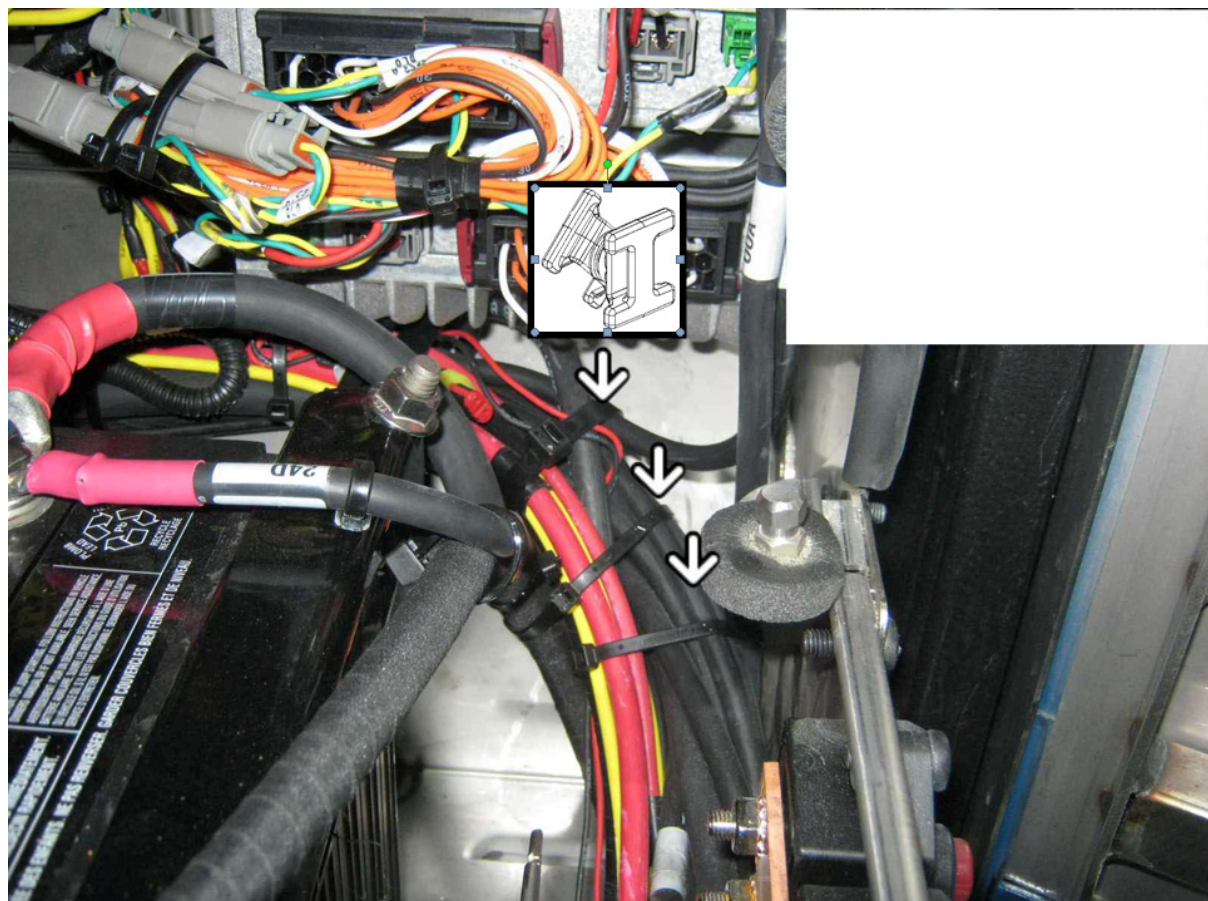
Secure cable bundle at arrow locations making sure to clear the heat sink of the nearby Multiplex module.

Install #504751 double swivel cable tie base with 509491 cable tie on cable bundle.

Base should be installed behind the bundle and bearing on the edge.

Use base as a permanent spacer to maintain a distance from the edge.

Secure the remainder of the bundle with 504016 cable ties.
