Hose protection for hydraulic pressure pipe 9700 (B13R)

Safety Recall

SR12-65

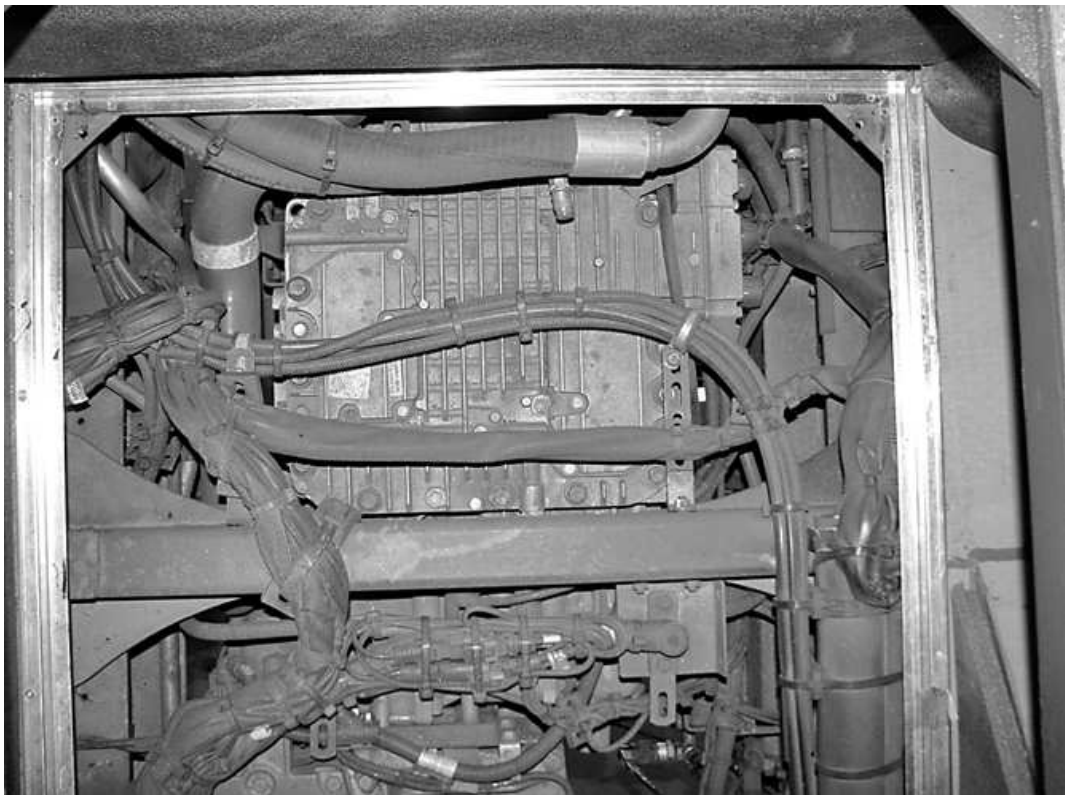
1. Open external and internal service hatches at the gearbox.

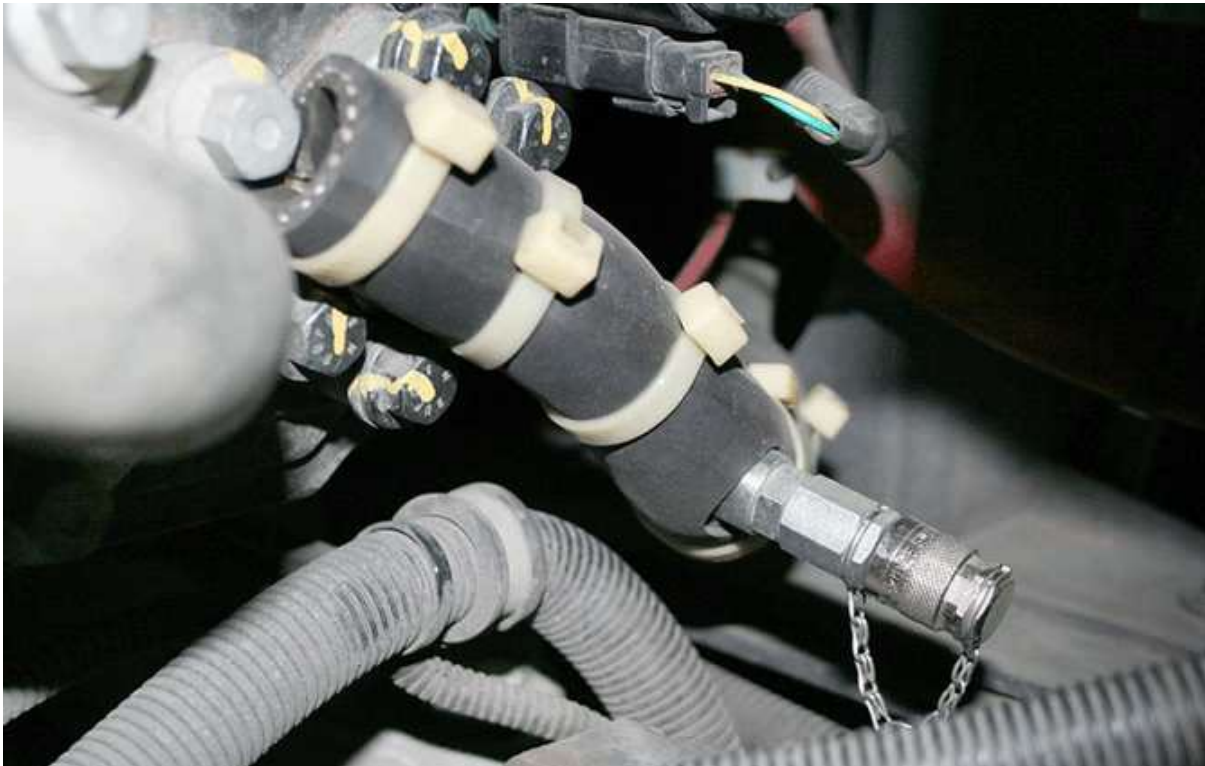
3. Fit the supplied protection hose on the pressure pipe/hose. Rubber protection hose shall cover the whole pipe, up to the connecting flange. Due to the tight bend of the pipe, the protection hose must exceed the pipe end to cover it 100%. (US 10 shown)

Use heat resistant (white) cable ties, p/n 70312532, to secure the protection hose. Make sure the protection hose slit cut is facing downwards when hose is installed on the pipe, thus preventing any risk of oil spray on hot components.
