# SAFETY RECALL

**SR13-26**

DATE : AUGUST 2013	SECTION : 18 - Frame & Finish
SUBJECT : EMERGENCY EXIT SEQUENCE AND PROCEDURE ON AWNING WINDOW DECALS

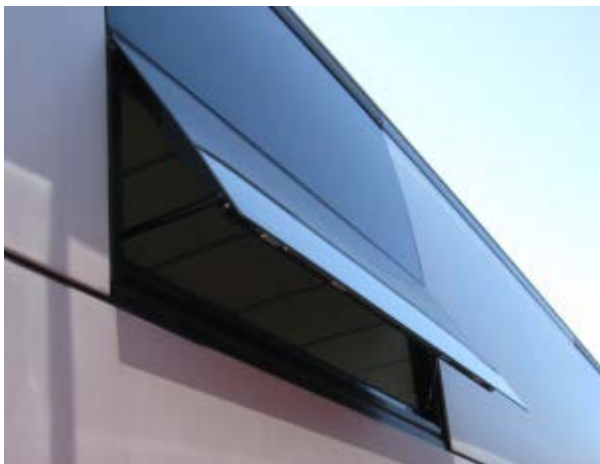
Fig.1 Typical awning-type window

1. Locate the awning window(s) installed on the vehicle (refer to images below for identification).

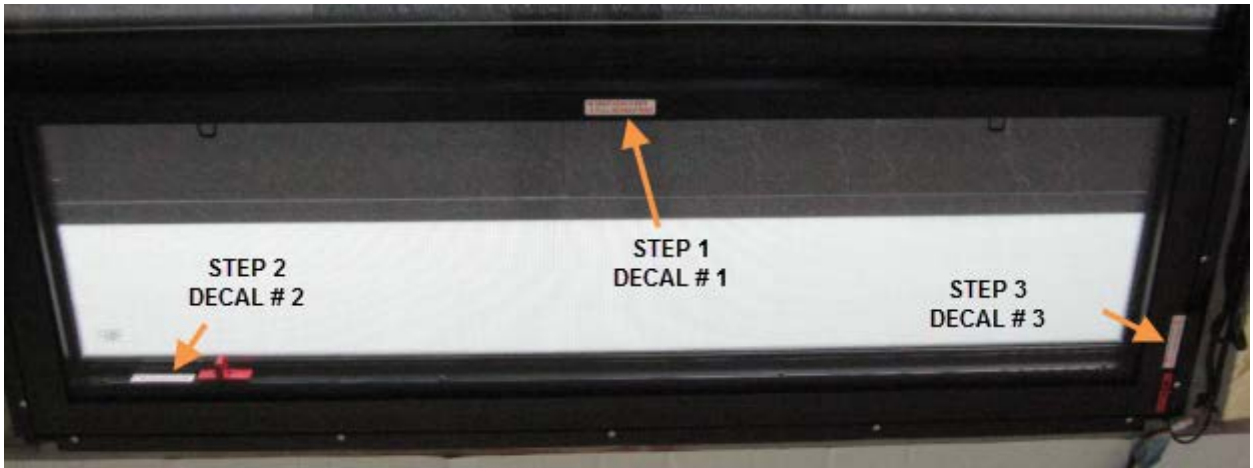
Fig.3 Awning window emergency exit opening sequence.

2. With the window(s) identified, locate the three (3) emergency exit decals around the frame of the window(s).
3. First, make sure that for each identified window, the decals are in the order shown in figure 3.  
In some vehicles, the decals # 2 and # 3 may have been applied in reverse order.

- **IMPORTANT:** The correct emergency opening sequence of the awning-type window is shown below.

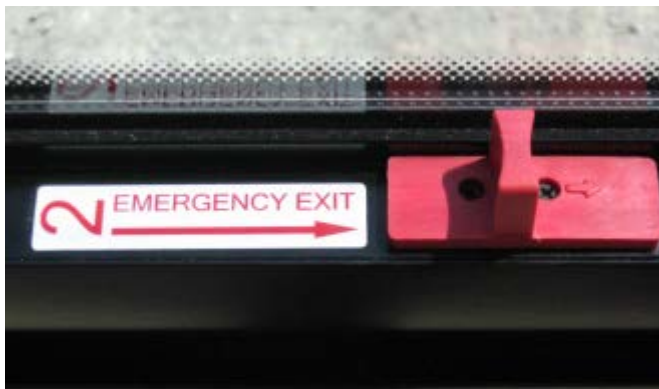
Fig.5 Decal # 2

- Decal # 2 (#790600) must be at the bottom left corner of the window (behind the window screen), pointing toward the safety latch as shown below. If a # 3 decal is present, it must be replaced.

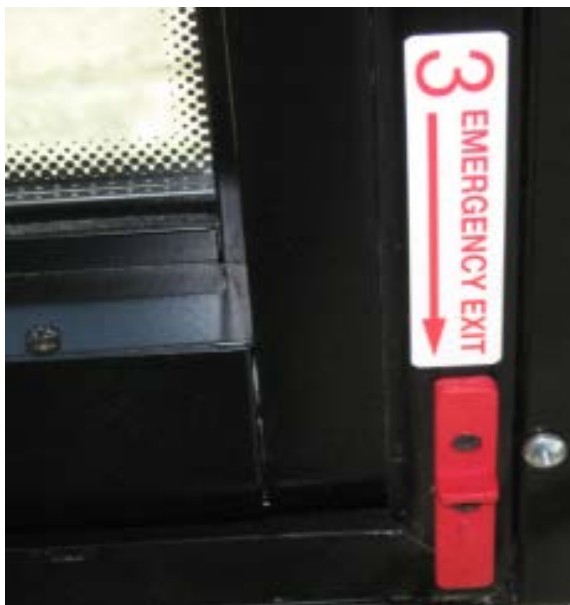
Fig.6b Original Decal To Be Replaced (#790601)

- Decal # 3 (#790601) must be replaced by a new decal (#299098) to provide additional information regarding the opening procedure. It must also be positioned at the bottom right corner of the window, over the second safety latch, pointing downward as shown below.

1. Following the reception of the new decals, prepare the window(s) for the new decals installation. The new decals can be installed over existing ones. To ensure proper adhesion, clean the factory installed decals surfaces with household glass cleaner prior to installation.
2. Peel off the protective backside of the new decals and carefully install them over the factory installed decals on the corresponding window.
3. Check for proper emergency exit operation of the window by opening it following the now correct sequence and procedure.
4. Repeat the procedure for each window.
5. Once the replacement is completed, fill out the “**Safety Recall Certification Sheet**” provided with this bulletin and return it to Prevest for recall follow-up and reimbursement purposes.
