Safety Recall

SR14-82

SLIDING SEATS PEDESTALS INSPECTION AND REPLACEMENT 9700 (B13R) US/CAN

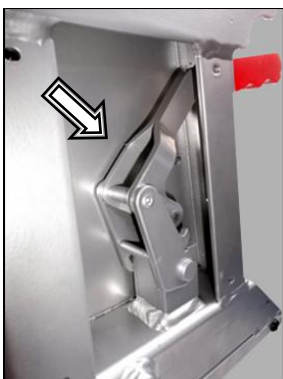
1) Inspection of Lever Mechanism Alignment.

With the pedestal side cover removed, inspect if the lever mechanism is aligned straight (as showed on picture below). If there is any deformation on the hand lever or any interference generated between components, likely caused by the over-torqueing or general misuse of the lever, it is necessary to replace the entire pedestal.

NOTE: If no damage is found go to next step, if damage is found go to Part II step 6 according to this bulletin.

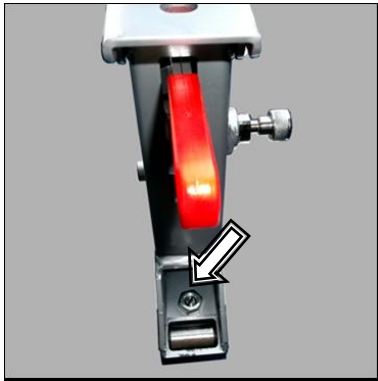
2) Inspection of the Adjusting Screw

Remove both adjusting screw covers; you will see the adjusting screw which permits the tightening of the guides. First inspect if the screw is loose; a loose screw could be caused by inadequate service. If you identify a loose screw, follow the adjusting instructions shown in Part II step 11

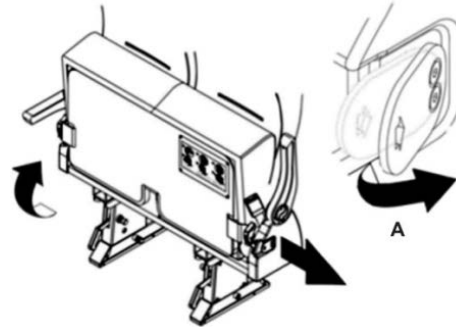
- 5) Pull the side lever (A) to release and flip up the seat cushion.

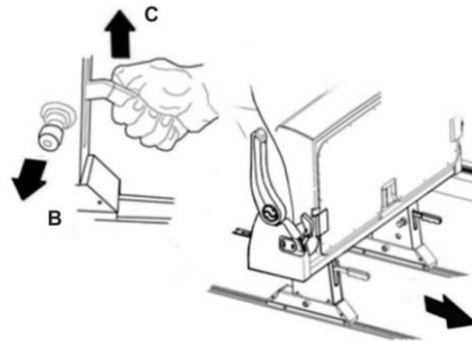
- 6) Pull the lock (B) and use your hand to move the lever up (C).

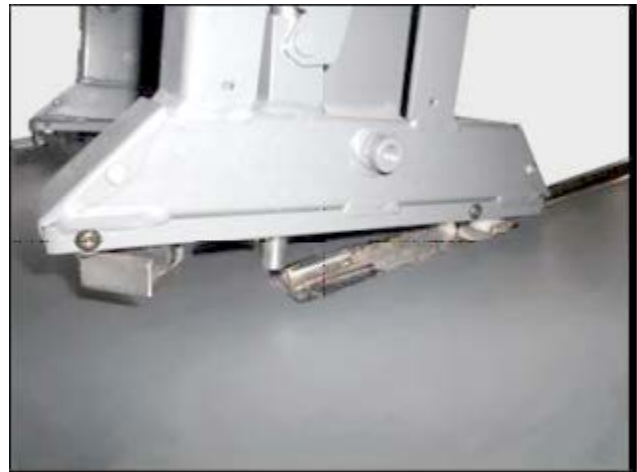
- 7) Slide the seat to the end of the rail and remove it.

The sliding seat is heavy and bulky. Be sure to use necessary lifting equipment. In case of failure, the sliding seat may fall suddenly and cause injuries.

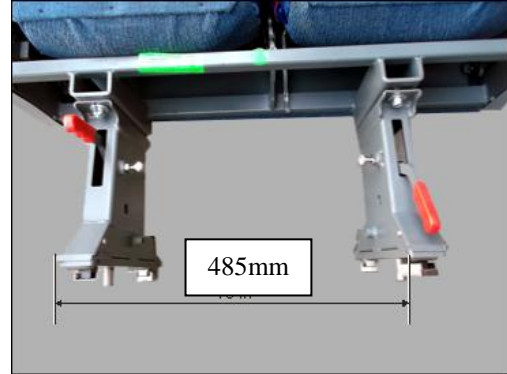
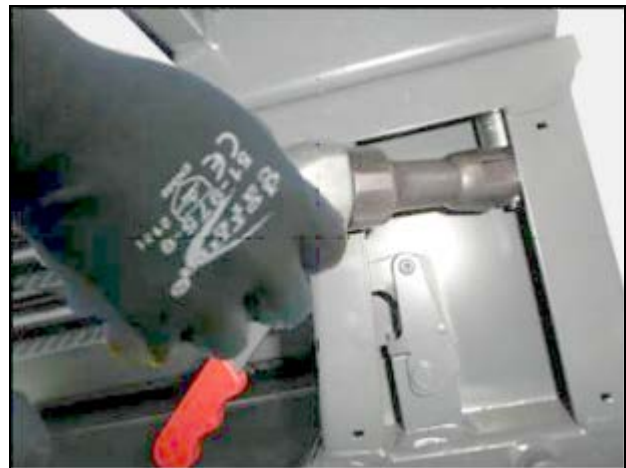
- 1.1 Install the new sliding pedestal(s) and tighten lightly, the distance between pedestals must be 485mm (19.1po).

NOTE: Make sure the guides are aligned to the rails.

- 1.2 Move the lever down and fix the pedestal

NOTE: Make sure that the seat slide freely, otherwise perform adjustment procedure Part II, step 11.

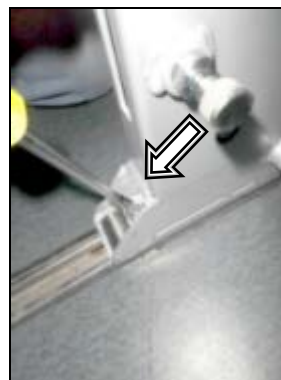
- 9) Adjustment Procedure.

- 9.1 Remove both adjusting screw covers.

- 9.2 Loosen the nut and hand tight the screws, back off 1.5 turns and tighten the nut.

NOTE: Be sure to untighten the screw one and a half turns in order to allow some clearance between the slider and the rail.

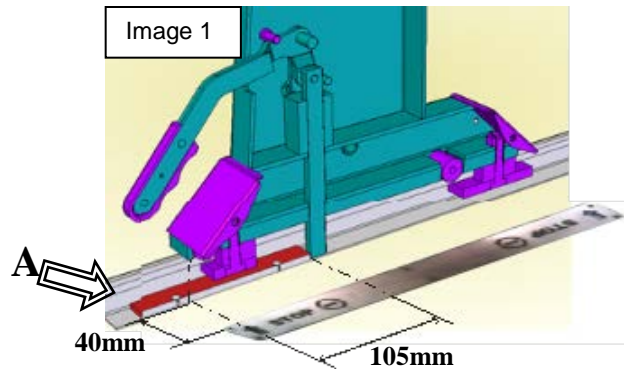
- 1) Install the plates according to the dimensions an orientation shown in images 1 and 2. Use the stopper plate as reference (A).

NOTE: Each sliding seat requires two plates.

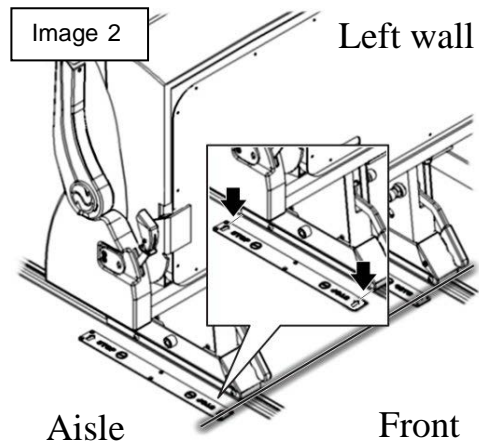
The edges of the pedestal need to be aligned with the arrows on the lateral plate. Do not try to push the levers down if the pedestal is not aligned with the arrows.

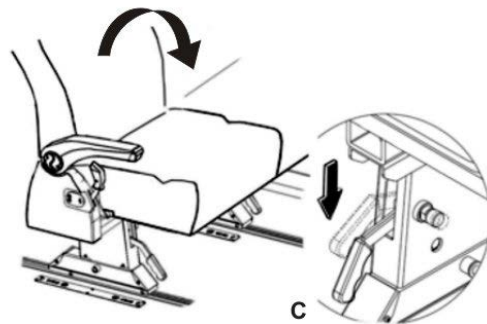
- 2) Push down the lever (C) using your hand. And fold the seat cushion down.

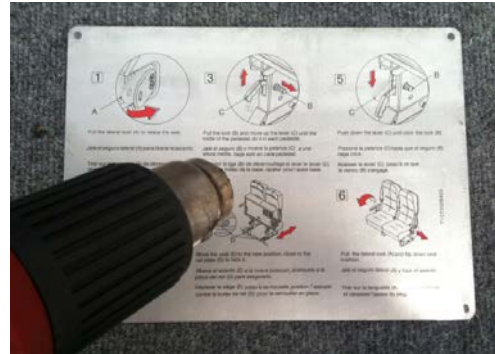
- 1) Heat with a heat gun and remove the decal.

NOTE: Clean remaining glue.

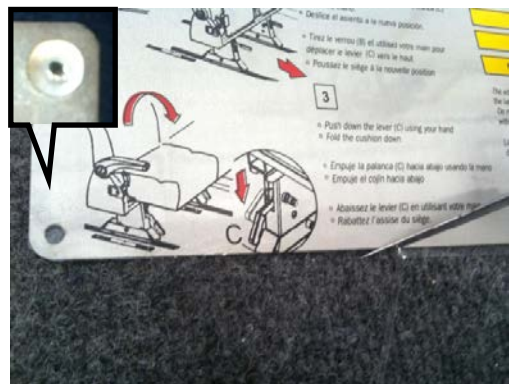
- 2) Stick and trim surplus material according to the plate profile.
