**WARRANTY
BULLETIN**

Wb08-09

DATE : JULY 2008	SECTION : 16 - Suspension
EXPIRATION: JULY 2010	
SUBJECT : REMOVAL OF EXPANSION TANKS LOCATED ABOVE DRIVE AXLE SUPPORT FRAME DOUBLE CROSS MEMBER

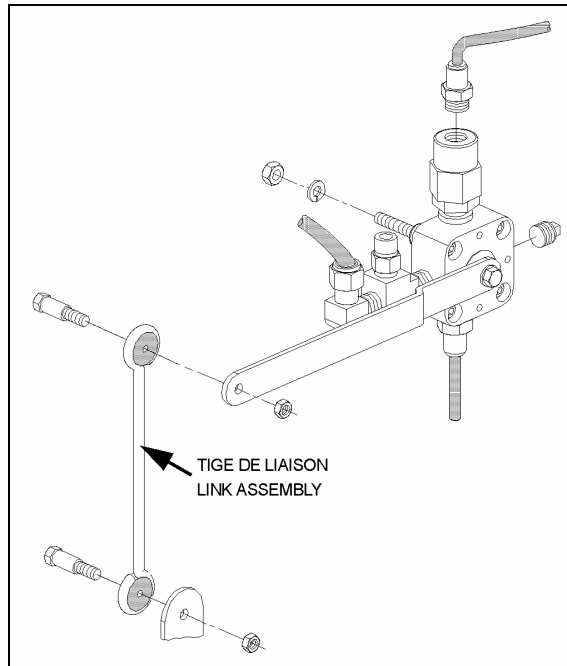
FIGURE 2

3. Remove the air from the drive axle support frame air springs. To do so, dismantle the link assembly from the height control valves (Refer to figure 2). Lower the valve lever to purge the air from the air springs.

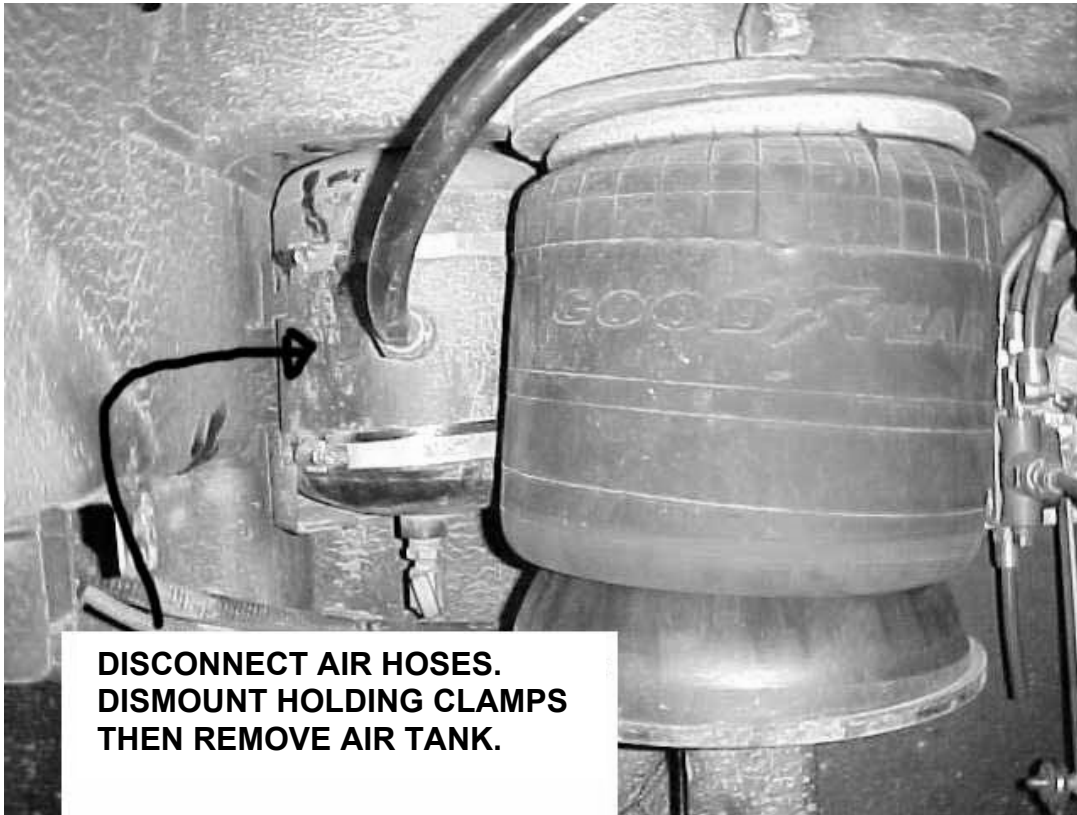
FIGURE 3

On the above-mentioned vehicles, the L.H. side and R.H. side expansion tanks located above the drive axle support frame double cross member must be removed. There is a possibility for the expansion tanks to rub against the air springs and thus create premature wear.

4. Raise rear of the vehicle using the tag axle jacking points.
5. Remove air hoses and fittings from expansion tanks.
6. Dismount air tank holding clamps then remove air tanks (Refer to figure 3).

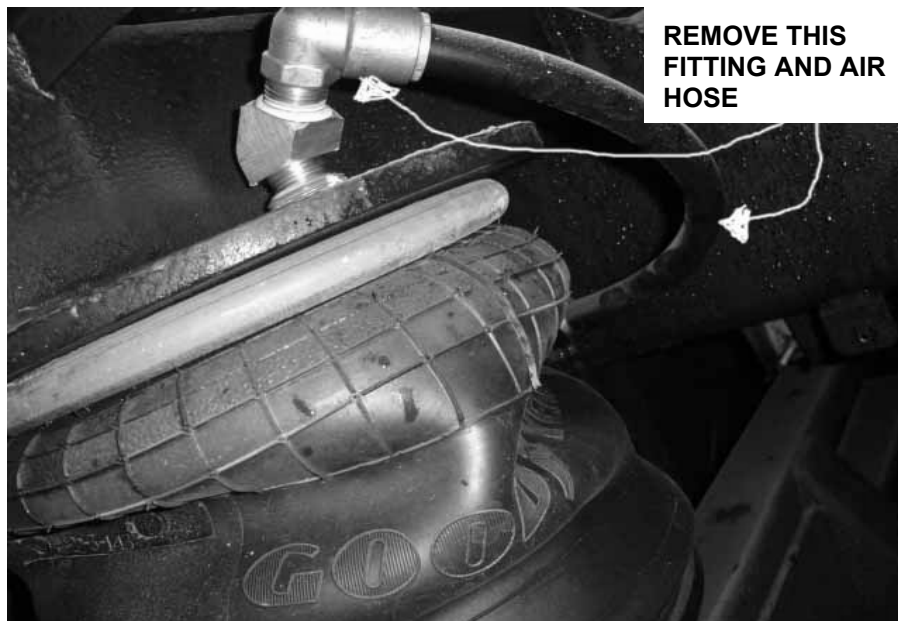
FIGURE 4

7. Remove elbow fitting located on top of air spring (Refer to figure 4).

8. Install elbow fitting (641175) onto top of air spring.

Apply some "Loctite 567 Thread Sealant" onto fittings.

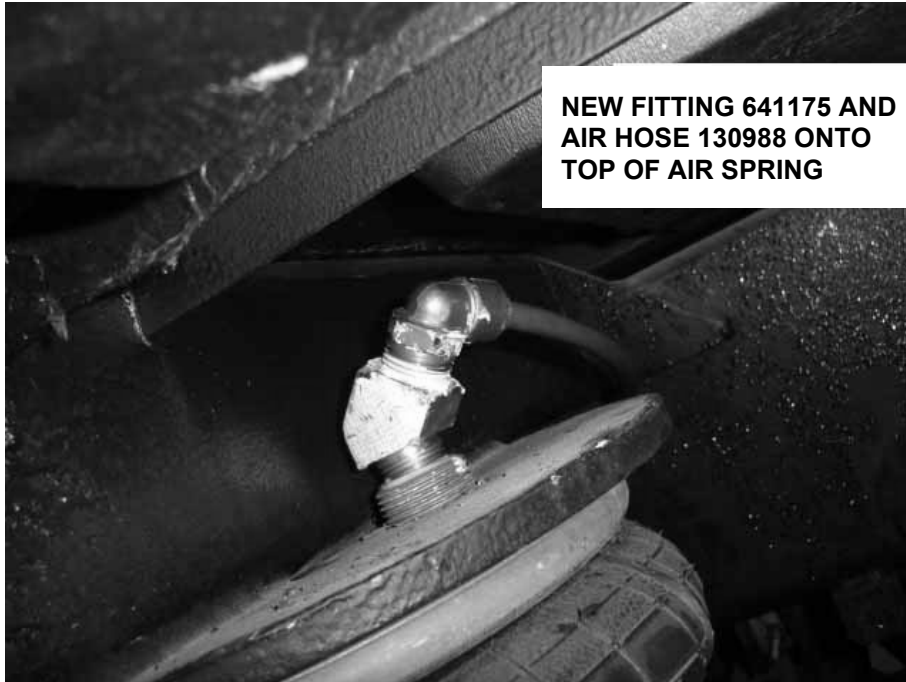
9. Connect 43" long air hose (130988) between elbow fitting located onto top of air spring and height control valve (Refer to figures 5 and 6).

10. Secure new hose using nylon ties (Ty-rap).
11. Pressurize the air system and check for leaks.
12. Reinstall the protective panels located in front of drive axle wheels.
