PREVOST

**WARRANTY
BULLETIN**

WB13-58

DATE :	OCTOBER 2013	SECTION :	01 - Engine
EXPIRATION:	OCTOBER 2015		
SUBJECT :	AIR INTAKE HOSE REPLACEMENT

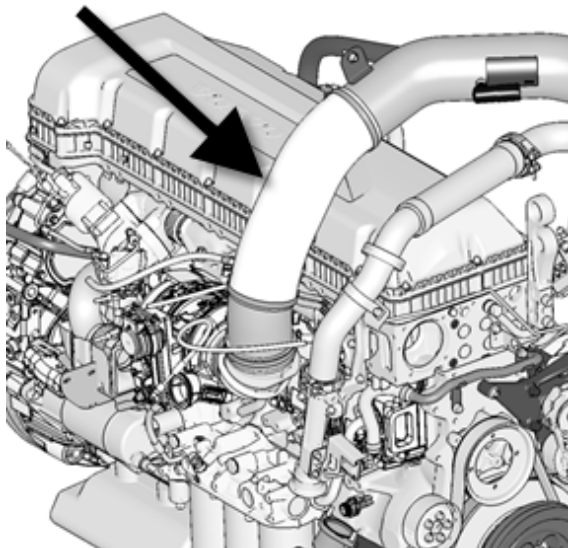
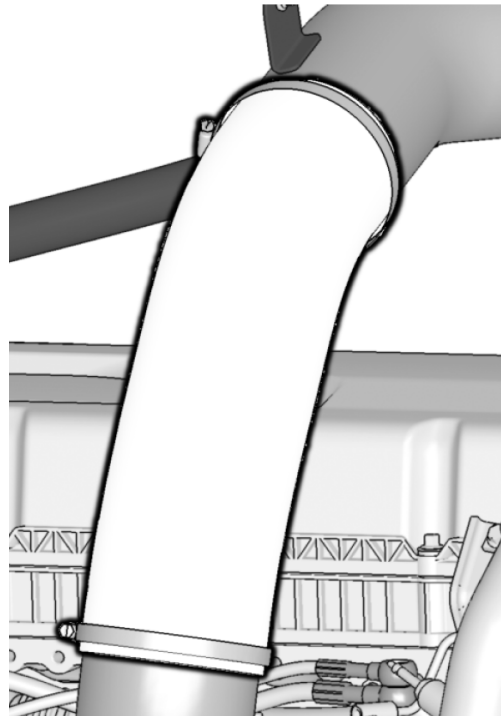
1. On the engine, locate this air intake flexible hose on the left side of the engine.

2. Remove the clamps and hose
3. Install a clean cap on engine air intake to protect from dust and debris.
4. Replace by new hose #033195 and #504786 clamps.

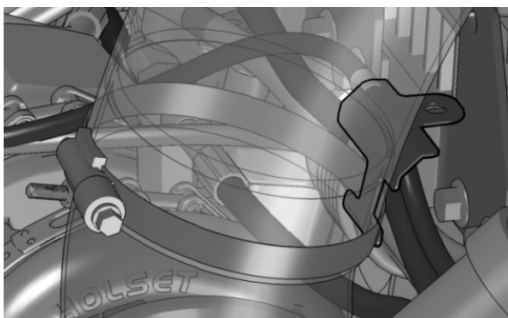
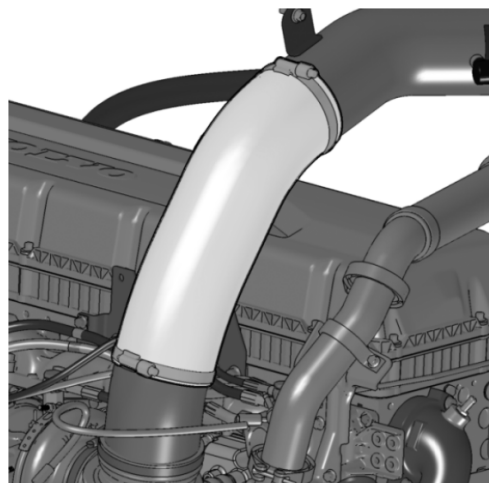
Attach lower clamp to support provided in this area.

5. Pay particular attention to the tail of the clamp to make sure it does not touch any hoses in the surrounding area.

Re-orient or shorten the tail if required.

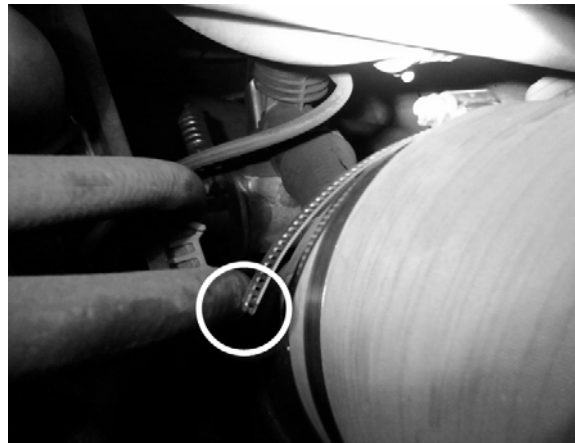
6. Verify for any air leaks and ensure proper operation.
