PREVOST

**WARRANTY
BULLETIN**

WB13-63A

DATE :	OCTOBER 2013	SECTION :	06 - Electrical
EXPIRATION:	OCTOBER 2015		
SUBJECT :	70 AMP CIRCUIT BREAKER INSPECTION AND REPLACEMENT

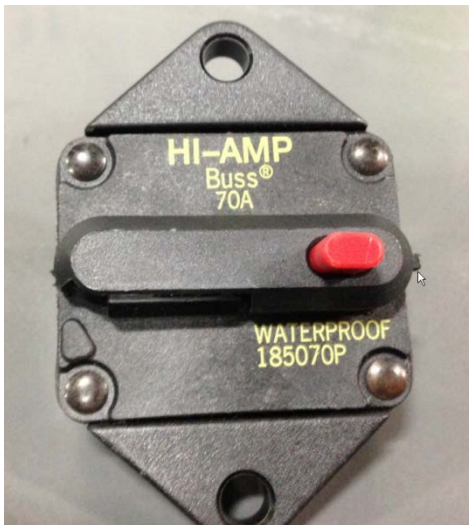
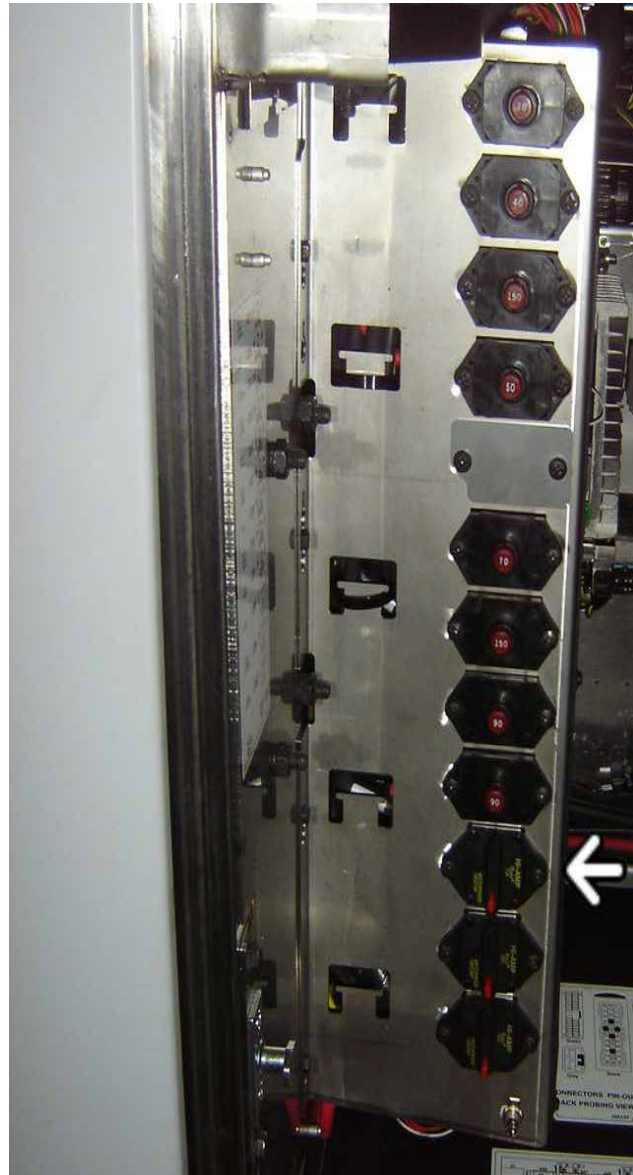
3. H3 coach:

Locate CB6

4. H3-45 VIP shells:

Locate CB4 and CB6

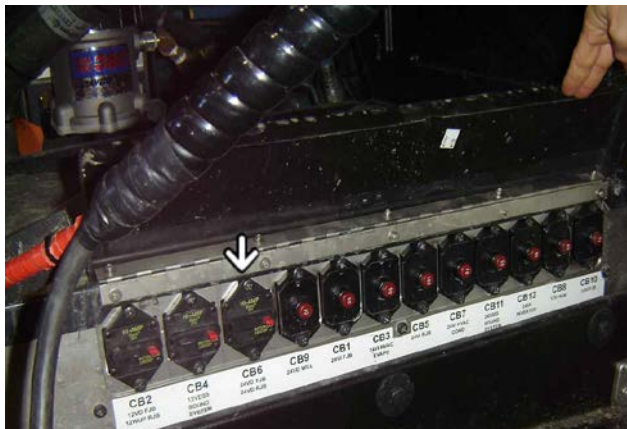
5. X3-45 coach:

Locate CB6

6. LeMirage XLII Entertainer:

Locate CB2

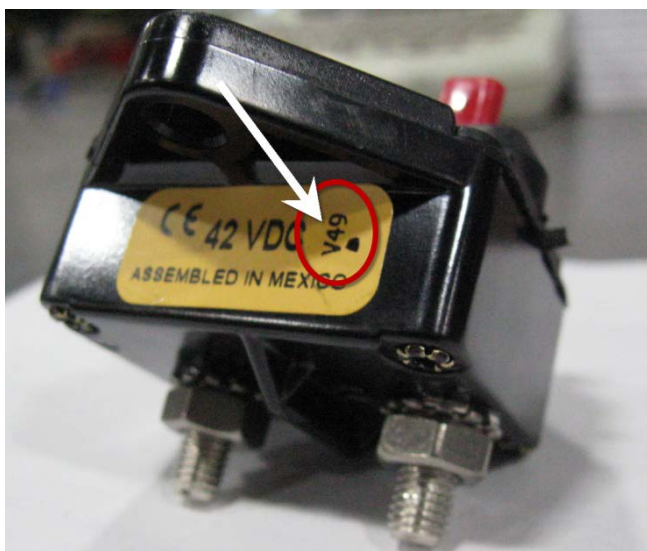
9. Fabrication code is on this label. Letter indicates year, numbers indicate week from 1 to 52.

10. If fabrication code is not included in defective range from **U19** to **V50 inclusively** no replacement is required.

11. If fabrication code is within defective range **U19** to **V50 inclusively**, replace breaker with new part #563424.

12. Make sure replacement breaker fabrication code is not included in defective range.

13. Install breaker.

Tighten mounting screws to 5 lbf-ft.
(60 lbf-in).
