PREVOST

WARRANTY BULLETIN

WB14-31

DATE :	JULY 2014	SECTION :	18 - Body
EXPIRATION:	JULY 2016		
SUBJECT :	CABLE PROTECTION IN FRONT FENDER

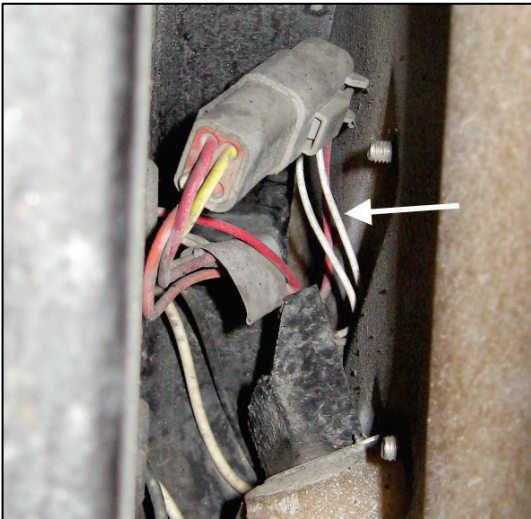
Figure 1

1. Looking in the gap between the fiberglass fender and the bus structure (Fig.1 & 2), perform a thorough inspection of the door switch wires between grommet and connector (Fig. 2 & 3) using a mirror to inspect all around wires.

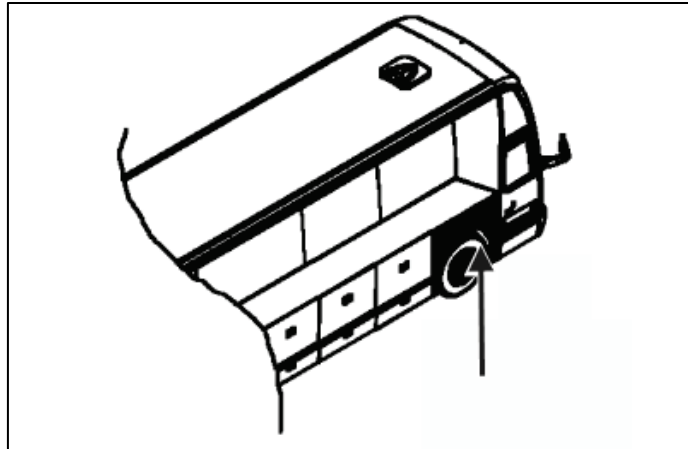
Figure 2

Check that the insulation material of the 3 wires is intact and in good condition. (Fig. 2, 3)
