# PREVOST

## WARRANTY BULLETIN

**WB15-06C**

DATE :	FEBRUARY 2015	SECTION :	06 - Electrical
EXPIRATION:	FEBRUARY 2017		
SUBJECT :	067954 CURRENT SENSOR INSPECTION AND REPLACEMENT

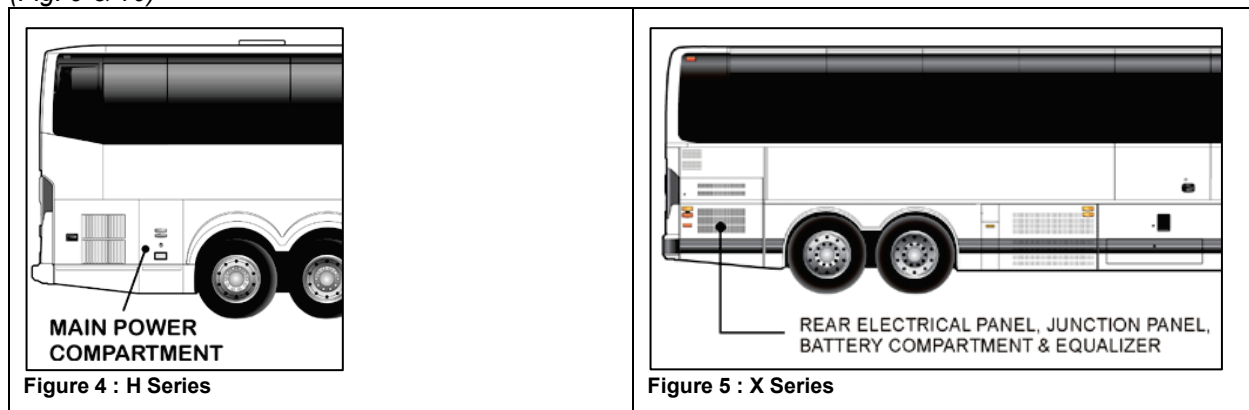
2. Locate sensors next to batteries (Fig 7 & 8). Defective Sensors have a serial number starting with **14300, 14307 or 14314** (Fig 6). If found, consult **Table 2** below to confirm serial number is part of list.

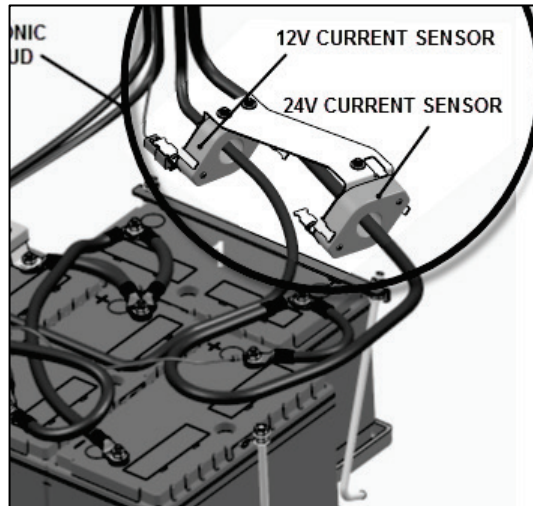
Figure 7 : H series

**H series vehicles:** *we recommend using an inspection mirror.*

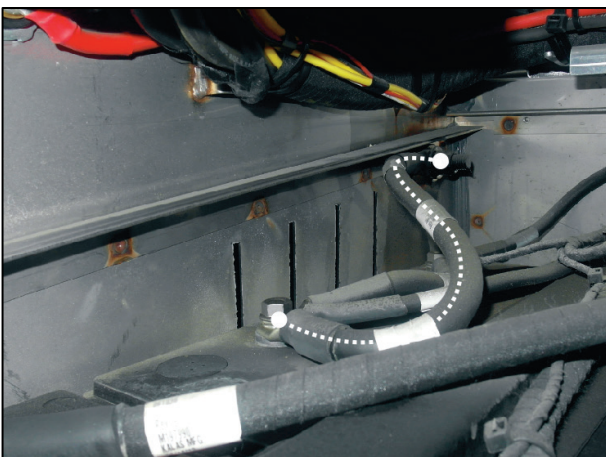
Figure 9 : H Series Ground

*We recommend disconnecting the battery ground prior to inspection to prevent accidental reconnection. (Fig. 9 & 10)*

3. Replace faulty sensor following instructions below. Reserve hardware for re-assembly.
4. Reserve removed sensor for warranty return process.
5. **Make sure battery ground on left side of battery bank is removed before performing any work.**

12. Replace sensor by a new #067954.
13. Make sure new part's serial number is not part of defective list in table 2.
14. Reconnect 12V and / or 24 V cables. Tighten to 170 lbf-in (14 lbf-ft)
15. Reconnect ground cable last. Tighten to 170 lbf-in (14 lbf-ft)

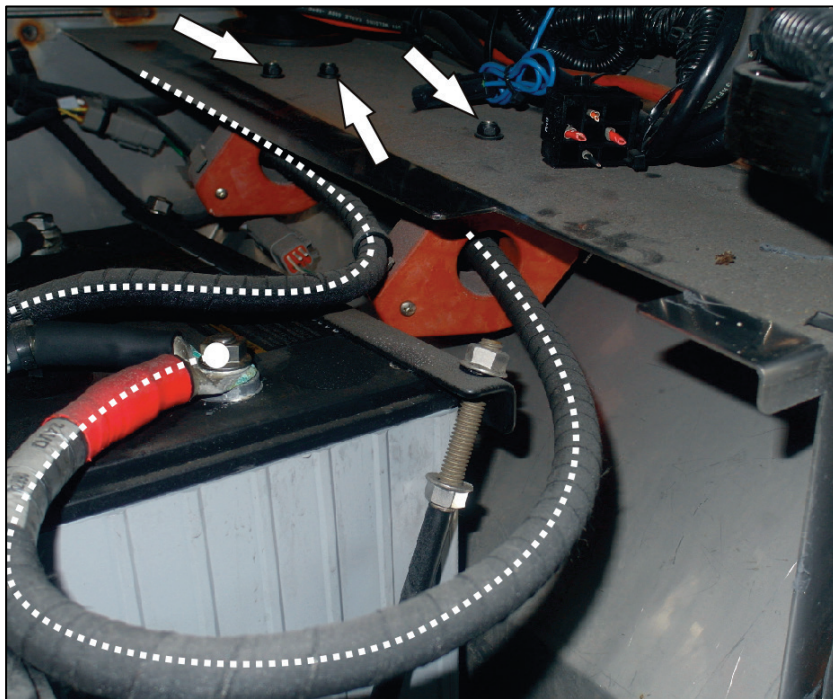
Figure 11 : H Series Power Cables

6. Remove 12V and / or 24 V power cables to allow sensor removal. (Fig. 11 & 12)

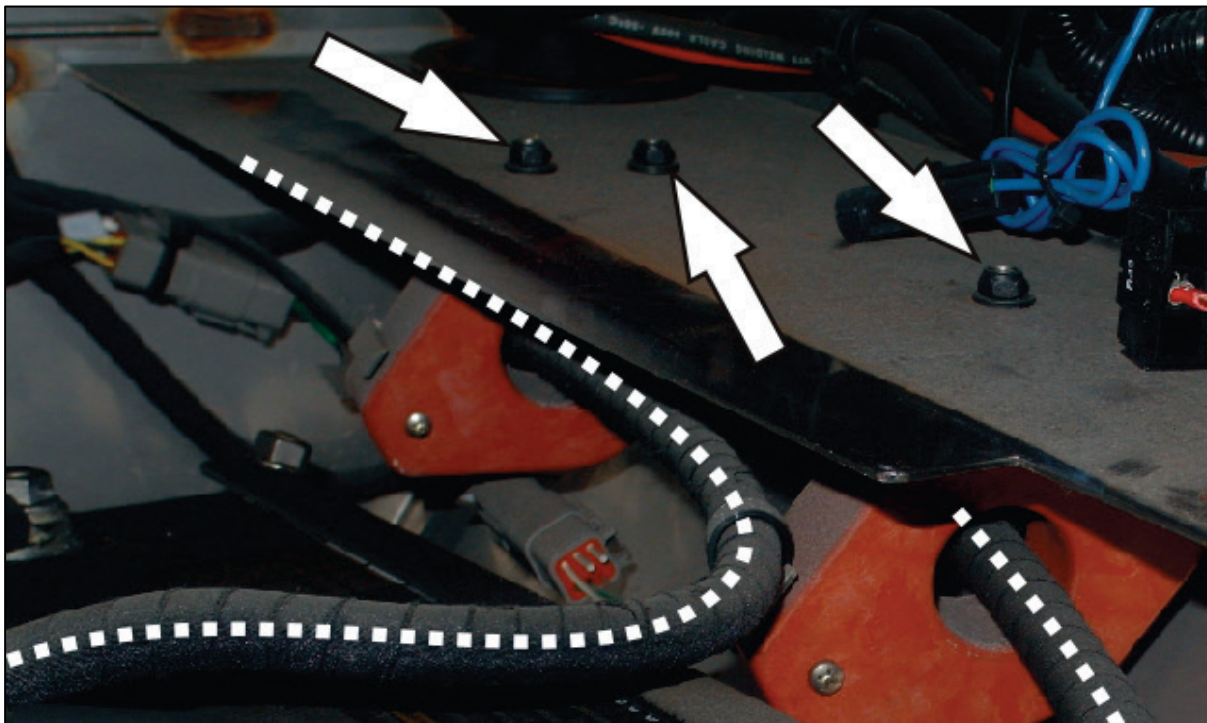
Figure 13 : H series sensor mounting screws

7. Remove sensors (Fig. 13 & 15)
8. H Series: remove mounting plate nuts. Reserve for re-assembly.
9. Remove Sensor mounting screws on a workbench.  
(Mounting Screw #5001694 Pan Head, Philips M4 x 40mm)

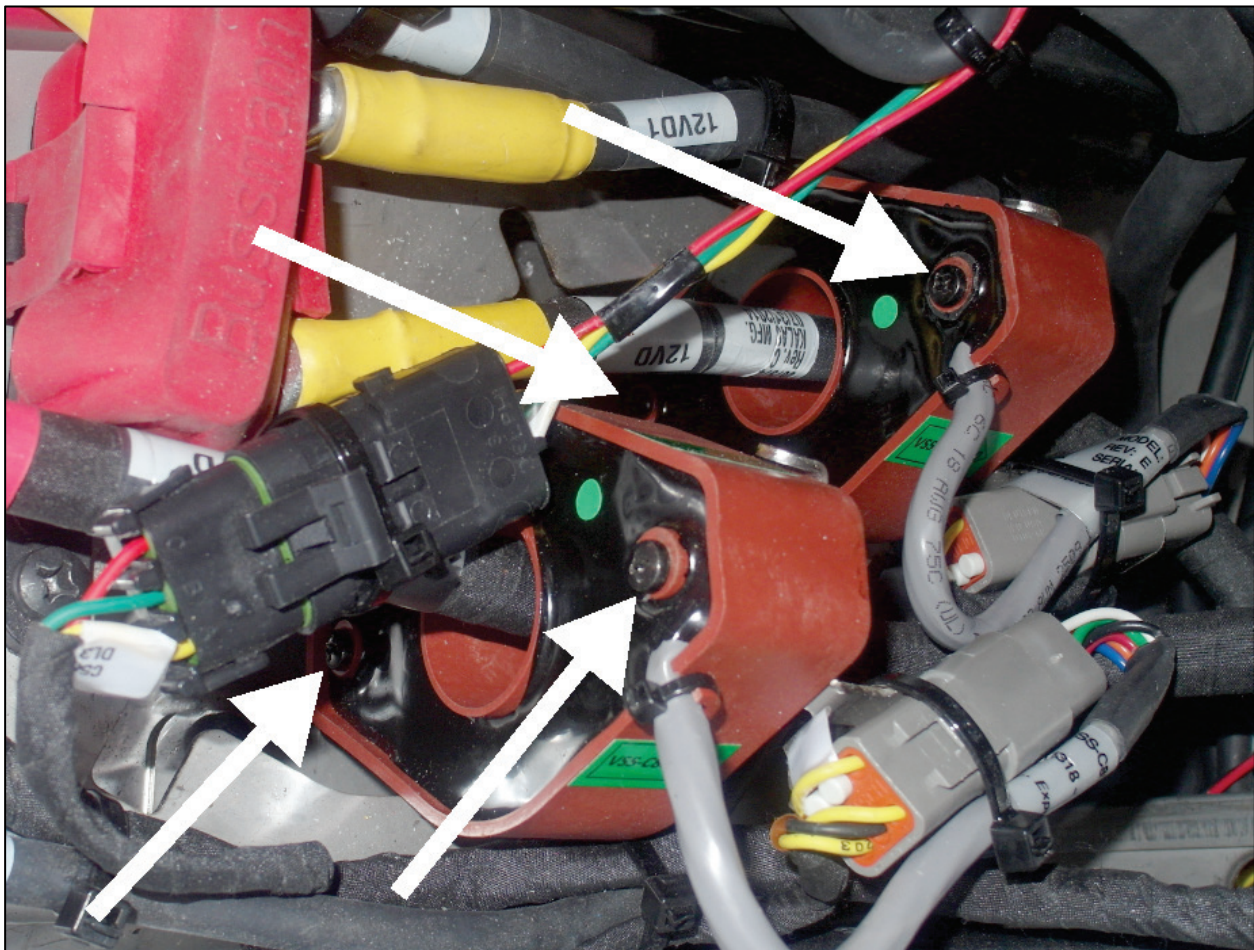
Figure 15 : X series sensor mounting screws

11. X Series: To remove the lower screws, use the smallest ratchet possible and a flex ratchet extension (Fig. 1, 2). (Mounting Screw #5001694 Pan Head, Philips M4 x 40mm)

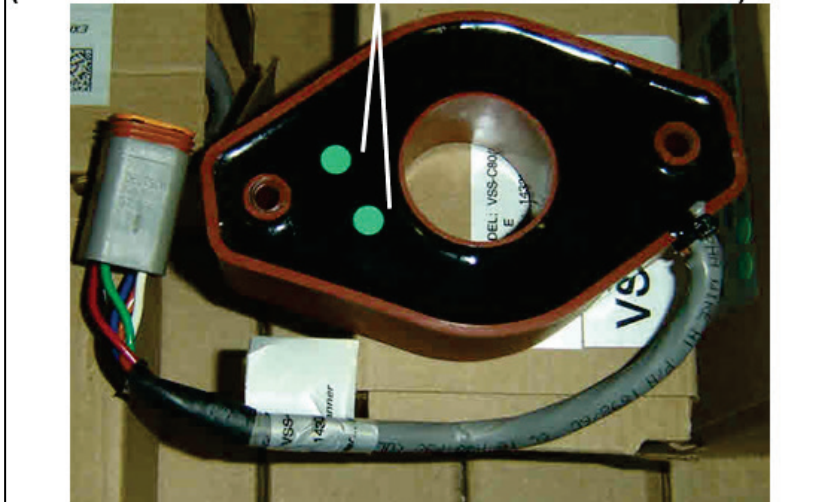
Figure 16 : Recalibrated “good” sensor

Also, note that green dot labels (Fig. 16) have been applied to the sensor to attest calibration by the supplier. Refer to **Table 1** below to know if part should be replaced.

*IF PART BEARS TWO GREEN DOTS, PART IS CONSIDERED GOOD (NO REPLACEMENT) (FIG. 16)*

**TWO GREEN DOTS: PART IS OK!  
(PART HAS BEEN RECALIBRATED BY SUPPLIER)**
