**MAINTENANCE
INFORMATION**

MI15-24B

DATE :	MAY 2015	SECTION: 06 - Electrical
SUBJECT :	POWER CABLES INSPECTION GUIDELINES

Revision: B Added: Power cables for L.H. side alternator & fan drive breaker box
 March 25, 2020

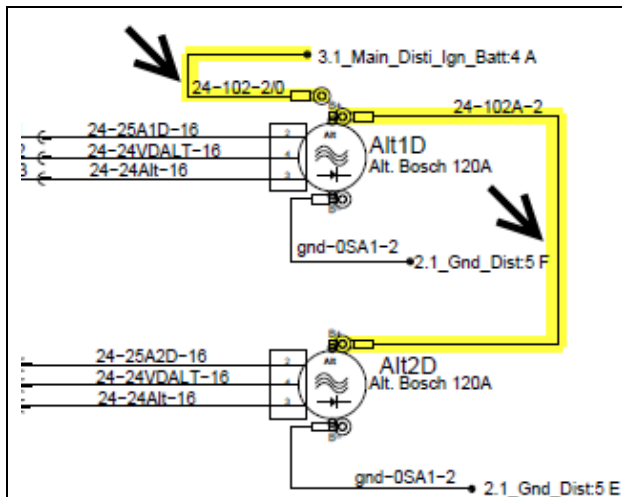
Figure 1 – R.H. SIDE ALTERNATORS (2x BOSCH)
MECHANICAL COOLING FAN DRIVE CONFIGURATION

- On the **alternators positive (+) stud terminal** and from there, up to junction block in the electrical compartment (Figure 1 to 5).

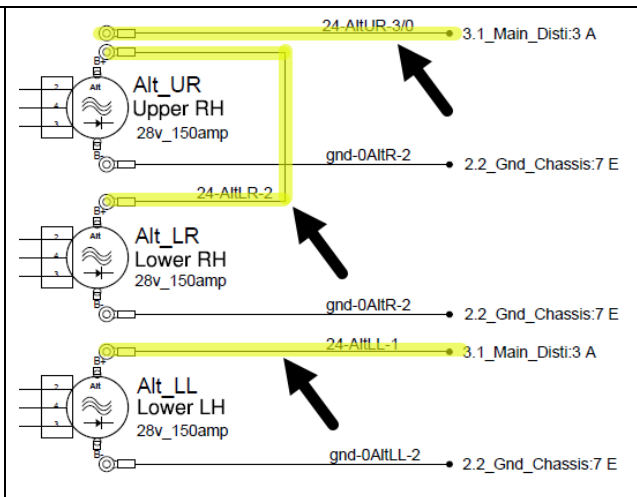
Figure 2 – L.H. + R.H. SIDE ALTERNATORS (3x BOSCH)
ELECTRIC FAN DRIVE CONFIGURATION

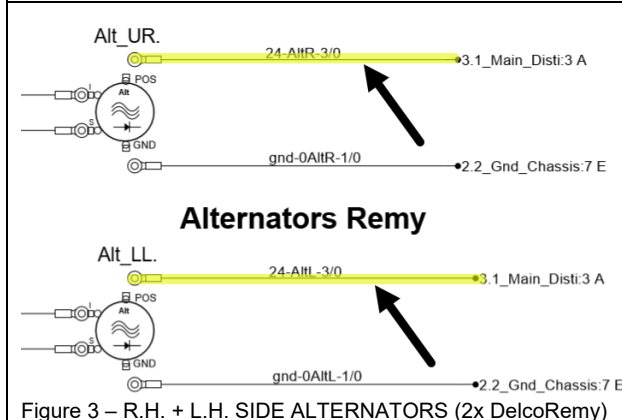
Figure 3 – R.H. + L.H. SIDE ALTERNATORS (2x DelcoRemy)

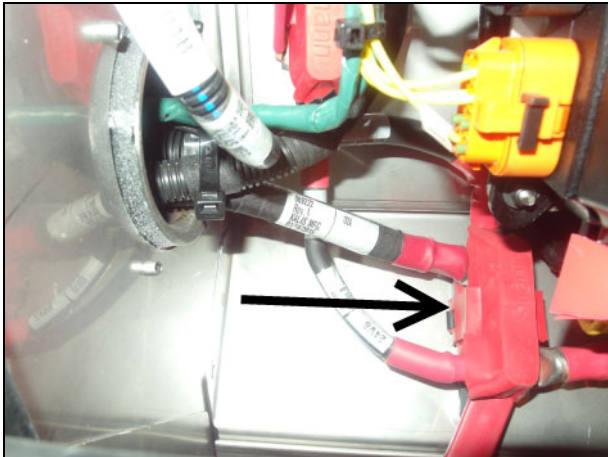
Figure 4: Bussman Junction Block - X3 Series.

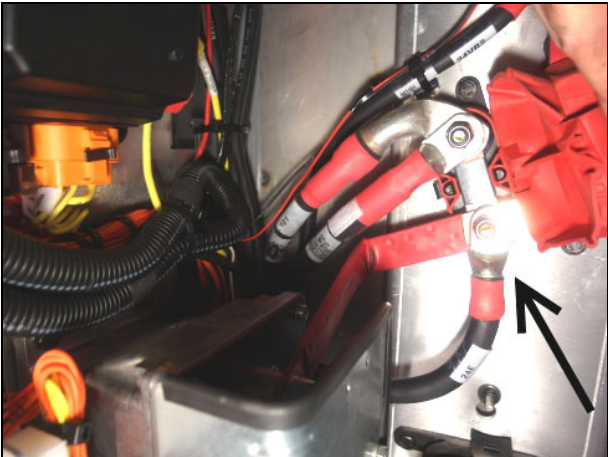
Figure 5: Bussman Junction Block - H3 Series.

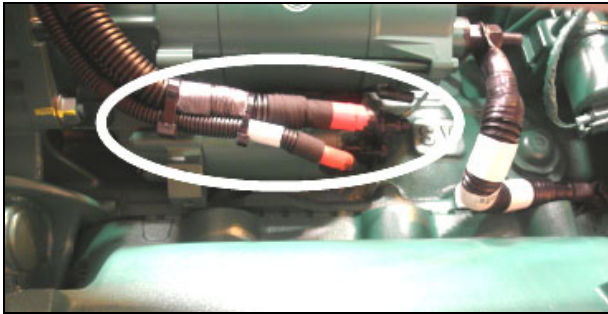
- On the **starter positive (+) stud terminals** and from there, up to Bussman junction block in the electrical compartment (Figure 6, Figure 7).

Figure 7: starter cables

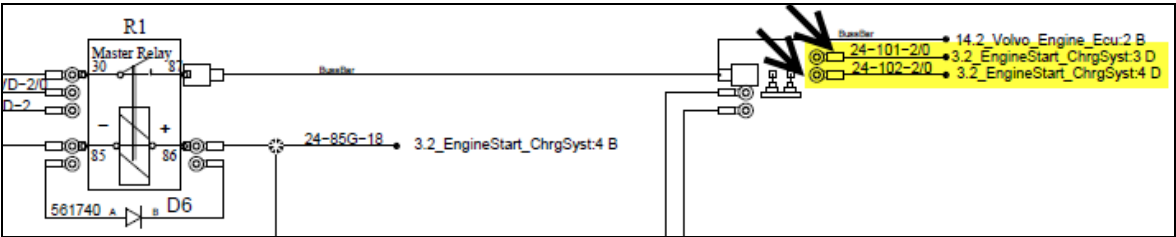
Figure 8

- In the electrical compartment, **connected to the junction block** (Figure 8).

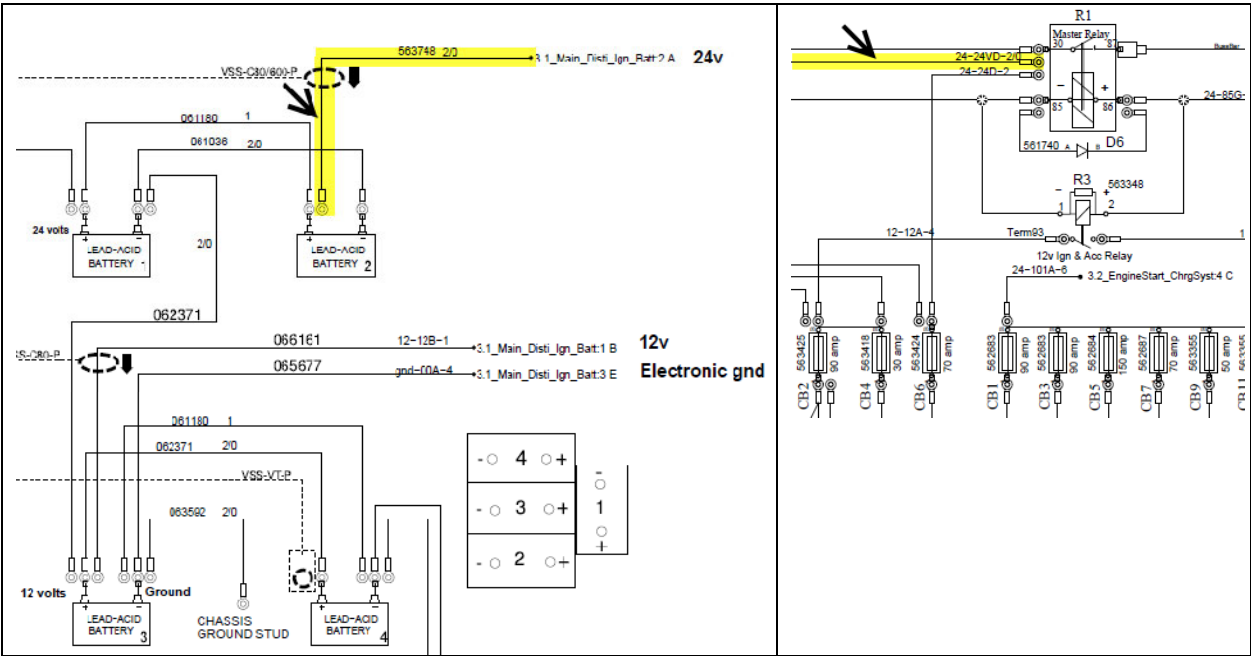
Figure 9

- In the **battery compartment** between **battery and master relay R1** (Figure 9).

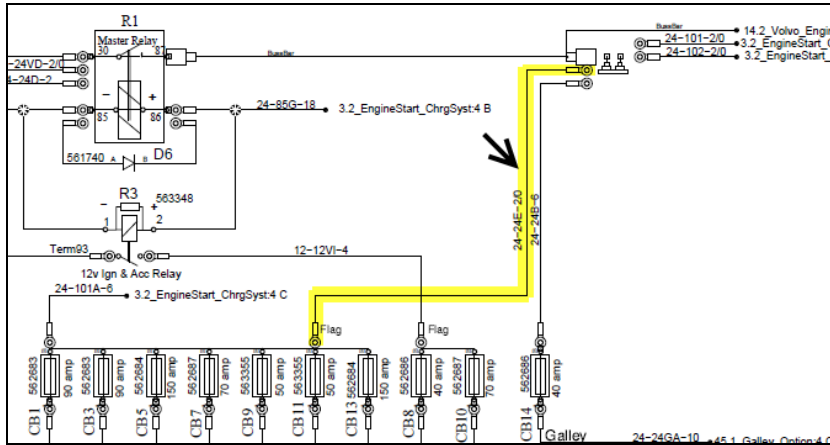
Figure 10

- Between **Bussman junction block** and **main circuit breaker bus bar** (Figure 10 & Figure 11).

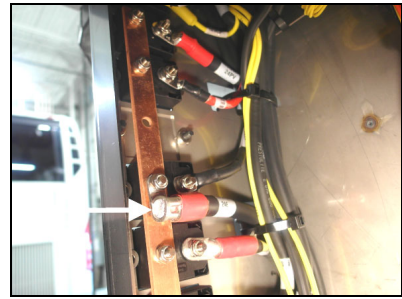
Figure 11: Power cable on main circuit breakers' bus bar.

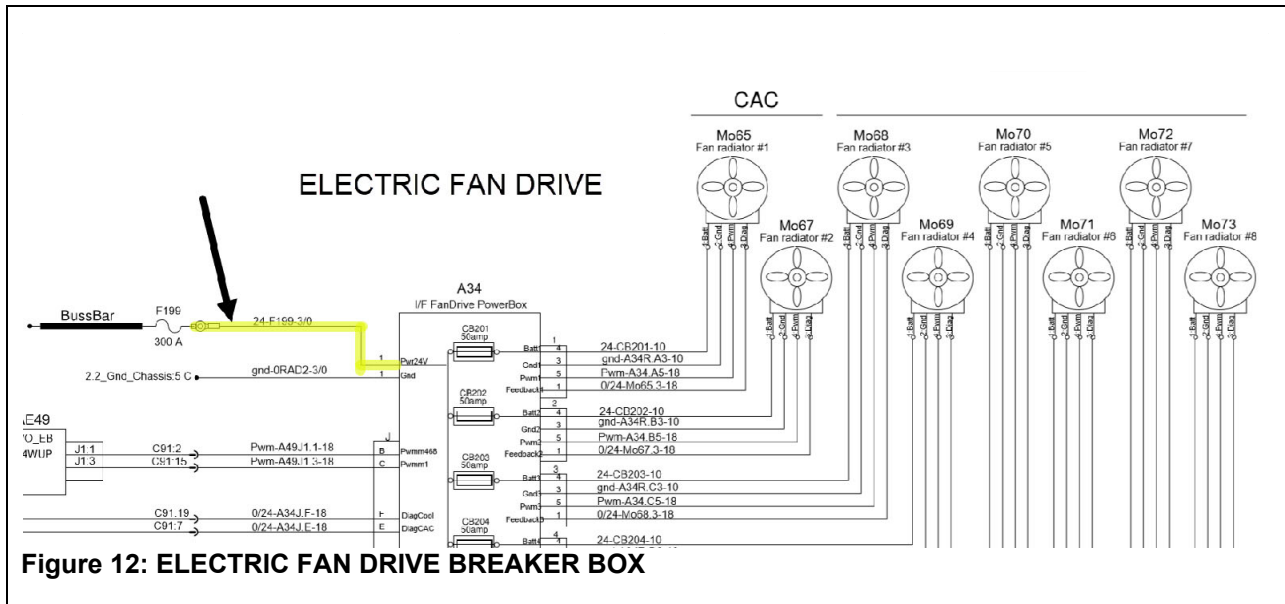
- From the electric fan drive breaker box up to fuse F199 in main power compartment (Figure 12)

Figure 12: ELECTRIC FAN DRIVE BREAKER BOX

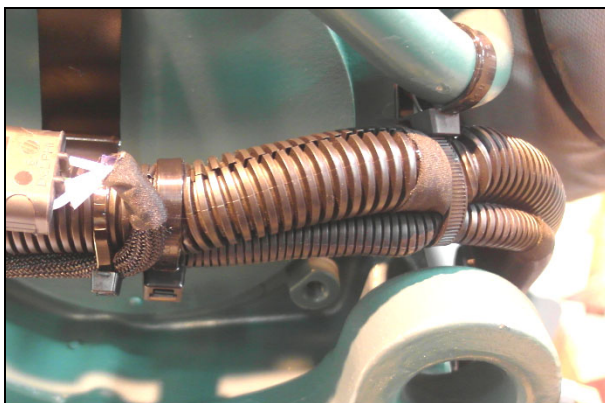
Figure 13: starter cables in a corrugated protective sheath.

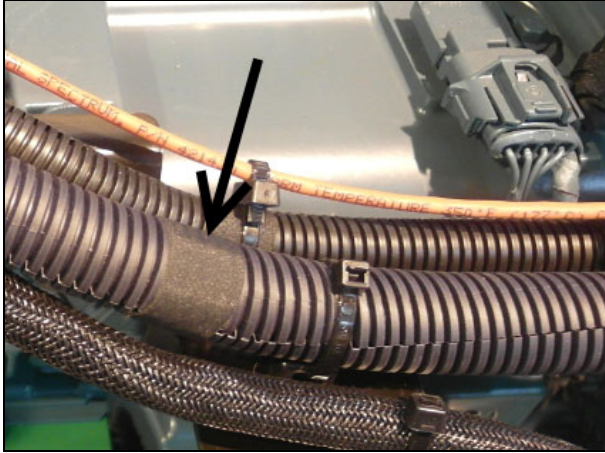
Figure 14: Two layers of fabric tape applied every 3 to 6 inches to prevent the cable from coming out of the corrugated protective sheath.

- For power cables passing through a corrugated protective sheath, it is recommended to apply two layers of fabric tape every 3 to 6 inches minimum to prevent the cable from coming out of the corrugated protective sheath (Figure 14). The ends of the corrugated protective sheath should be covered with fabric tape (figure 15).

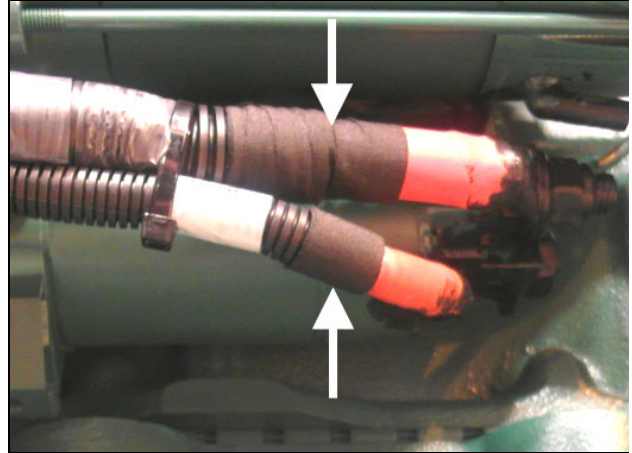
Figure 15: The ends of the corrugated protective sheath should be covered with fabric tape.

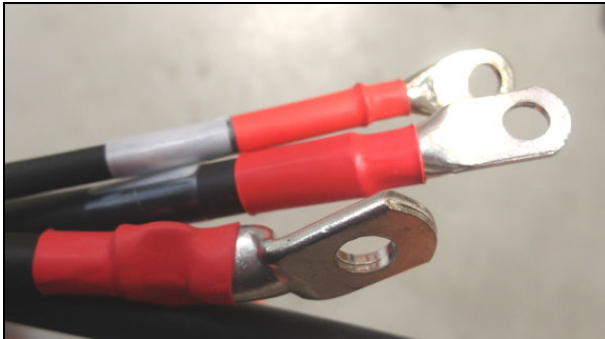
Figure 16: Cable lugs must be closed type, crimped or welded.

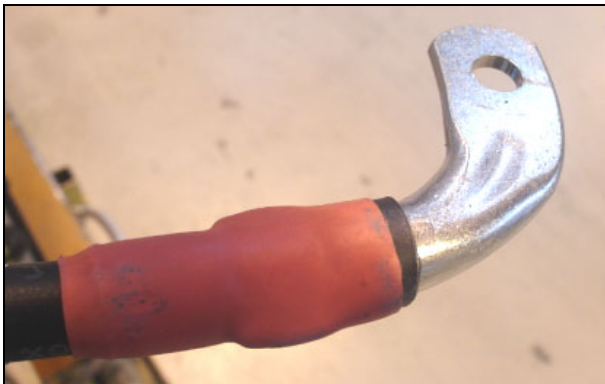
Figure 17: Power cable shouldn't be bent just next to the cable lug. Angled cable lugs are used to avoid mechanical stress.

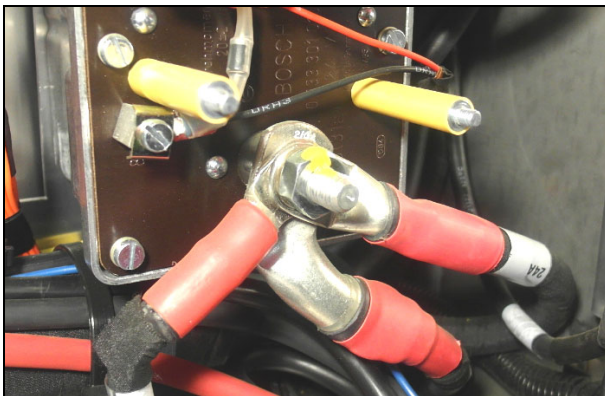
Figure 18: When several terminals are connected on a single stud terminal, the largest cable lug must be placed first, followed by the second larger and so on. Cable lugs should be distributed around the stud terminal in a way that no cable lug is distorted when tightening the nut.

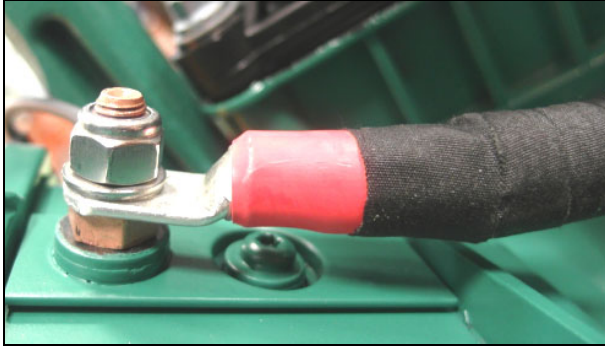
Figure 19: No exposed or broken copper strands.

- A shrink tubing (or fabric tape) should cover the copper strands.
- Ensure that the power cables and ground wire are not stretched tight.
- Ensure that the cable lugs are still properly crimped on the copper conductor, that the conductor strands are not broken so that the power cable retain its capacity and ensure unrestricted current flow.

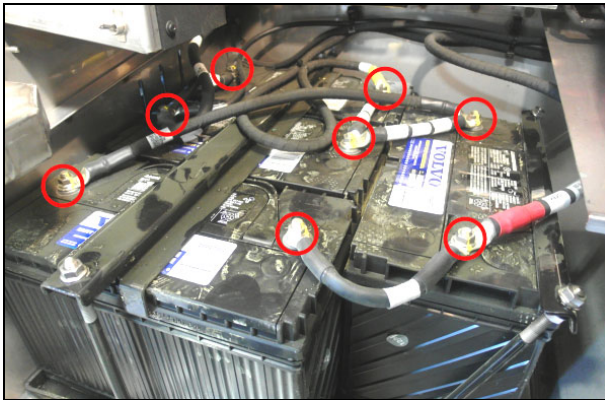
Figure 20: battery bank

- Battery interconnection cables must be checked too :
 - Ensure the cables are properly fastened to battery posts and that the cables are in good condition (consult battery manufacturer documentation for appropriate tightening torque).
 - No corroded or cut copper strands. No apparent copper strands. Protective sheath in good condition, no cuts, no rubbing against metal edges.

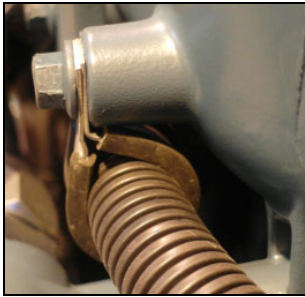
Figure 22: P-clamp with appropriate diameter prevents the power cable or corrugated protective sheath from moving and rubbing inside the clamp.

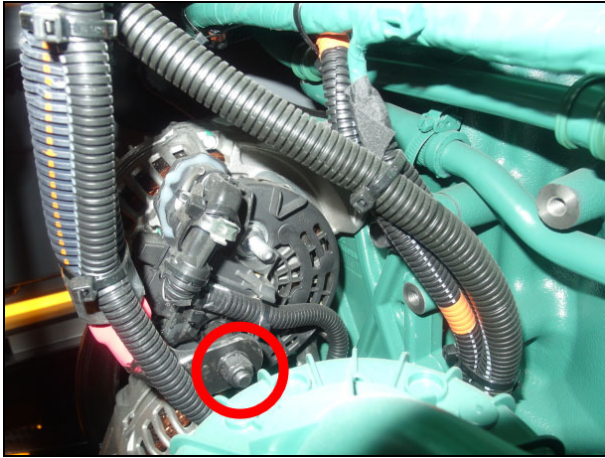
Figure 23: Make sure power cables/positive cables (+) are properly connected to alternator, that stud terminal nuts are properly tightened.

TERMINAL NUT PRESCRIBED TORQUE

- D+: 21-28 lbf-in
- B+, B-: 88-115 lbf-in
- W: 36-48 lbf-in

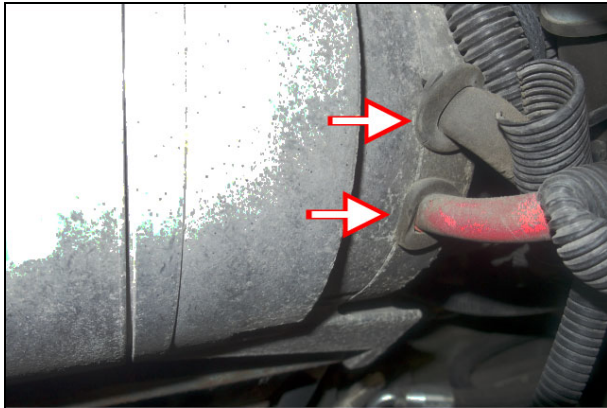
Figure 24: Bosch T1 alternator with the two required rubber grommets. Alternator cables connected to the alternator stud terminals must be protected against metal edges with rubber grommets.

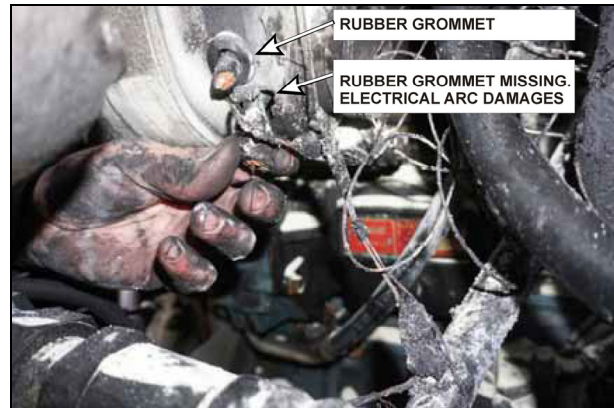
Figure 25: Fire in engine compartment caused by rubbing of power cable against metal edge of Bosch T1 alternator rear cover. Lower rubber grommet was missing when fire occurred. Evidence of electrical arc can be seen.

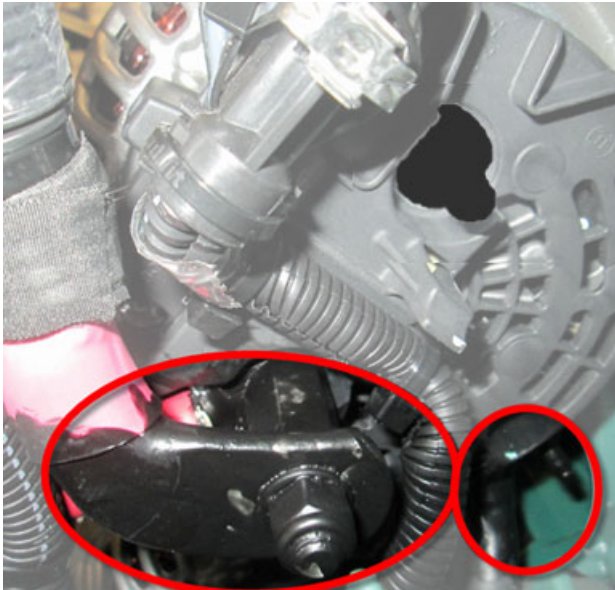
Figure 27: Upper R.H. side Bosch alternator power cable lug protected with Color Guard rubber coating.

- Power cable connections on alternators, starter and ground connections exposed to water, dust, etc. should be protected against corrosion with Loctite Color Guard rubber coating (**Figure 26**) (Prevost p/n: 684013).

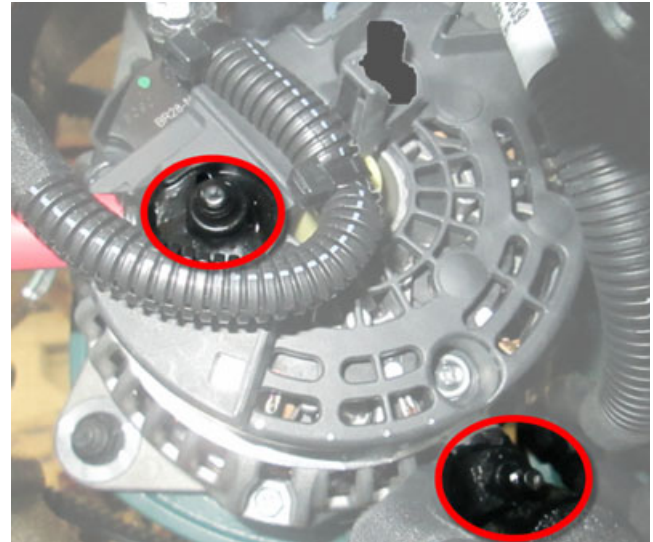
Figure 28: Lower R.H. side Bosch alternator power cable lug protected with Color Guard rubber coating.

Protect the cable lug similarly on the L.H. side alternator (with electric fan drive)

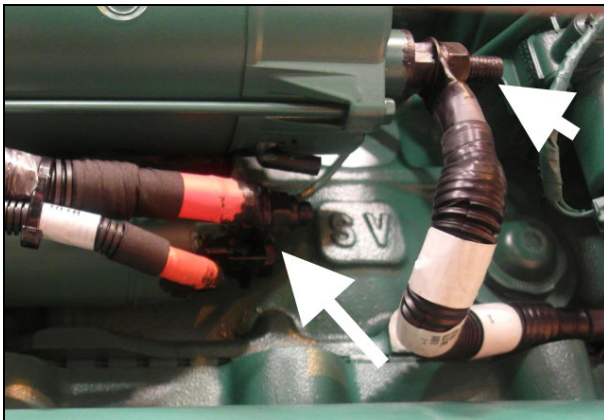
Figure 30: Starter power cable and ground cable lugs protected with Color Guard rubber coating.
