SAFETY RECALL

SR15-52

DATE :	NOVEMBER 2015	SECTION :	16 - Suspension
SUBJECT:	5 th Bar attachment studs on IFS suspension

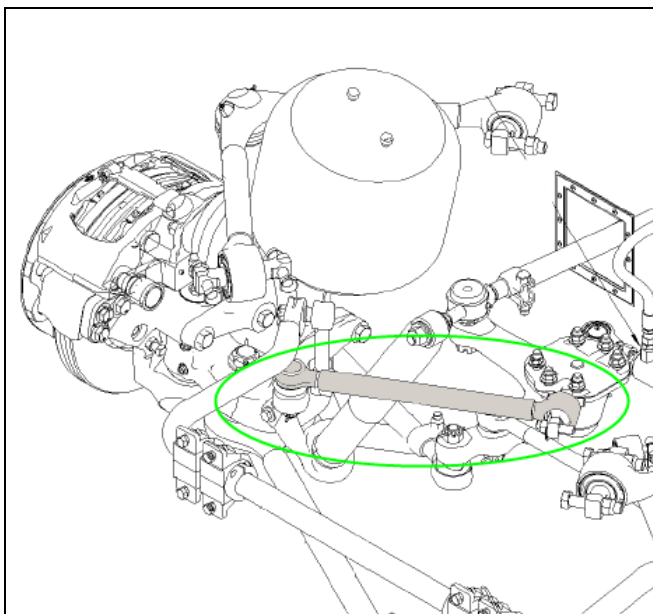
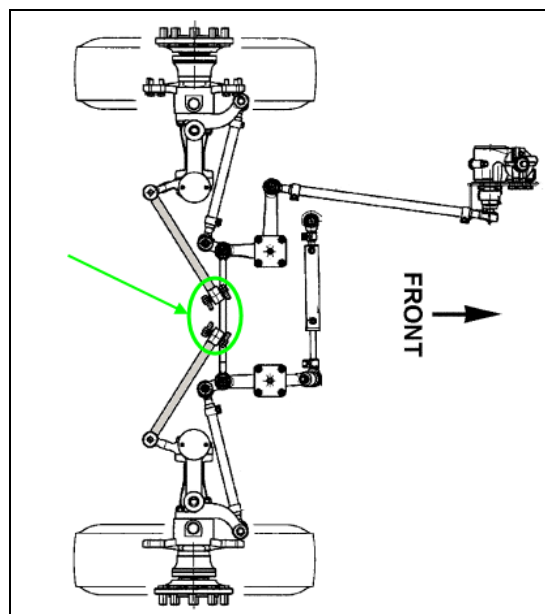
Overview of the vehicle 5th bar and studs to be removed.

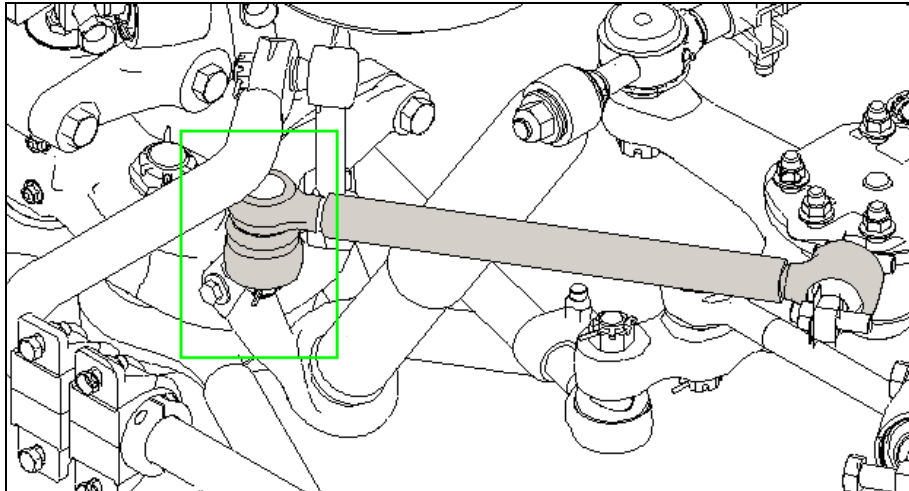
Disconnect bar, wheel side.

2. Disconnect wheel side of the bar (remove the cotter pin and the castle hex nut).

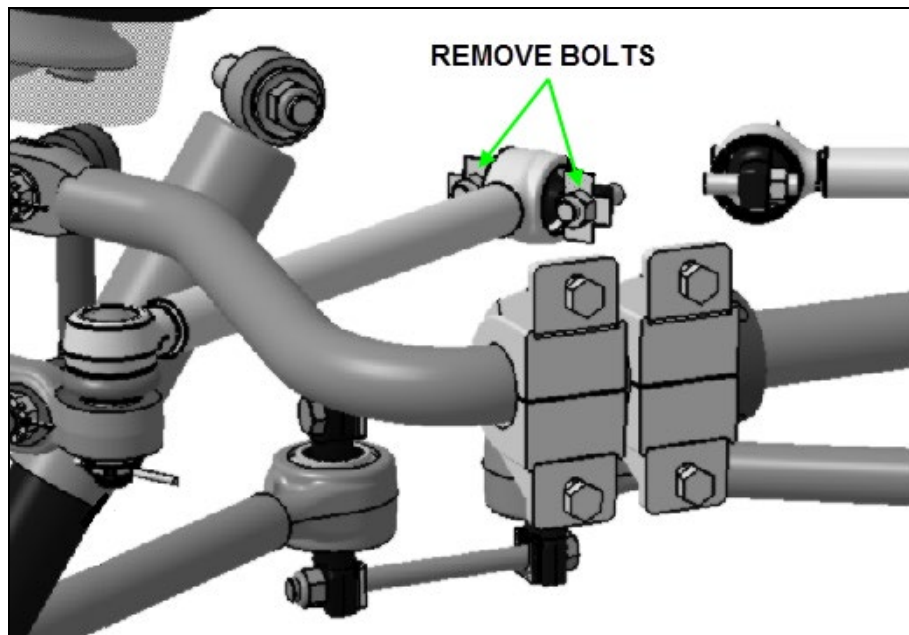
Remove and discard bolts and tab lock.

3. Disconnect the bar at the vehicle structure side by removing the two M16 hex nuts (discard nuts and tab locks).

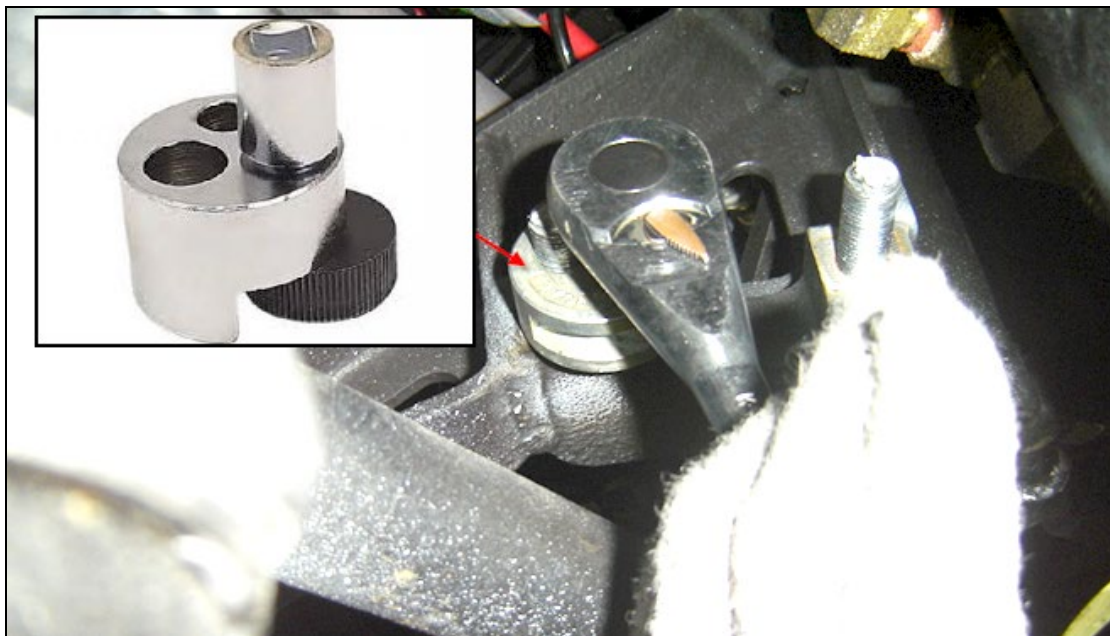
Removing studs with a stud removing tool.

- Using a stud removing tool (for M16 studs), unscrew the two studs mounted on the vehicle structure (Alternately, the double nut technique (double nutting) can be used to remove the studs if a stud removing tool is not available).

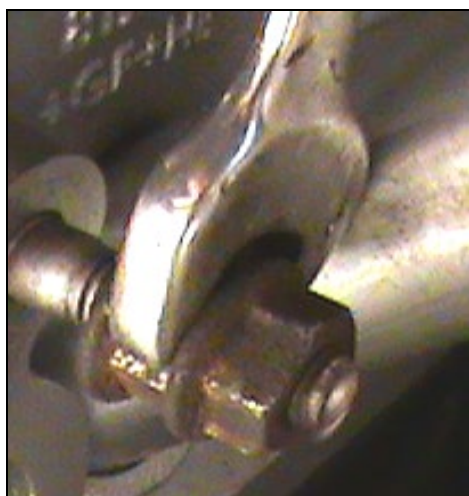
Double nut to remove stud.

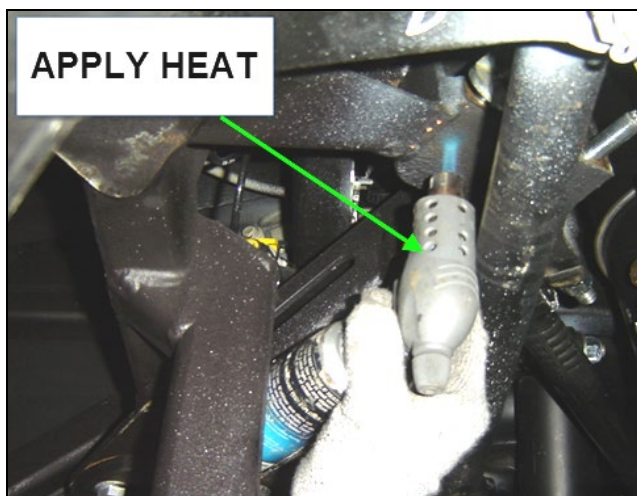
Heat applied to structure to ease stud removal.

Studs are factory installed using red « high strength » thread locker (Loctite # 262), it may be necessary to heat the structure around the studs to “melt” the thread locker and ease stud removal.

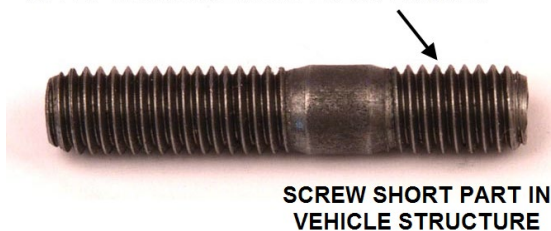
APPLY HIGH STRENGTH TREAD LOCKER

7. Apply high strength thread locker (Loctite 262 or equivalent) to the short threaded section of the new studs.
8. Screw (hand tight) the studs in the vehicle structure.

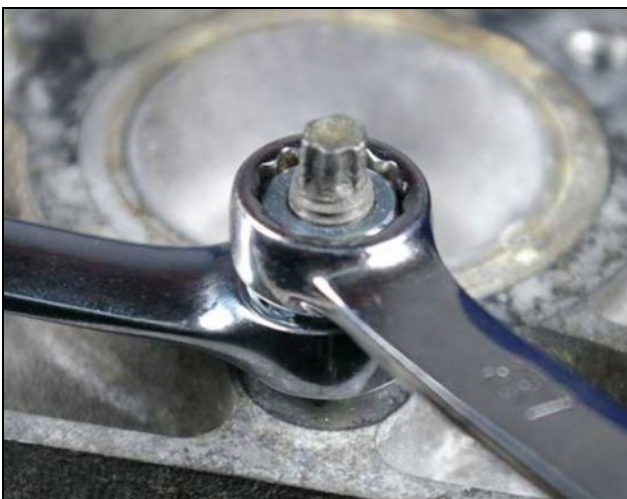
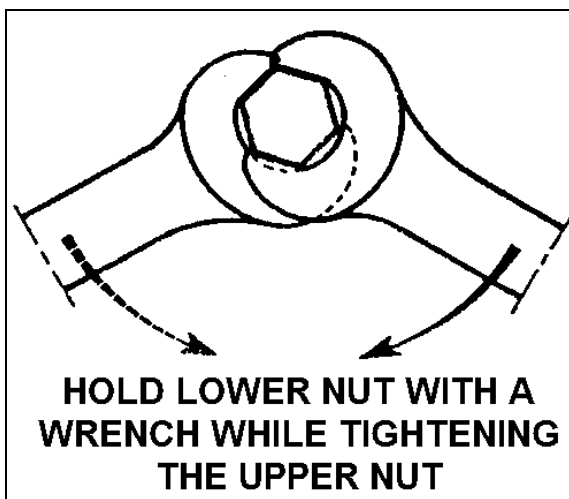
Double nutting the stud to tighten : 100lb-ft (finish with torque wrench).

9. Using the double nut technique (double nutting), torque the new studs to 100lb-ft.

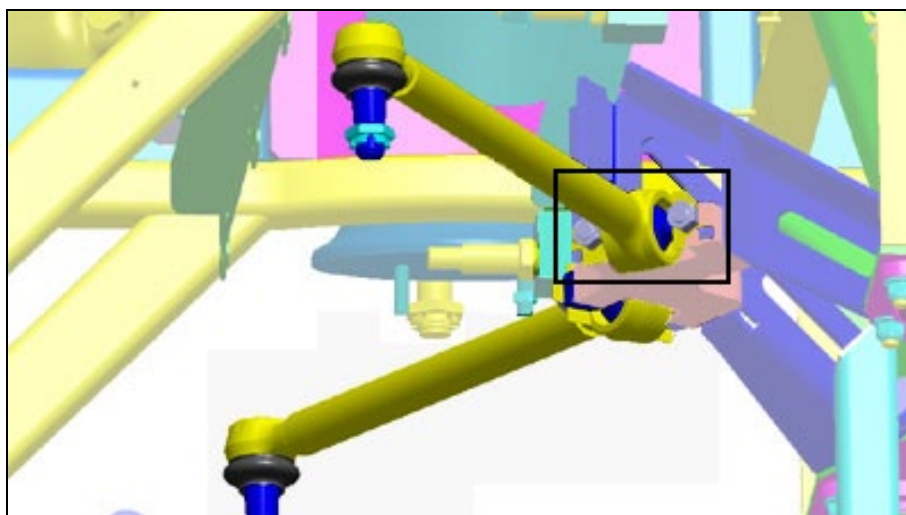
Reinstall bar and lock nut without tab locks.

10. Wipe any thread locker excess.
11. Reinstall the bar at the structure end of the vehicle, use supplied nuts and flat washers (do not reuse tab locks with supplied nylon lock nuts). Torque to 148lb-ft.

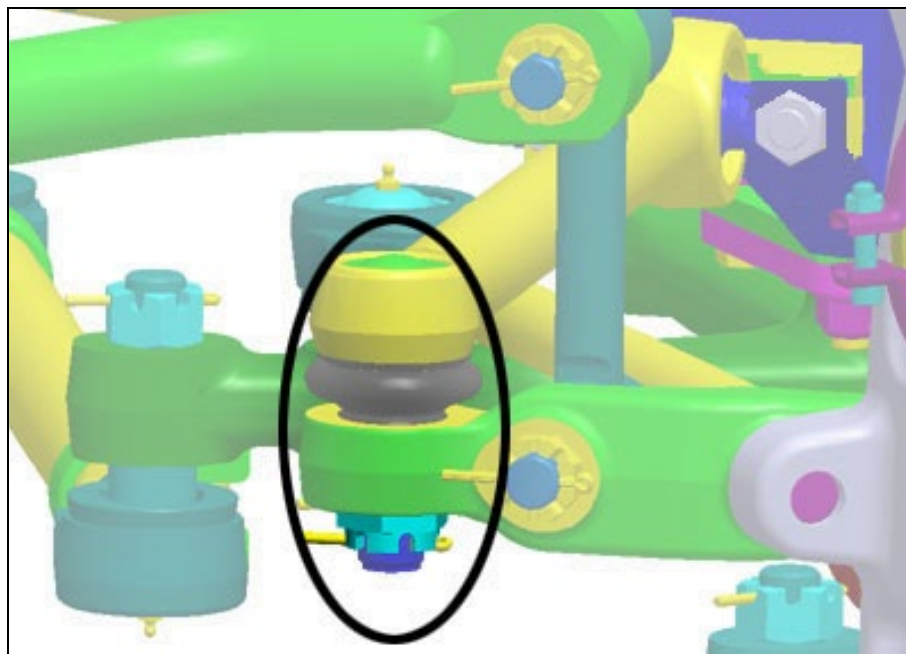
Reinstall bar, lock with cotter pin.

12. Reconnect the bar at the suspension side, torque the castle nut to 150lb-ft.
13. Install the supplied cotter pin to lock the castle nut.

If the cotter pin hole and the castle nut do not line up, tighten the castle nut to next aligning cotter pin slot. Do not unscrew or go below 150lb-ft.
