SAFETY RECALL

SR24-86

EMERGENCY EXIT DECAL REPLACEMENT 9700 (B13R)

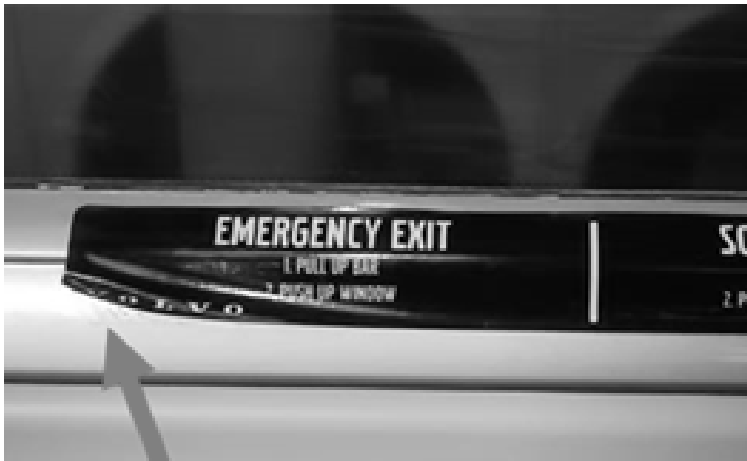
- 1) Mark the position of the decal on the window release mechanism handle with two pieces of tape, one at the top edge of the decal and one at left edge of the decal.
- 2) Remove the emergency exit decal from the window release mechanism handle and discard.

Note: It is recommended to use a heat gun to remove the decal. If you do not have one, you can use alcohol with a clean cloth and rub over the decal, start at its edges to peel it off.

CAUTION: Do not use any solvents to remove the decal. Do not use hand tools such as knives, putty knives or any other objects to scrape the surface. Failure to do so will result in window release mechanism handle finish damage.

- 3) Clean the surface with alcohol where the old decal was located.
- 4) Install the new decals 406941 at the same position marked by the tape.
- 5) Use a decal squeegee to smooth out the decal to eliminate any air bubbles and ensure that it conforms to the shape of the window release mechanism handle to avoid the possibility of peeling.
- 6) Remove the two pieces of tape.
