PREVOST

**SAFETY
RECALL**

SR24-03

DATE :	September 2024	SECTION :	23 ACCESSORIES
SUBJECT:	WHEELCHAIR LIFT SYSTEM – THRESHOLD WARNING SENSOR LIGHT REPLACEMENT

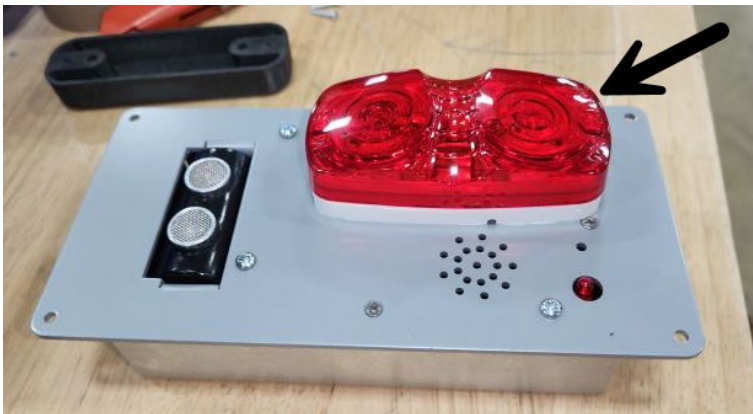
Figure 1 : Red lens cover to be removed

1. Cut the electrical power to the wheelchair lift system using the dashboard WCL switch.
2. Use a small prybar to remove red lens from TWS light, and discard. Figure 1.

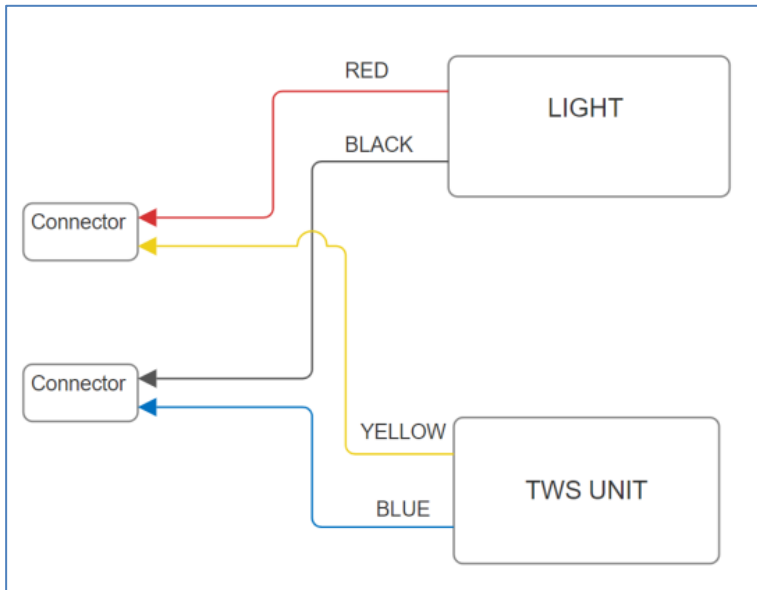
Figure 9: Wiring diagram

- Raise both levers on 2 wire splice connectors, then insert red wire into one connector slot and yellow wire into other slot. Push both levers down to fasten wires. Repeat the previous step for black and blue wires. Figures 8 and 9.
