VALID LEVELING SYSTEM

Installation Guide

PART# VTL01K013-IM

This document outlines the procedure of installing the pneumatic components of a Valid Leveling System on a Prevost H3 coach and must be read in conjunction with the attached drawings **VTL01K013** and **D140299P1REV_B_MOD**.

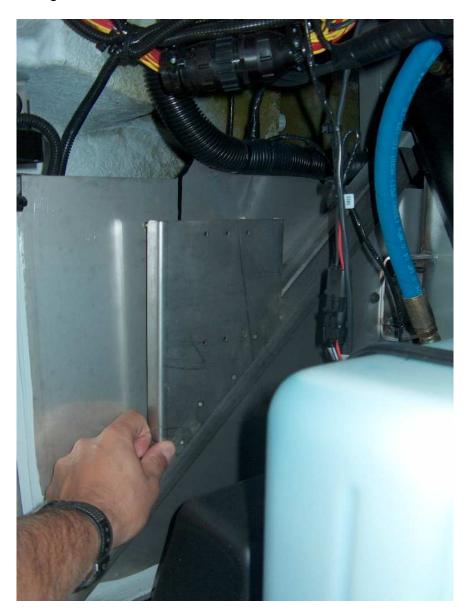
Figure 1

The front level sensor mount (H390P-004-01) should be welded in place or attached with rivets in the front service compartment located beneath the driver as shown in Figure 1.

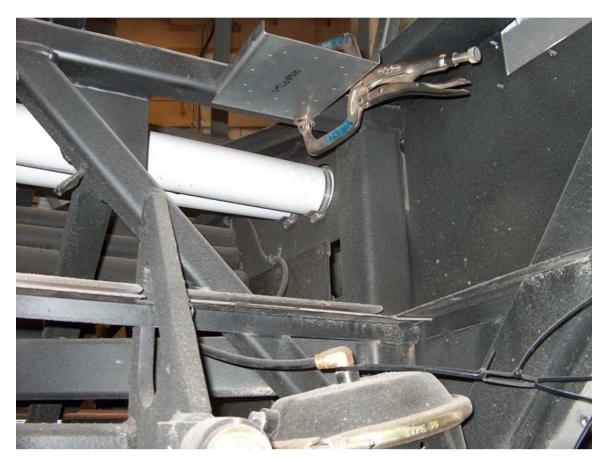
Figure 2

The rear level sensor mount (VTL01P010S) should be welded in place or attached with rivets on the frame member behind the driver side rear fender as shown in Figure 2.

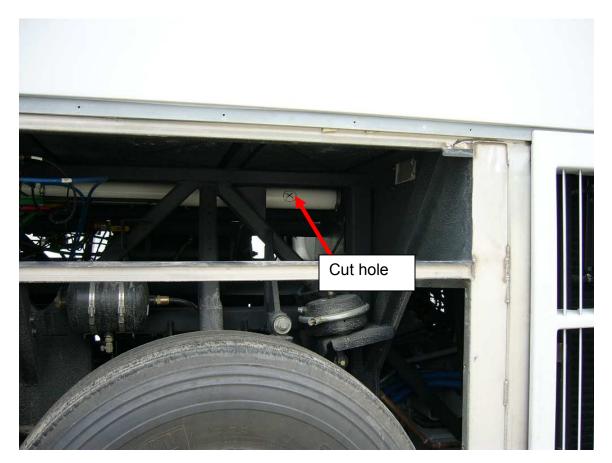
Figure 1

1. Cut a 2" hole in the white plastic conduit at the rear of the driver side of the coach (remove rear fender for access) approx. 8" from the firewall, as shown in Figure 1.
