# SECTION 09: PROPELLER SHAFT

## Section 09: PROPELLER SHAFT

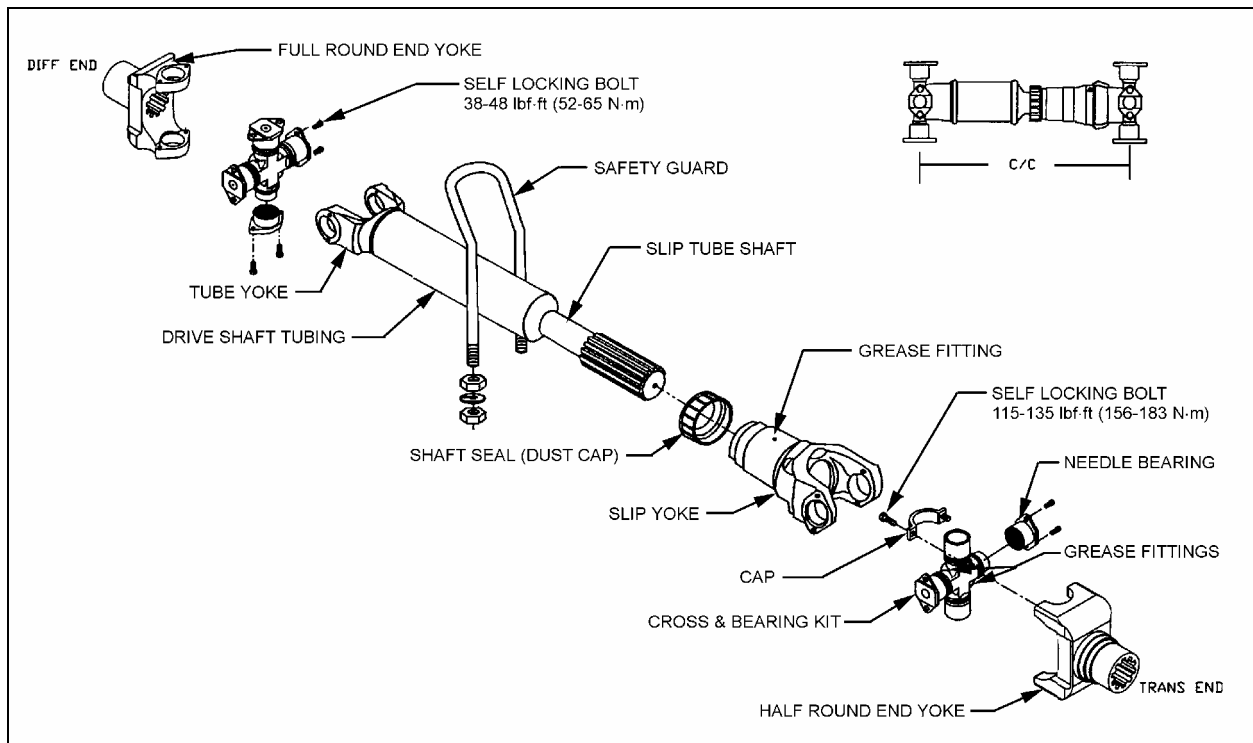
FIGURE 1: PROPELLER SHAFT ASSEMBLY

The propeller shaft transmits power from the transmission to the differential (Fig. 1). Refer to paragraph "6. SPECIFICATIONS" at the end of this section for propeller shaft length. The propeller shaft is "Dana 1810" type with tubular shafts. It is provided with two heavy-duty universal joints (Fig. 1).

The propeller shaft has a full round end yoke at one end and a half round end yoke at the other end. The tube yoke is connected to the differential by the full round end yoke with four needle bearings.

The other extremity (slip yoke assembly) is connected to the transmission by the half round end yoke with two needle bearings.

Furthermore, a slip joint on the propeller shaft compensates for variations in distance between the transmission and the differential, or between the output retarder (optional on the automatic transmission) and differential.

- Remove or install propeller shaft safety guard.
- Screw bolts to the specified torque (Fig. 1).

Make ..... Hayes-Dana Inc.  
U-joint kit (tube yoke), Supplier number ..... 5-281X  
U-joint kit (tube yoke), Prevost number .....580043  
U-joint kit (slip yoke), Supplier number ..... 5-510X  
U-joint kit (slip yoke), Prevost number .....580062  
Cap and bolt kit, bolt torque 115-135 lbf•ft (156-183 N•m), Supplier number .....6.5-70-18X  
Cap and bolt kit, bolt torque 115-135 lbf•ft (156-183 N•m), Prevost number .....580063  
Bolts kit, bolt torque 38-48 lbf•ft (52-65 N•m), Supplier number ..... 6-73-209  
Bolts kit, bolt torque 38-48 lbf•ft (52-65 N•m), Prevost number .....580071
