**PREVOST**

## MAINTENANCE INFORMATION

Mi06-06

| SUBJECT : ZF ASTRONIC TRANSMISSION | INSPECTION AND LUBRICATION PROCEDURE & HARSH ENGAGEMENT PROBLEM SOLUTION |

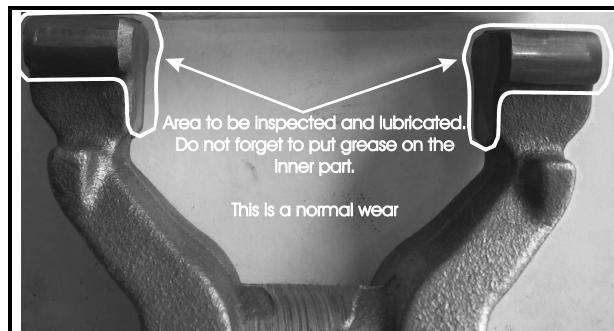
11. Check for abnormal wear on the release fork-to-release bearing (12) mating surface.

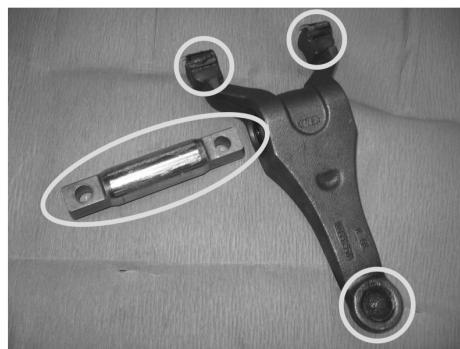
# OVERVIEW OF GREASE APPLICATION

DO NOT grease release bearing to input cover hub surfaces. This surface is coated with Teflon.

Grease clutch fork to release bearing interface

Grease clutch fork pivot shaft

Grease both actuator rod ends and ball joint sockets
