WARRANTY BULLETIN

Wb06-01

DATE : AUGUST 2006	SECTION : 06 - Electrical
EXPIRATION: AUGUST 2008	
SUBJECT : BAGGAGE COMPARTMENT DOOR SWITCH REPLACEMENT

Model	VIN	
H3-45 VIP Model Year : 2006	From 2PCV3349861010361 up to 2PCV3349161010430 incl.

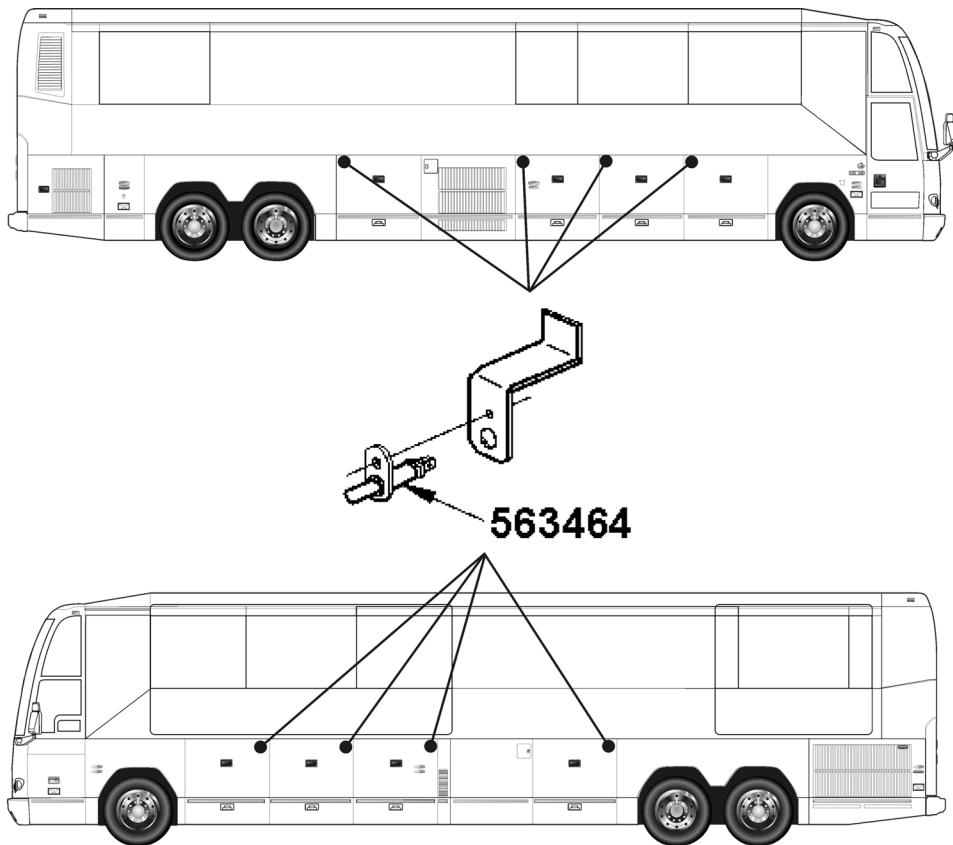
1. Open baggage compartment door of the defective switch.
2. Disconnect red wire from the back of the switch.
3. Unfasten the screw fixing the switch onto its bracket.

4. Install and secure the new switch (563464) onto its bracket.
5. Reconnect red wire at the back of the switch then close and open baggage compartment door to check for proper operation.
