**WARRANTY
BULLETIN**

Wb08-03

| SUBJECT : REPROGRAMMING THE ELECTRONIC STABILITY PROGRAM (ESP) SOFTWARE | | |

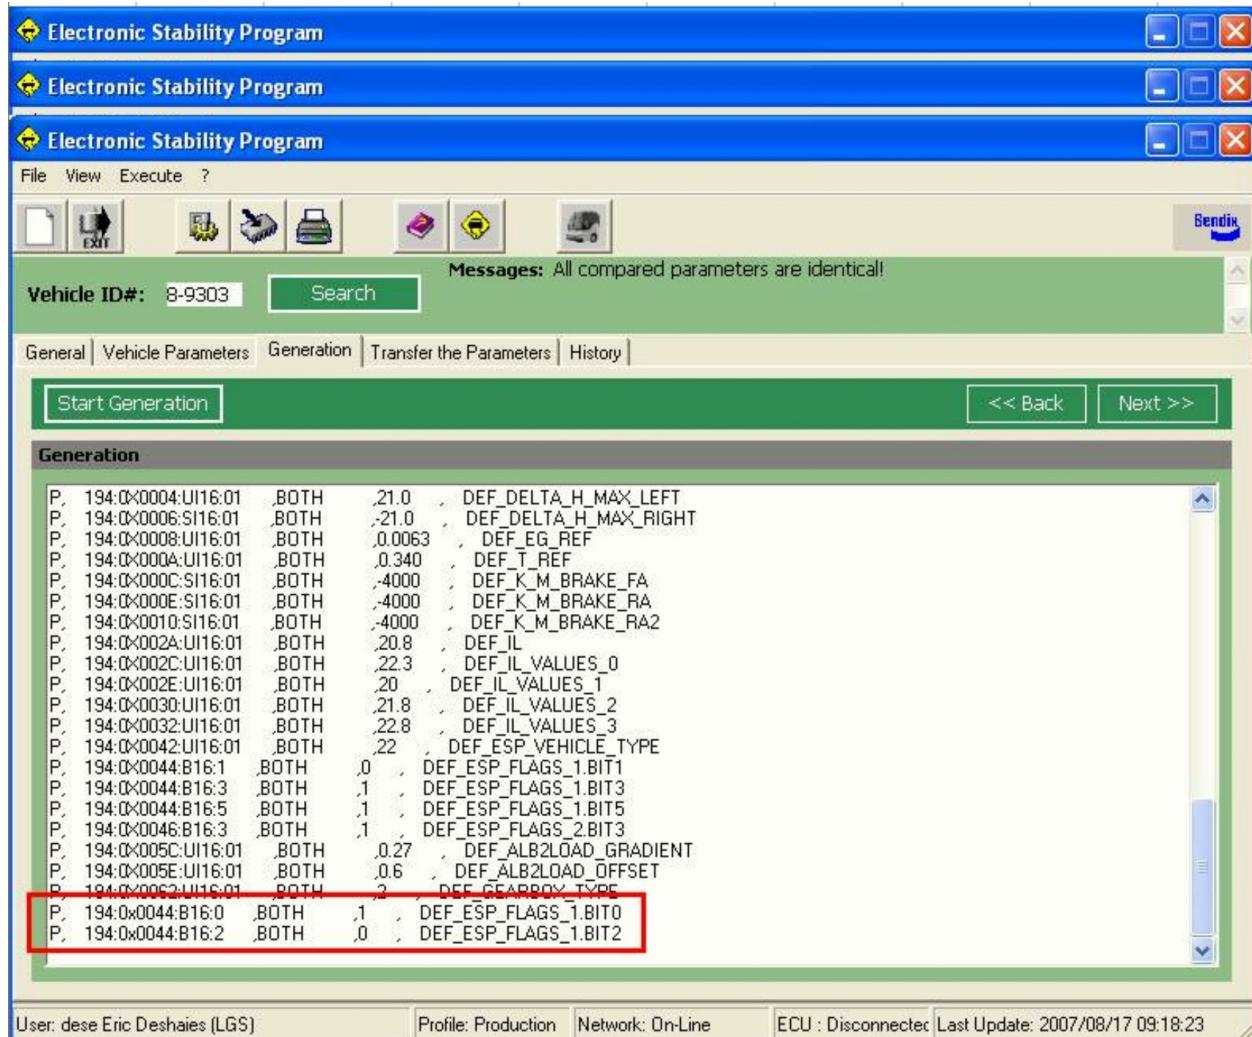
Electronic Stability Program

Messages: RECOMMENDATION: Generate and Transfer the parameters!
Vehicle generic template has changed since last generation!
Parameter(s) have been added or deleted!

Compare parameter values between SAP Value and Current Value << Back Next >>

Vehicle Parameters

To prevent this situation from happening, we strongly recommend that you make an appointment with your Prevost Service Center or that you contact your Regional Service Manager to reprogram the Electronic Stability Program (ESP) software.
