WARRANTY BULLETIN

Wb09-14

DATE : OCTOBER 2009	SECTION :	12 - Brakes
EXPIRATION: OCTOBER 2011		
SUBJECT : MODIFICATION OF THE AIR SUPPLY CIRCUIT FOR THE TP3-DC TRAILER BRAKE CONTROL VALVE

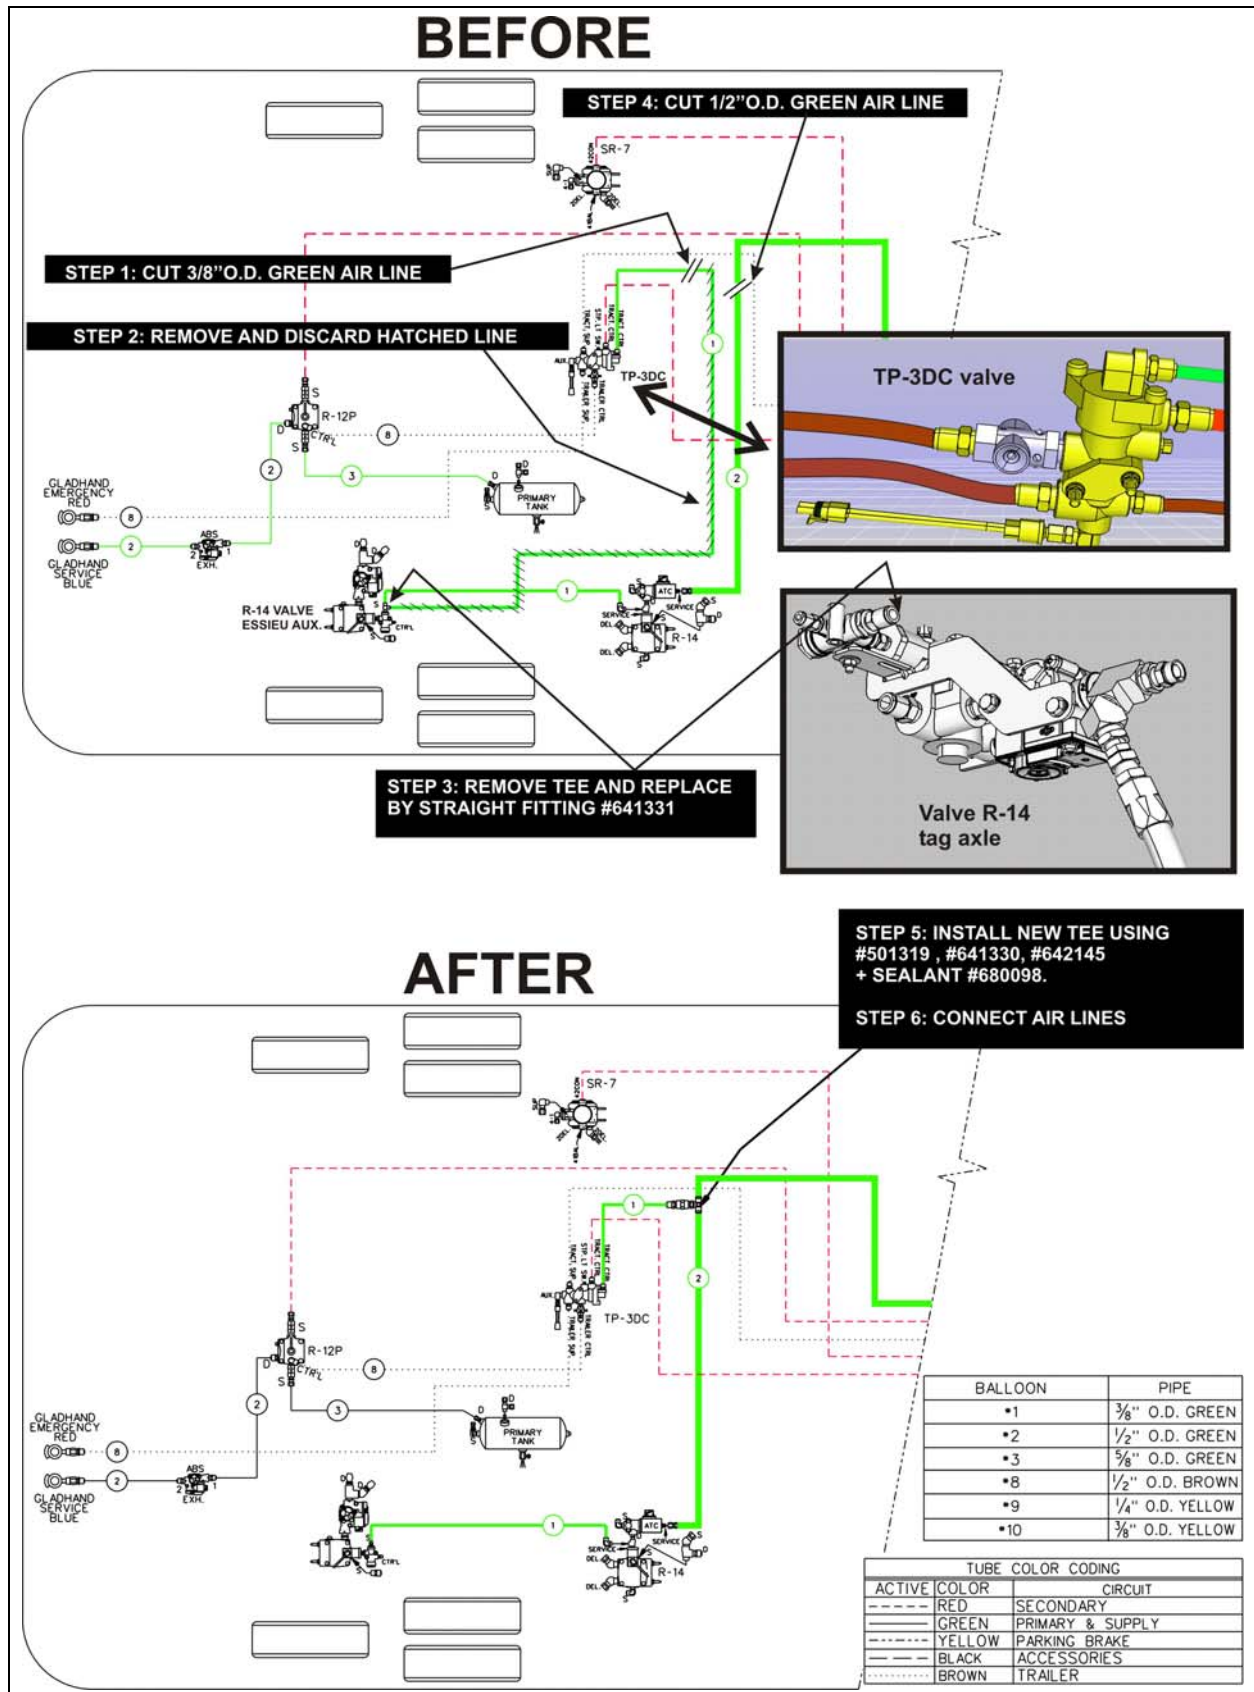
FIGURE 1

On the vehicles affected by this bulletin (trailer hitch with trailer air brakes connections), it is necessary to change the air supply circuit of the valve responsible for trailer service brake application. According to the existing circuit, if the vehicle service brakes are applied by the ATC system (Automatic Traction Control), trailer brakes application will also occur, which is not wanted. For this reason, it is important to proceed to the following instruction to ease starting of the vehicle when the ATC system intervenes.

1. Preassemble parts #642145, #501319 and #641330. Apply an appropriate thread sealing product like Loctite 567 Thread Sealant (Prevost #680098).
2. Perform step 1 up to 6 of figure 1. Use figure 2, 3, 4 and 5 to help you identify TP-3DC and R-14 valves.

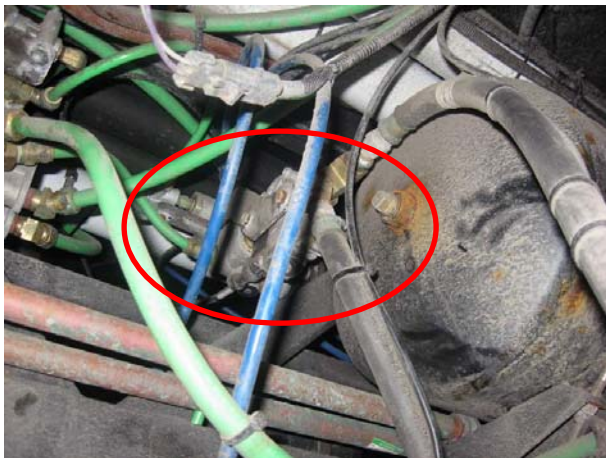
FIGURE 4 : TAG AXLE R-14 VALVE

Tag axle R-14 valve is located on the right hand side of the vehicle, next to the primary air tank.
