PREVOST

WARRANTY BULLETIN

Wb11-20

DATE : MAY 2011	SECTION : 18 - Body
EXPIRATION: MAY 2013	
SUBJECT : BELT ROUTING DECAL, OIL SPECIFICATION, COOLANT SPECIFICATION AND FUEL TANK SPECIFICATION DECALS

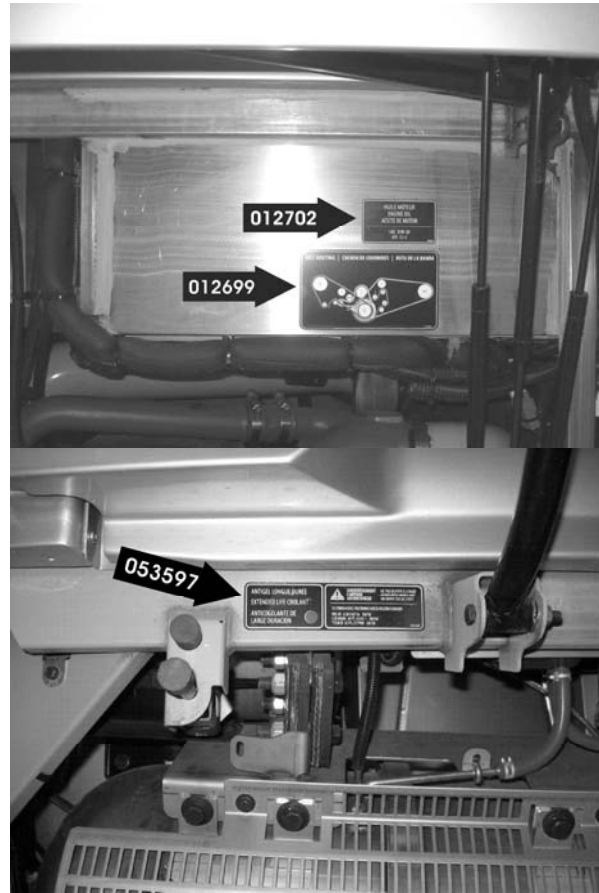
2. Affix new belt routing decal #012699 at the upper right section of engine compartment as shown on picture, replacing former decal #019095. Do not leave decal #019095 in the engine compartment if it remains visible.
3. Affix new oil specification decal #012702 as shown on picture, replacing former decal #012399(eng/fr) or #012400 (eng/esp). Do not leave the existing decal in the engine compartment if it remains visible.
4. Affix new coolant specification decal #053597 as shown on picture, replacing former decal #053487(eng/fr) or #053488(eng/esp). Do not leave the existing decal in the engine compartment if it remains visible.

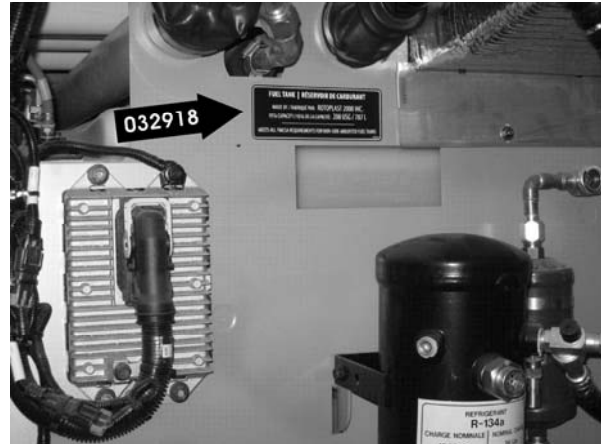
1. The fuel tank specification decal #032918 must be clearly visible in the condenser compartment. Affix this decal in the condenser compartment at the location shown on picture.

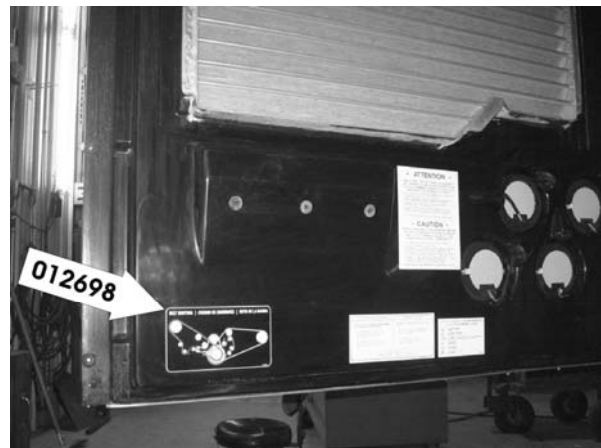
2. Affix new belt routing decal #012698 on the left engine compartment door as shown on picture, replacing former decal #019095. Do not leave decal #019095 on the door if it remains visible.

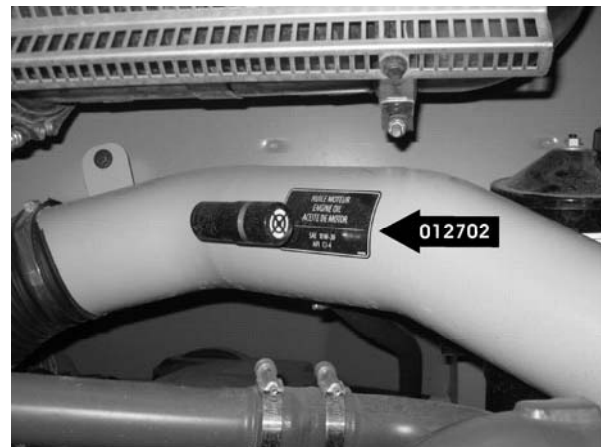
3. Affix new oil specification decal #012702 as shown on picture, replacing former decal #012399(eng/fr) or #012400 (eng/esp). Do not leave the existing decal in the engine compartment if it remains visible.

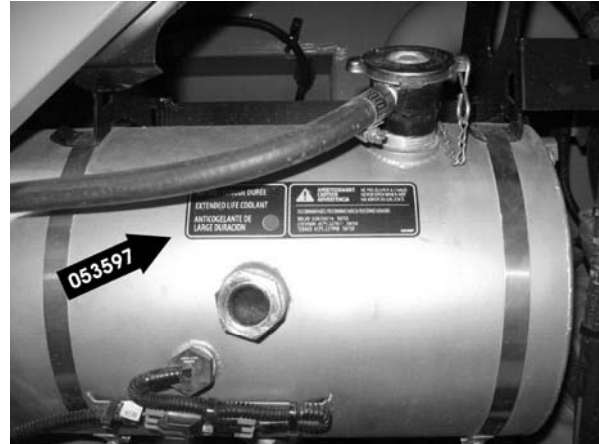
4. Affix new coolant specification decal #053597 as shown on picture, replacing former decal #0534787(eng/fr) or #053488(eng/esp). Do not leave the existing decal in the engine compartment if it remains visible.
