PREVOST

**WARRANTY
BULLETIN**

WB14-27

DATE :	APRIL 2014	SECTION :	18 - Body
EXPIRATION:	APRIL 2016		
SUBJECT :	CABLE INTERFERENCE WITH REAR DRIVE AXLE TRIPOD

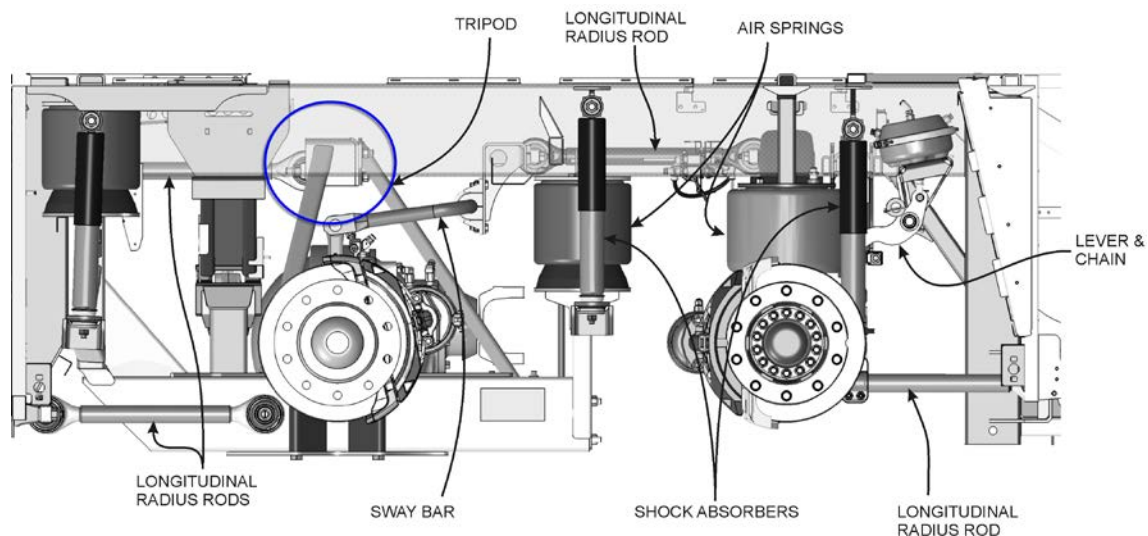
Figure 1

1. Deflate suspension air springs.
2. Lift vehicle using mobile column lifts. Make sure you are lifting the rear end by the drive axle.
3. Locate tripod above the drive axle. The tripod is a triangular arrangement of tubing with an anchor point for a radius rod.

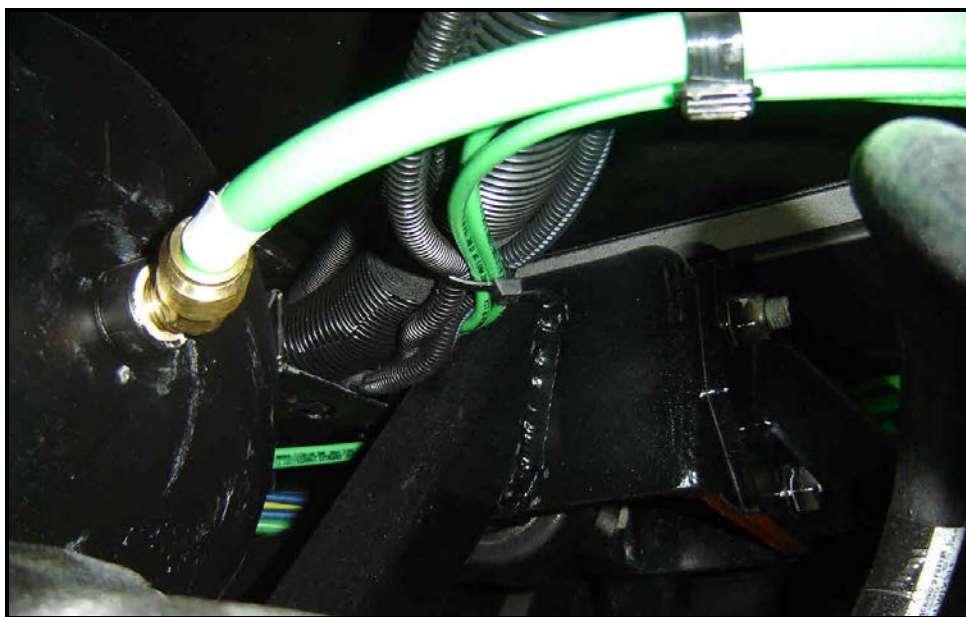
4. There may be an interference with the cables and tubes in this area, similar to figures 2, 3 and 4.

Figure 2 Side, looking towards curb side

5. If there is contact, move cables above or below large corrugated tube and away from interference zone.

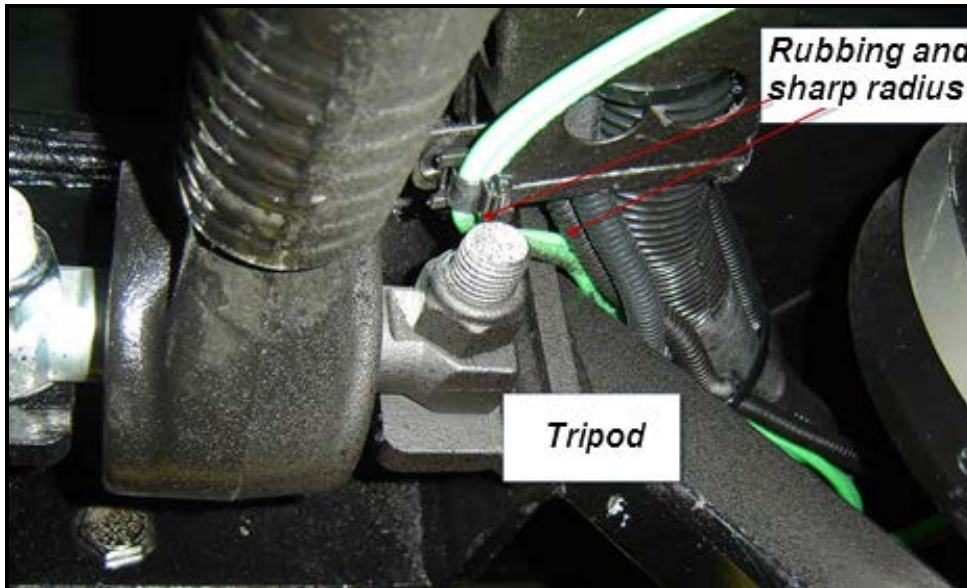
Figure 3 Front looking towards back
