PREVOST

WARRANTY BULLETIN

WB15-08

.DATE :	FEBRUARY 2015	SECTION :	18 - Body
EXPIRATION:	FEBRUARY 2017		
SUBJECT :	DRIVER'S SEAT BASE

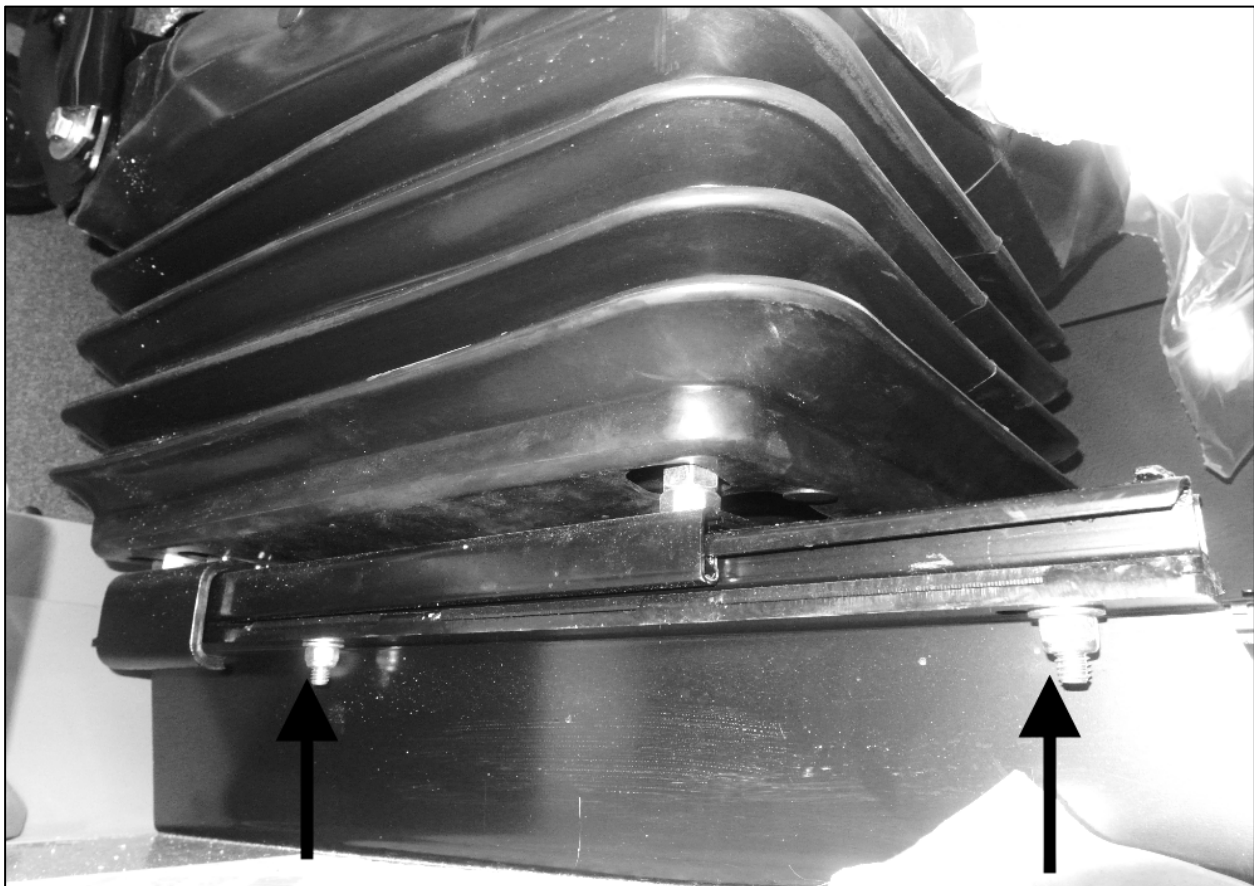
Figure 1

On the vehicles affected by this bulletin, inspect the driver's seat base to make sure specific bolts are properly tightened.

On each side of the seat base, make sure the four (4) nuts are tightened. (Fig. 1)

Tighten to 11 lbf-ft
