**WARRANTY
BULLETIN**

Wb98-07

DATE : June 1998	SECTION : 22
SUBJECT : USE OF THERMOSTAT TO CANCEL ALL A/C MODULE FUNCTIONS

On the above-mentioned vehicles, the air intake duct thermostat located in the HVAC compartment is used to cancel all A/C module functions in order to extend the life span of 05G A/C compressor.

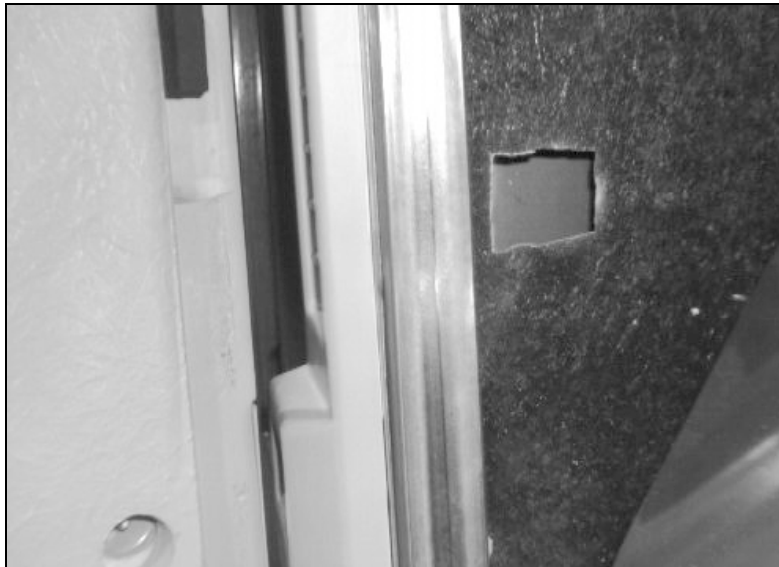
FIGURE 2 : THERMOSTAT INSTALLATION IN HVAC COMPARTMENT

- Using a hollow drill, drill a 1 5/8" hole in the center of the air intake duct. Enlarge the hole if needed to insert the thermostat (Prévost #373444). Secure using two 3/4" - 8 screws (Prévost #500641) and apply silicone if necessary for sealing (refer to fig. 2).

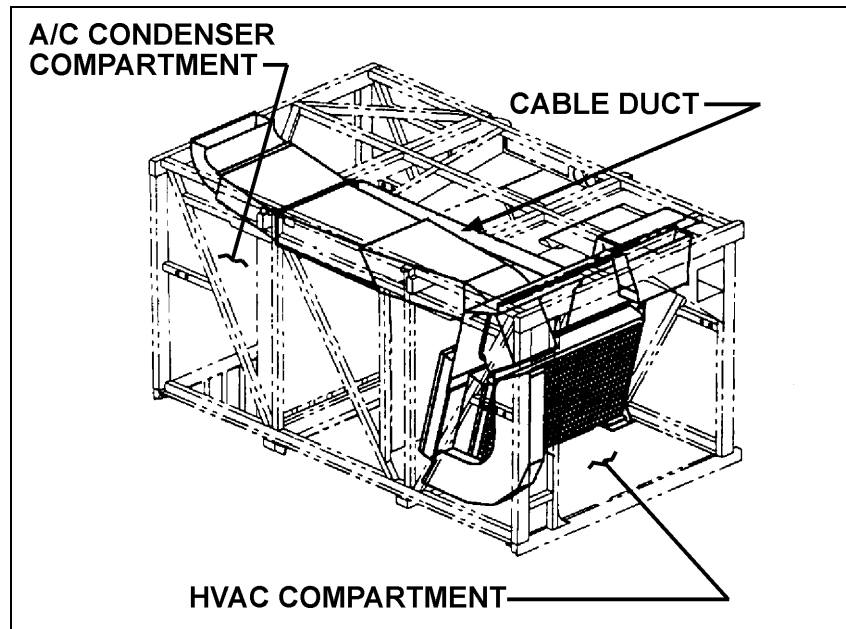
FIGURE 6 : CABLE DUCT

4. Insert pin 36 of wire 2M and pin 37 of wire 2B into the appropriate housing of C136 connector. Secure cable assembly inside A/C junction box using cable ties.
5. Starting from A/C condenser compartment, route cable assembly (Prévoist #064772) through cuff end bellows then through cable duct located between A/C condenser compartment and HVAC compartment (refer to fig. 6). Connect two pins of cable assembly with C136 connector inside A/C condenser compartment and connect cable assembly C151 connector with connector that was previously temporarily fixed (not used if the vehicle was not equipped with a thermostat), also connect cable assembly C550 connector with new thermostat located inside HVAC compartment. Secure cable assembly using cable ties.

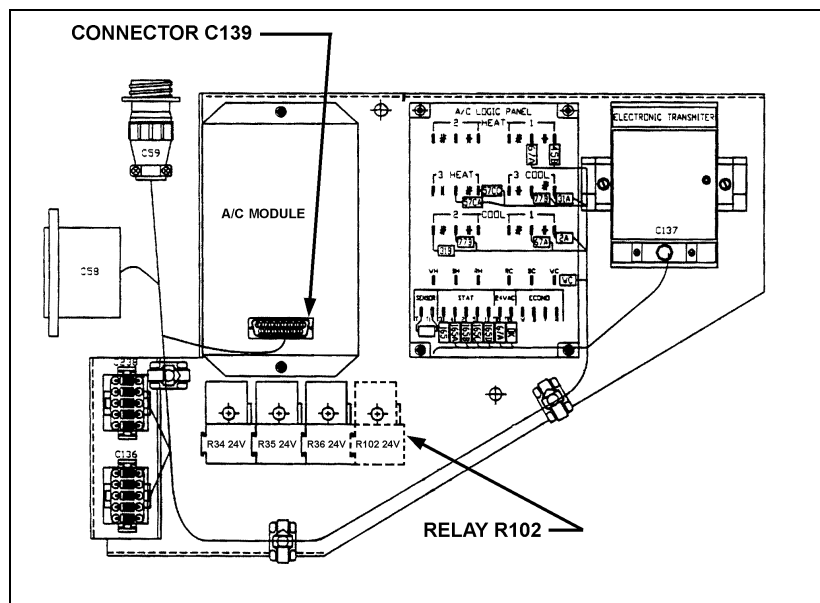
FIGURE 8 : REAR ELECTRICAL COMPARTMENT A/C JUNCTION PANEL

Note : Verify in rear electrical compartment if relay R102 was installed (refer to fig. 8), if so, complete procedure for vehicles serial numbers comprised between W-2204 and W-2284. If relay was not installed, go on with the present procedure.

2. From inside rear electrical compartment, disconnect C139 connector from A/C module (refer to fig. 8). Connect cable assembly (Prévost #064750) C139M connector with A/C module and C139 connector with connector just disconnected from module. Refer to wiring diagram D060882 P. 13.1 Rev. 07.

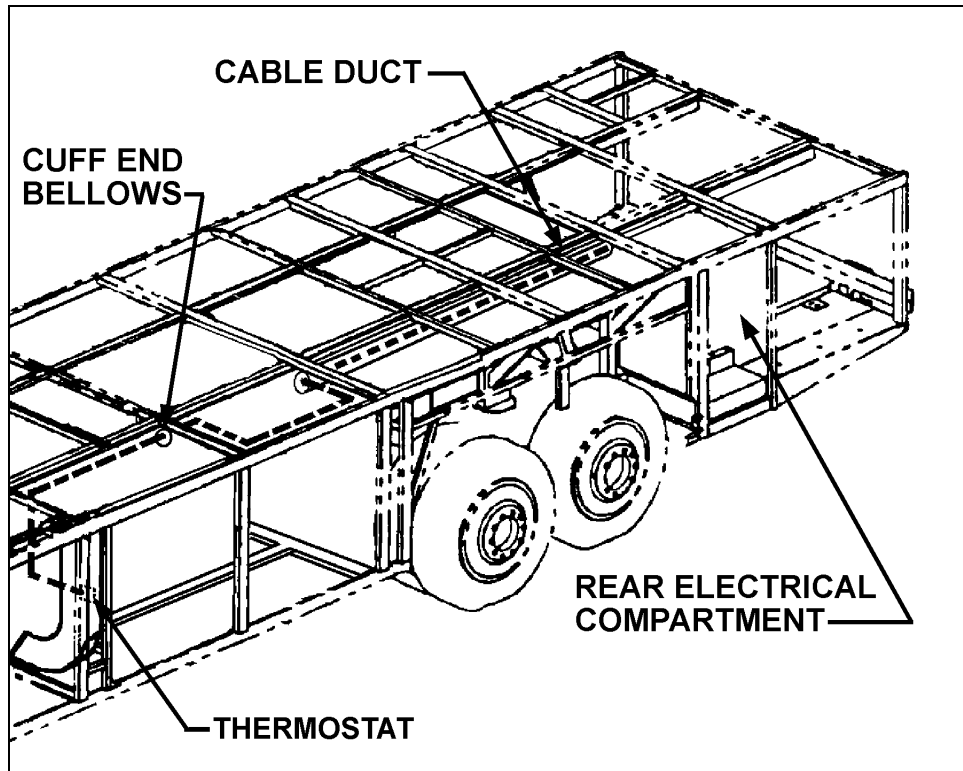
FIGURE 9 : CABLE ASSEMBLY 064750 CABLE ROUTING

- Starting from rear electrical compartment, route cable assembly (Prévost #064750) through cuff end bellows then through cable duct located above wheel housing (refer to fig. 9). Secure cable assembly inside rear baggage compartment, route cable assembly through cuff end bellows then inside HVAC compartment up to the thermostat. Disconnect connector from thermostat, connect cable assembly C151 connector with connector that was installed onto the thermostat, also connect cable assembly C550 connector with thermostat located inside HVAC compartment. Secure cable assembly using cable ties.
