**PREVOST**

**WARRANTY  
BULLETIN**

Wb99-03

DATE: February 1999	SECTION : 28, Body
EXPIRATION: February 2000	
SUBJECT: SECURING THE REAR LIGHTS' CABLES

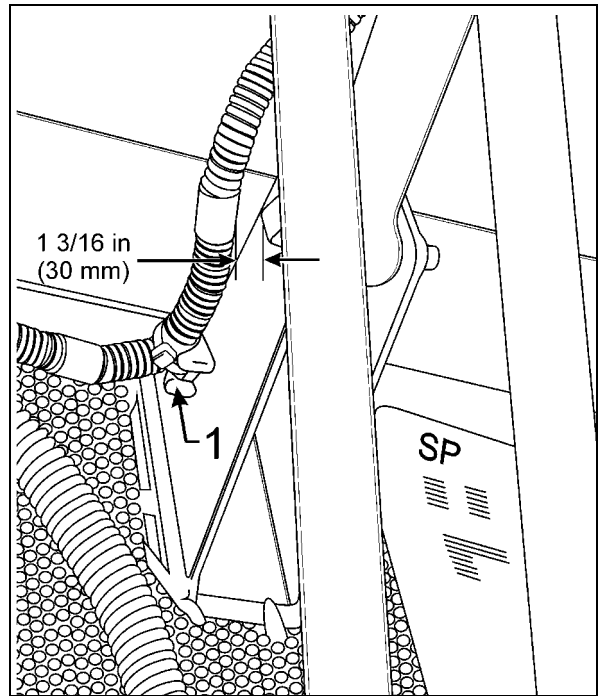
**Figure 3:** Rear lights' cables, on the entrance door side. **(1)** Tie mount and cable tie.
