**WARRANTY
BULLETIN**

Wb99-15

| SUBJECT: PROTECTION OF LAMPS LOCATED IN THE DRIVER'S SECTION | |

| Model | VIN |
|--|--|
| H3-40, H3-41 and H3-45 Coaches Model Year : 1992 - 1998 | From 2P9H33407N1001198 up to 2PCH33496W1012283 incl. |

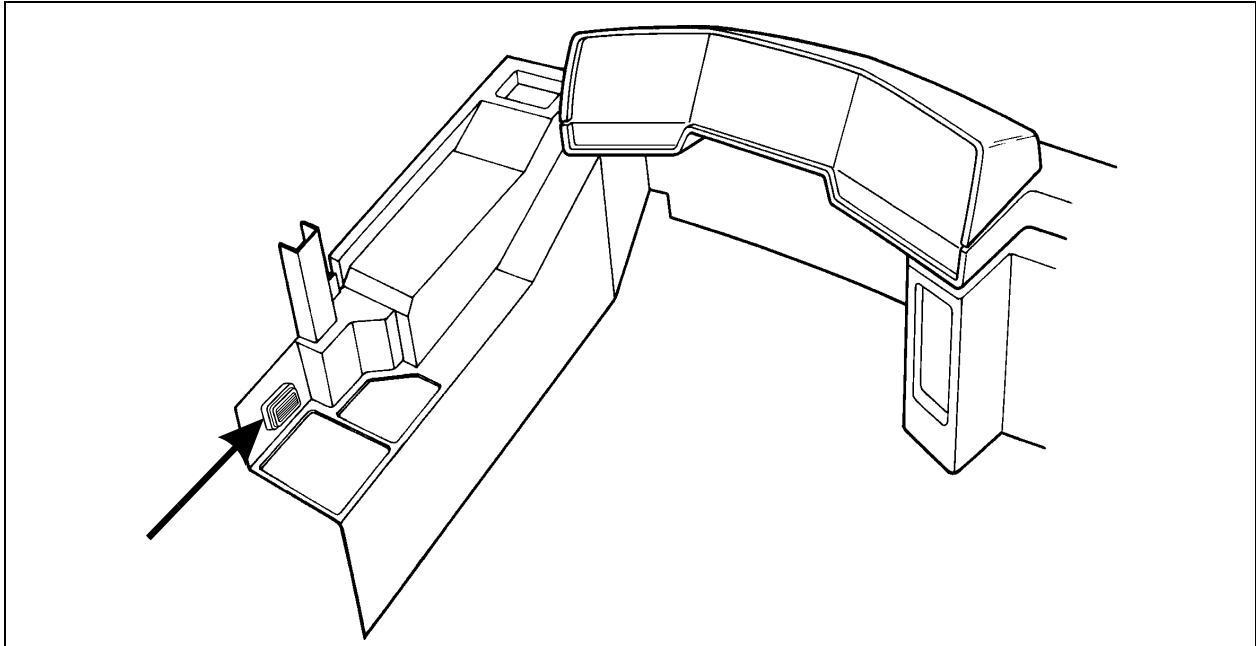
Figure 1: Typical location of the lamp, in the driver's section.

1. Locate the lamp (figure 1).
2. Open the front service compartment.
3. Identify and cut lamp wire #83.
4. Cut fuseholder wire, skin ends. Select the proper spring for #560893 fuse. Remove remaining springs, insert #560893 fuse and reassemble.
5. Twist wires and cover with a shrinkable tubing. Heat.
