**SAFETY  
RECALL**

**SR22-83A**

DATE :	September 2022	SECTION :	06 ELECTRICAL
SUBJECT:	9700 ALTERNATOR BELT REPLACEMENT

Revision A

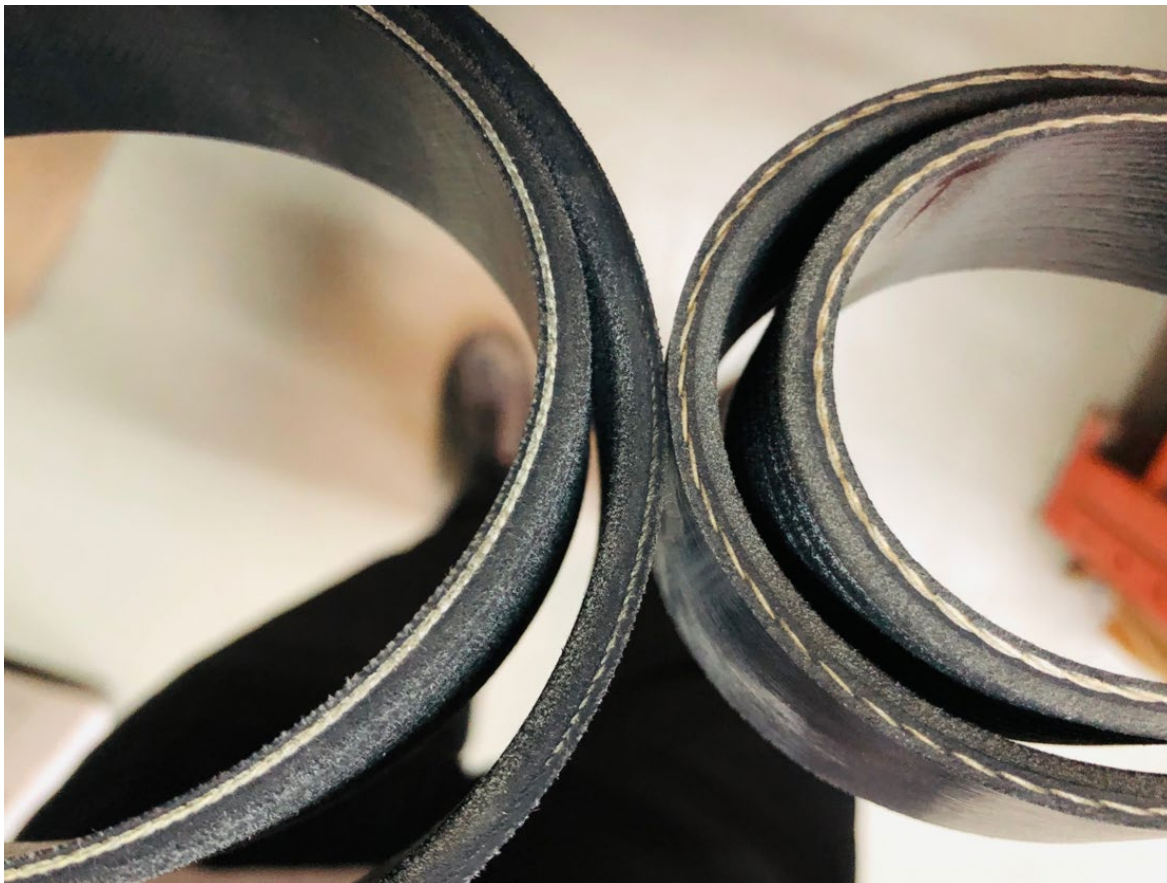
**Aramid reinforced cord belt (left) vs new polyester cord belt (right).**

5. Inspect the alternator belt (refer to the picture above).
  - If the belts are polyester reinforced reinstall them.
  - If the belt is reinforced with aramid cords, complete the inspection and replace it with a new polyester belt (see interchange table).
6. Reverse the procedure to reinstall the other belts on the vehicle.

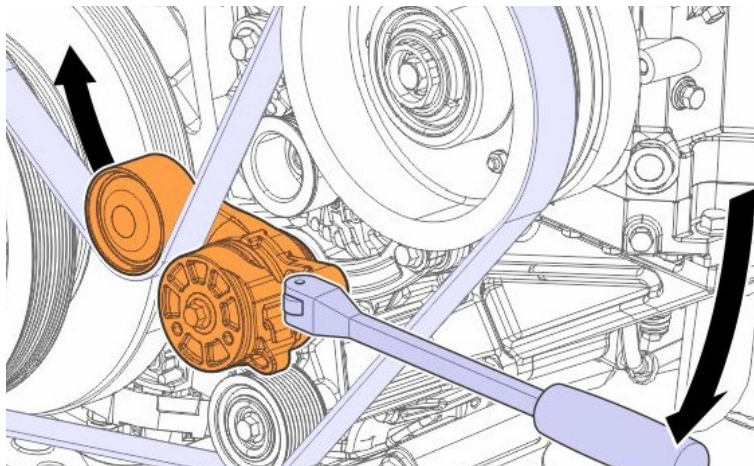
1. Remove the AC compressor belt.

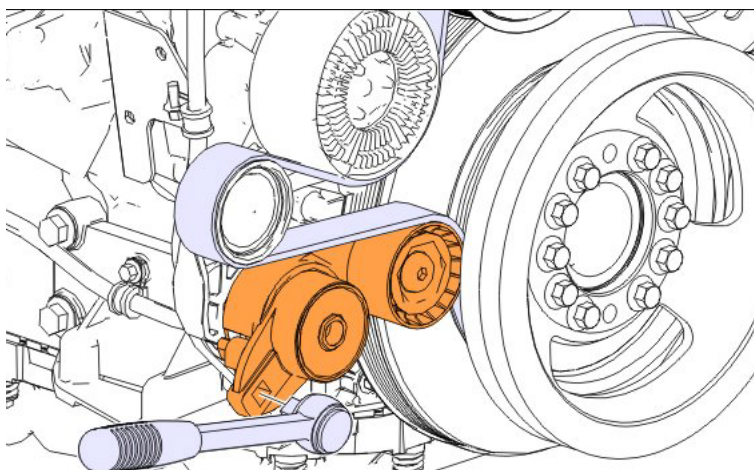
2. Remove the water pump belt.

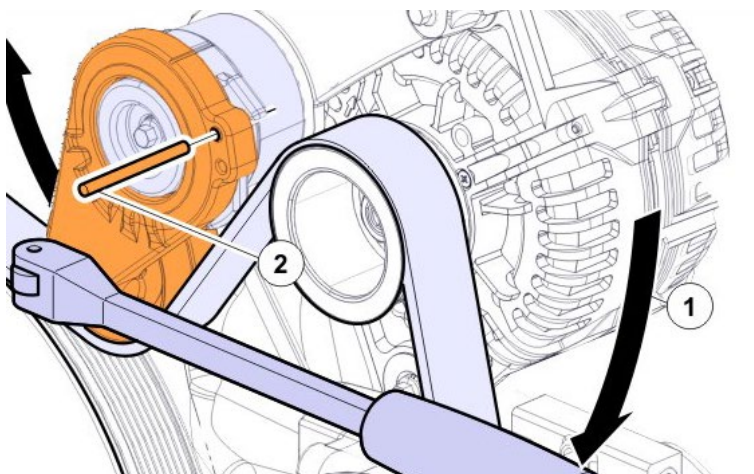
3. Remove the alternator belt.

- Apply torque clockwise to the tensioner (1).
- Insert locking pin (2).

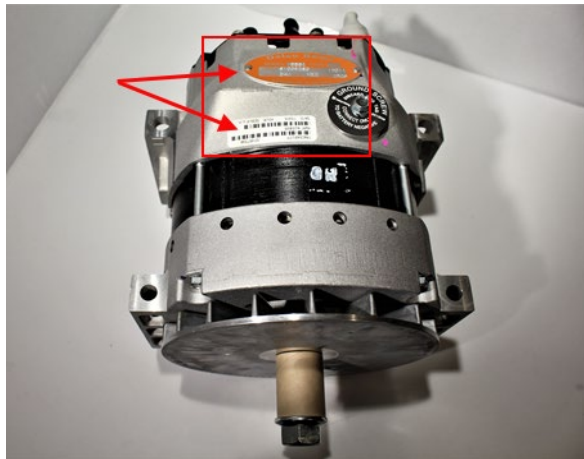
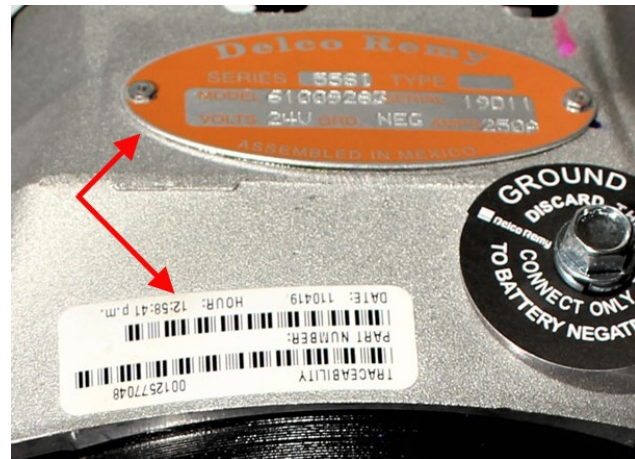
#### REMY 55S 250AMP

- REMY 55S Alternator will have a Delco-Remy identification plate riveted to the body as well as a bar code sticker next to the ground stud as shown.
