# PREVOST

## WARRANTY BULLETIN

**WB24-39**

DATE :	November 2024	SECTION :	06 ELECTRICAL
EXPIRATION:	November 2026		
SUBJECT :	FUSE F130 REPLACEMENT

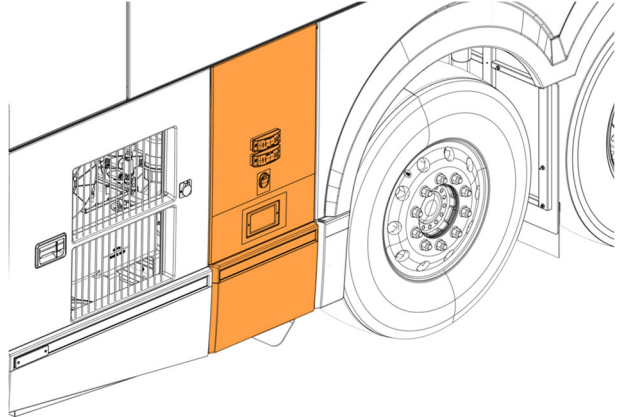
1. Open the main power compartment door on the curbside.

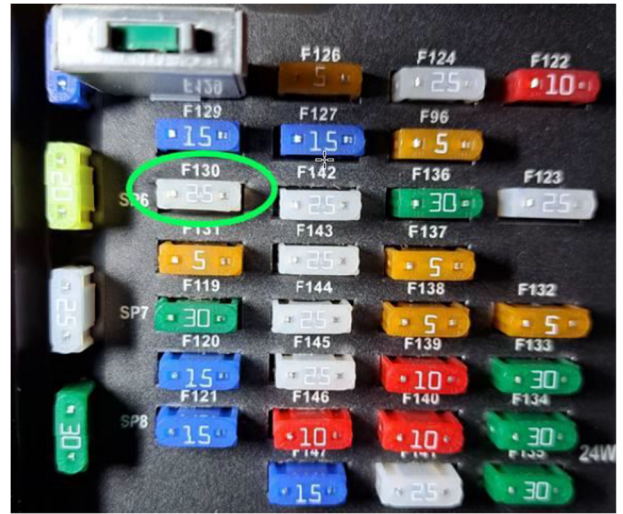
4. Check fuse F130:

- If it is a 25A fuse, no action is required.
- If it is not a 25A fuse, carefully remove it using needle nose pliers, then, install new fuse **563153**.

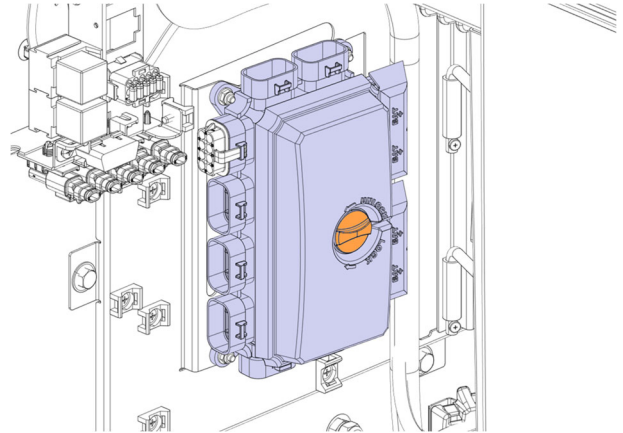
5. Close the VECR cover
