# SAFETY RECALL

# SR16-86E

## 12-VOLT POWER SOURCE RELAY REPLACEMENT 9700 (B13R)

On the vehicles affected by this recall, it is necessary to replace one (1) and in some cases two (2) 12-volts power source relays.

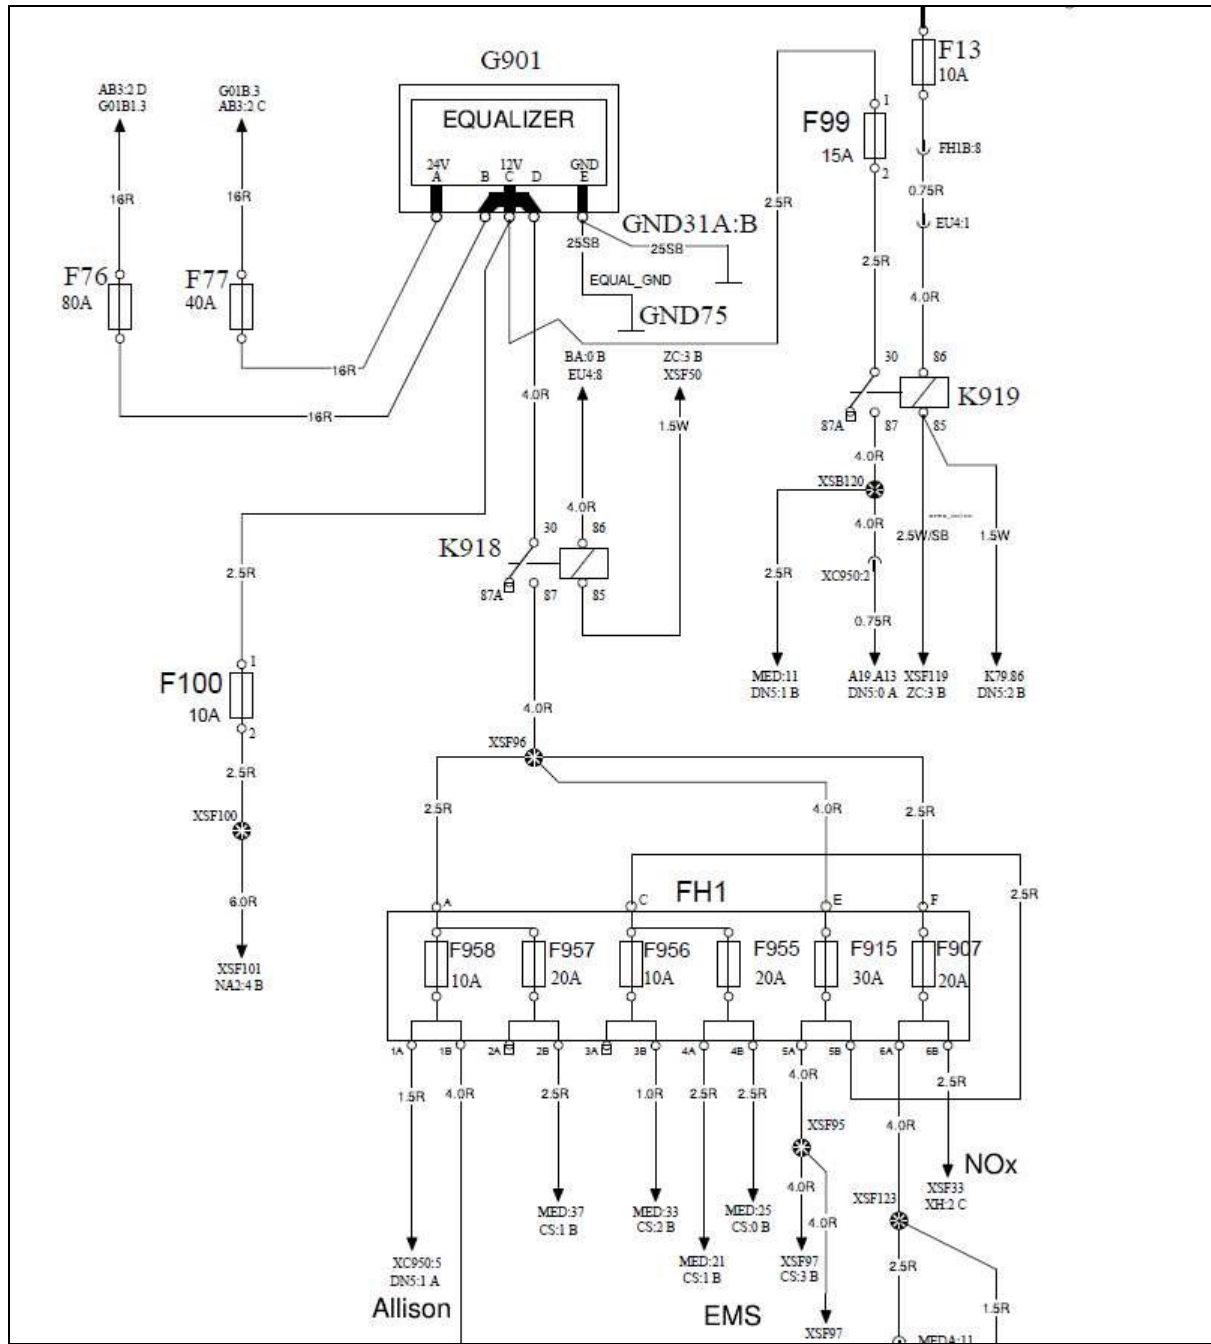
FIGURE 1: WIRING DIAGRAM SHOWING K918 & K919 – EQUIPPED WITH ALLISON TRANSMISSION

RANGE	WHAT TO DO
Model Year: up to 2013 Vehicles up to 3CET2S22XD5 <u>160297</u>	<b>Relay K917:</b> Replace existing relay K917 with relay p/n 21244697 (Cartier <b>Mini</b> ) <b>Relay K918:</b> Replace existing relay K918 with relay p/n 564218 (Cartier <b>Maxi</b> ). Refer to the following instruction.
Model Year: 2013 – 2015 From 3CET2S225D5 <u>160756</u> up to 3CET2V227F5 <u>168569</u>	<b>Relay K918:</b> Replace existing relay K918 with relay p/n 564218 (Cartier <b>Maxi</b> ). Refer to the following instruction.
Model Year: from 2015 Equipped with <b>Allison transmission</b> From 3CET2V224F5 <u>169811</u>	<b>Relay K919:</b> Replace existing relay K919 with relay p/n 21244697 (Cartier <b>Mini</b> ) <b>Relay K918:</b> Replace existing relay K918 with relay p/n 564218 (Cartier <b>Maxi</b> ). Refer to the following instruction.
Model Year: from 2015 Equipped with <b>I-Shift transmission</b> From 3CET2V224F5 <u>169811</u>	<b>Relay K918:</b> Replace existing relay K918 with relay p/n 564218 (Cartier <b>Maxi</b> ). Refer to the following instruction.

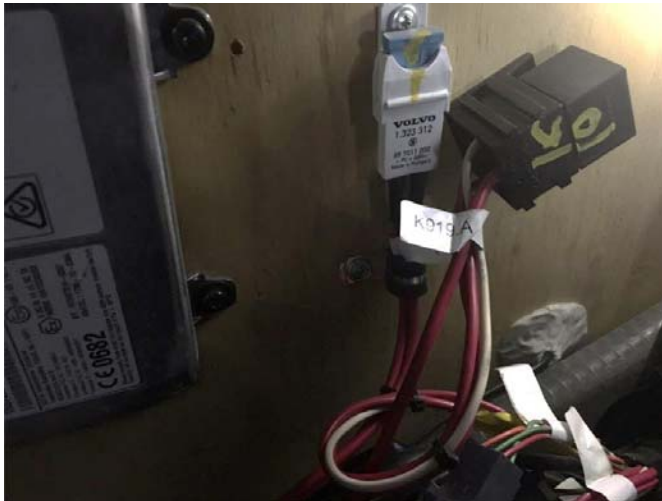
FIGURE 2: RELAY K919 LOCATED UNDER THE DRIVER AREA FLOOR

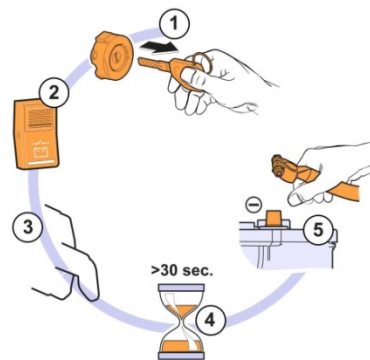
FIGURE 3

- 1) Turn off electrical vehicle system, by following these steps:
  - Remove ignition key;
  - Turn off vehicle main switch in the dashboard;
  - Turn off battery switch;
  - Wait at least 30 seconds;
  - Disconnect **NEGATIVE** cable from vehicle battery,

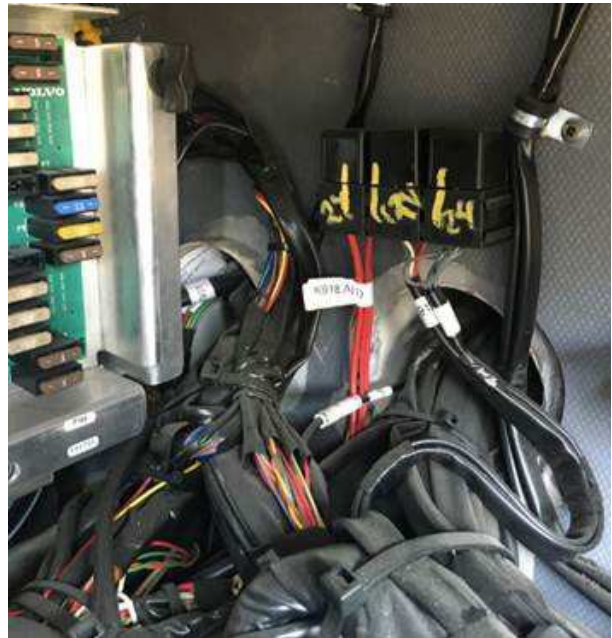
FIGURE 4: For vehicles not equipped with I-START dual battery system (until **3CET2V42XG5176275**), find K918 at the right side of electrical distribution unit.

- 2) Identify the scenario applicable to the vehicle.
- 3) Locate the relays that are involved in accordance with the applicable scenario (one or two relays to be replaced).
- 4) Remove the existing relay and change it for a new relay in accordance with the scenario above. An easy adaptation is necessary when replacing relay K918. To do it, perform steps 5 up to 15.
- 5) Locate relay K918. See FIGURE 4 & FIGURE 5

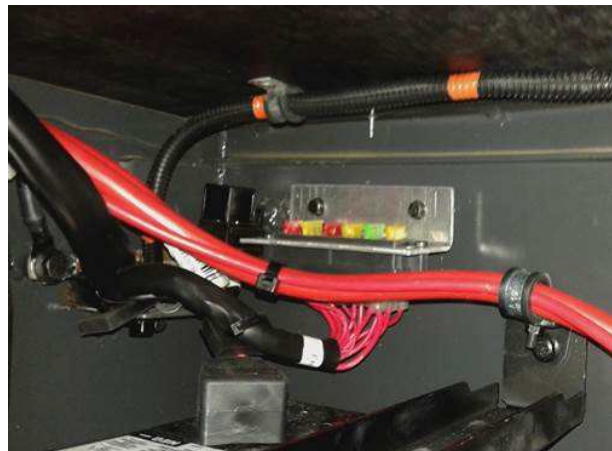
FIGURE 5 : For vehicles equipped with I-START dual battery system (from **3CET2V220G5177311**), find K918 at the starter batteries compartment.

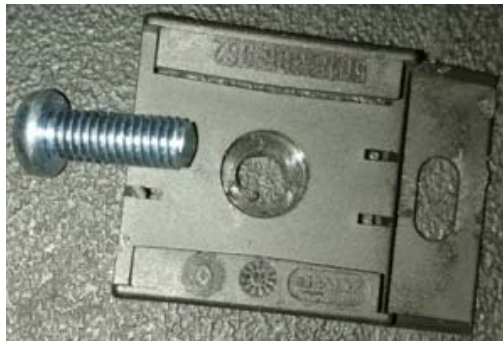
1. Install the relay wall bracket **on the existing weld bung**. A M6-1x16mm will be required (Prevost p/n 502817 will do) machine screw.
2. Drill out the mounting hole with a 1/4" drill bit to accept the new screw (see image below).

In order to install the wall bracket at the same location as former relay, proceed as follows:

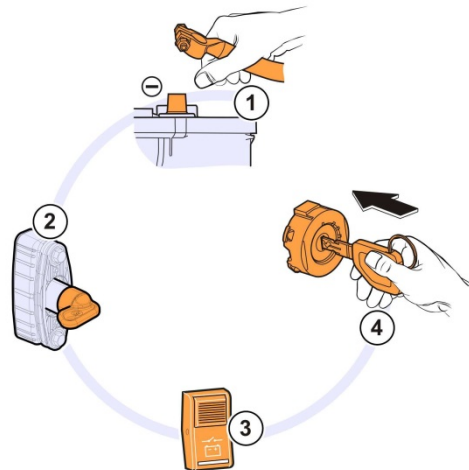
FIGURE 9

15) Turn on the vehicle. Follow these steps:

- Connect NEGATIVE cable in vehicle battery;
- Turn on battery switch;
- Turn on vehicle switch in the dashboard;
- Insert vehicle key.
