**SAFETY
RECALL**

SR17-09B

DATE :	May 2017	SECTION :	23 ACCESSORIES
SUBJECT:	LOWER WINDSHIELD WIPER ARMS INSPECTION

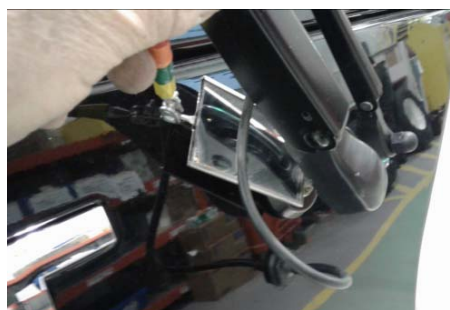
FIGURE 1

1. Using a mirror, identify the type of wiper arm head casting design (FIGURE 1).

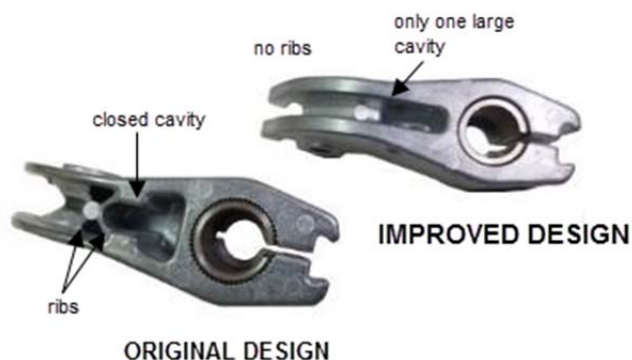
FIGURE 2

2. If both wiper arms are of the « **improved design** » (FIGURE 2), no replacement is needed. No other verification is required.
3. If at least, one wiper arm is of the « **original design** », then replace both wiper arms using kit **WB17-09** as per the instructions of PART 2.

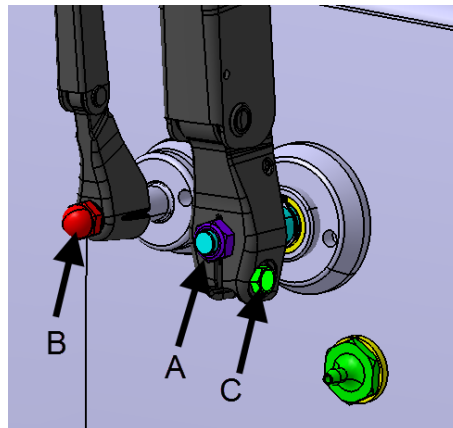
FIGURE 5

4. Loosen nut C and then remove nut A & B (FIGURE 5).
5. Remove the wiper arms.

Save the wiper arms. Components on the wiper arms must be reinstalled on the new wiper arms.

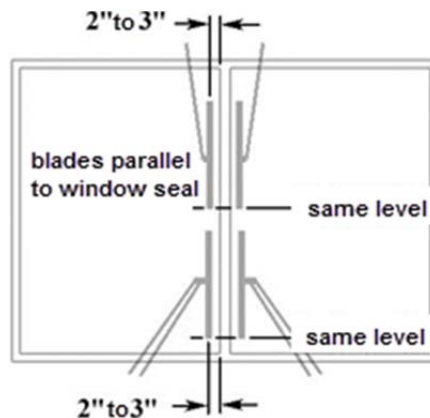
FIGURE 13

16. The wiper arms should be positioned in accordance with the diagram on the right (FIGURE 12).
