**SAFETY  
RECALL**

**SR23-05**

DATE :	September 2023	SECTION :	23 ACCESSORIES
SUBJECT:	AFSS OPTICAL SENSOR CORROSION

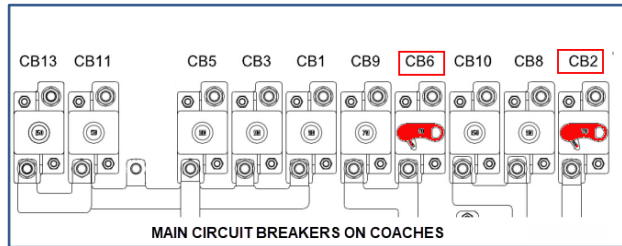
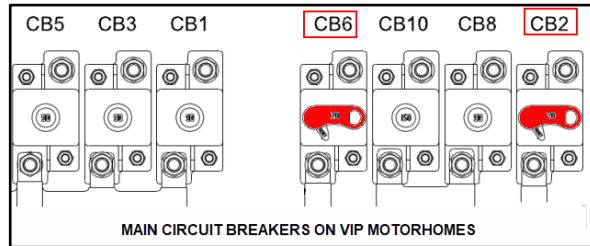
- Trip the CB2 and CB6 resettable breakers (rear junction box).

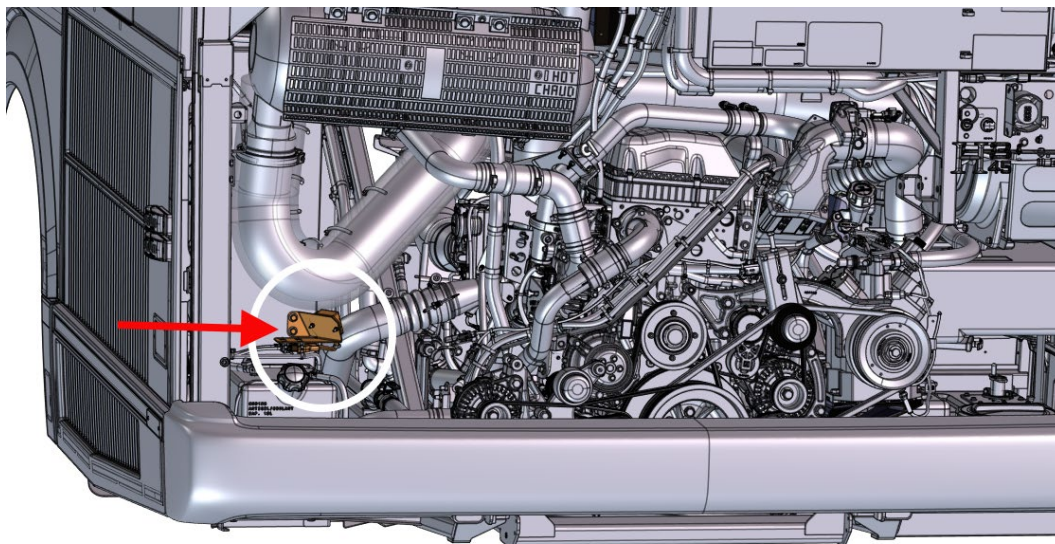
2. Locate the lower AFSS optical sensor in the engine compartment (recent H3 model shown).

**NOTE :** On older models, the sensor is located on the same side but lower near the bumper curve.

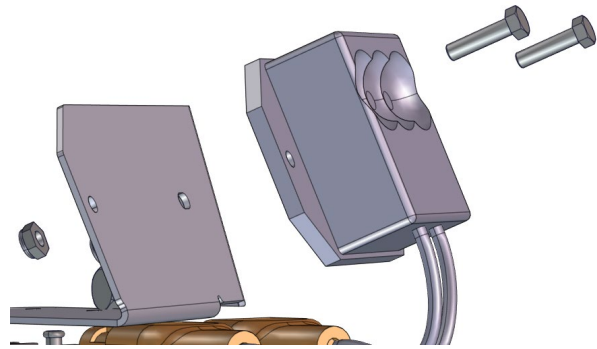
3. Remove the sensor from the support bracket.

- Remove screws and nuts
- Do not discard hardware

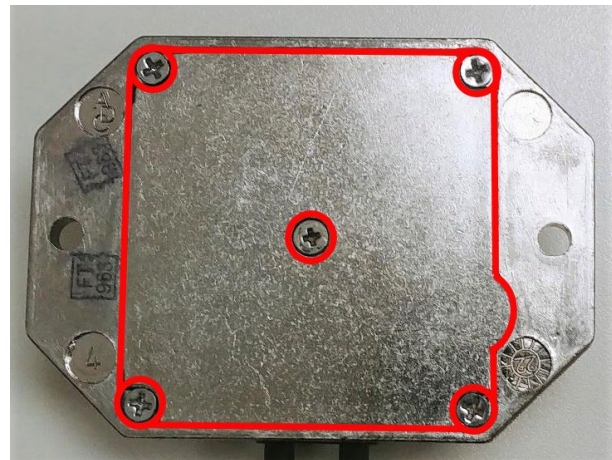
4. Inspect the backside of the sensor looking for sign of corrosion at the cover seam.

- Look for excess of aluminum oxide, a white (sometimes greenish) dusty looking material.
- If aluminum oxide is found and it is touching the seam of the backside cover, the sensor must be replaced.
- Superficial black spots (small crater) are ok unless they create a noticeably deep crevice at the seam area.

**AREA OF THE SENSOR BACKSIDE THAT MUST BE FREE OF CORROSION (WHITE ALUMINUM OXIDE POWDER)**

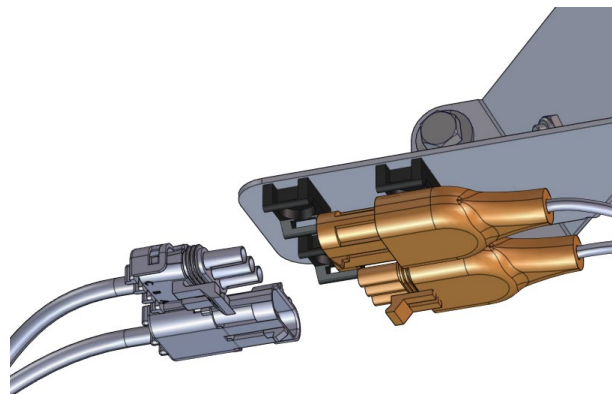
5. If the sensor is corroded, it must be replaced. Unplug the sensor two connectors under the bracket.

- Remove all cable ties.
- Unplug the connectors.

**\*\*\* DO NOT DISCARD THE OLD SENSOR\*\*\***

- Return the sensor for warranty.

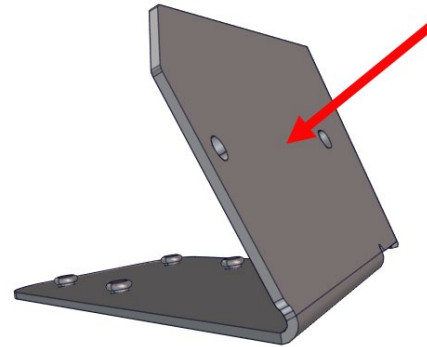
6. Clean the bracket mounting surface.

- Use cleaner/degreaser on a clean shop rag and scrub the bracket surface to remove road grime and oxidation.
- If the old sensor is going to be reinstalled, also clean the backside of the sensor.

**NOTE** : do not clean the front optical part of the sensor with strong degreaser or petroleum products.

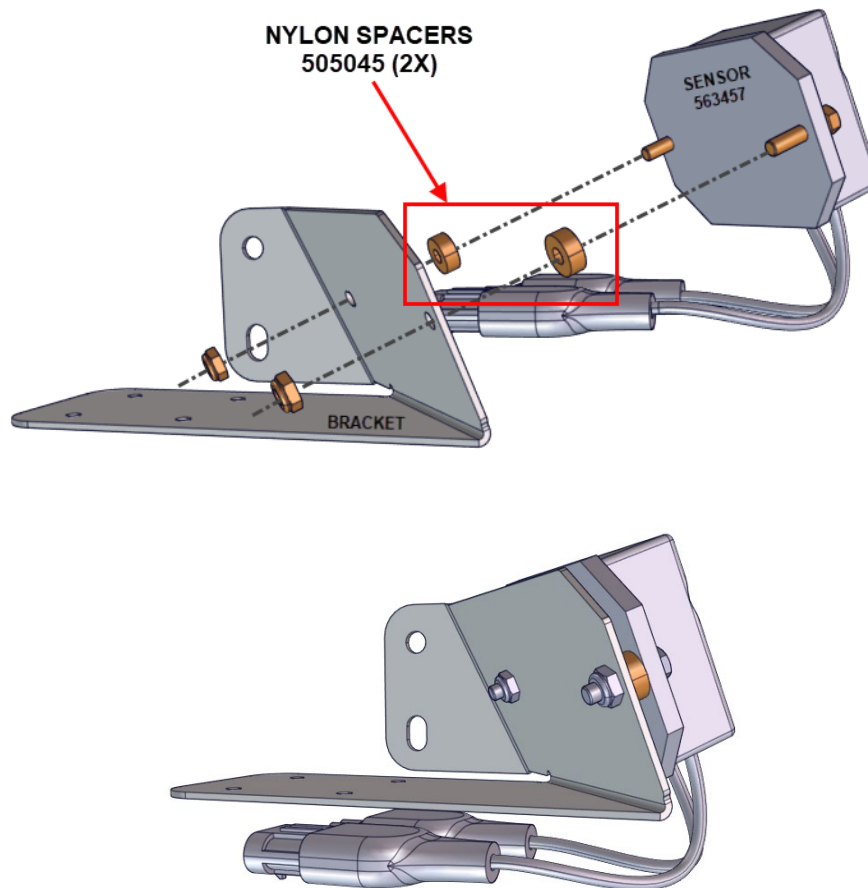
7. Reinstall (or install a new sensor, as required) the sensor on the bracket adding the supplied **505045** nylon spacers between the sensor and the bracket.

- Reuse mounting hardware (screws and nyloc nuts).

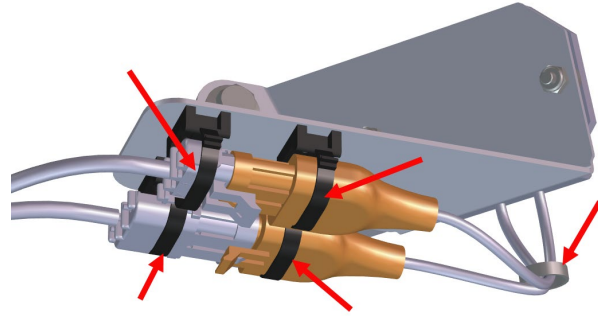
8. With new sensor, reconnect and secure the two connectors with cable ties under the bracket.

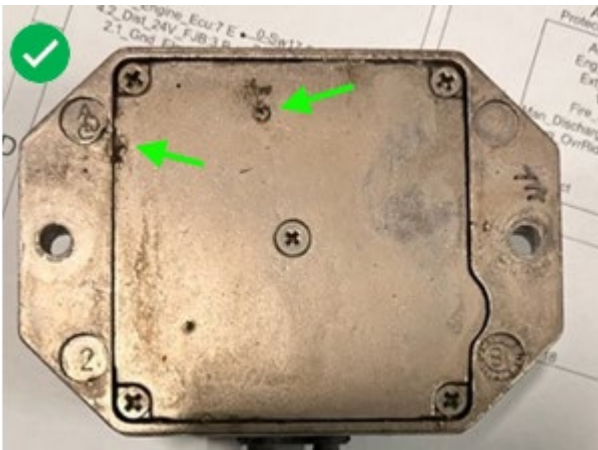
**SUPERFICIAL BLACK SPOTS ARE OK - CLEAN & REINSTALL**

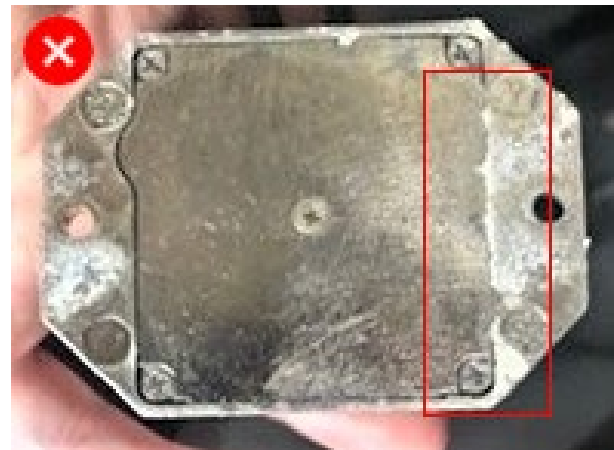
**WHITE CORROSION AT ONE EDGE - REPLACE**

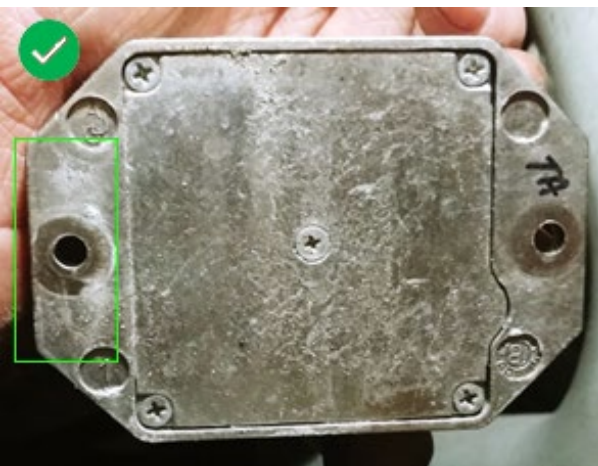
**WHITE SPOT FORMING BUT NOT TOUCHING THE COVER SEAM - CLEAN & REINSTALL**

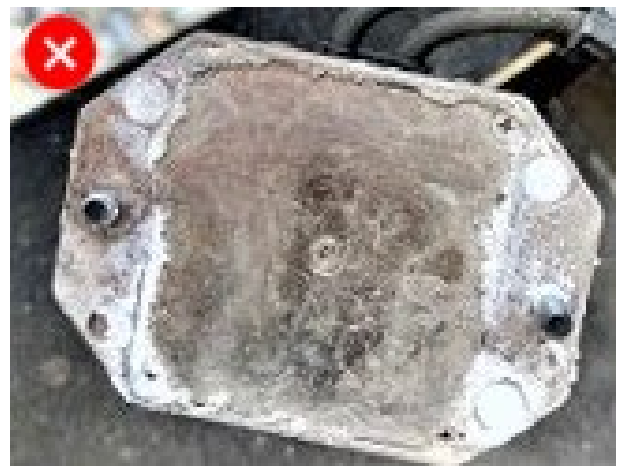
**WHITE CORROSION ALL AROUND THE COVER - REPLACE**

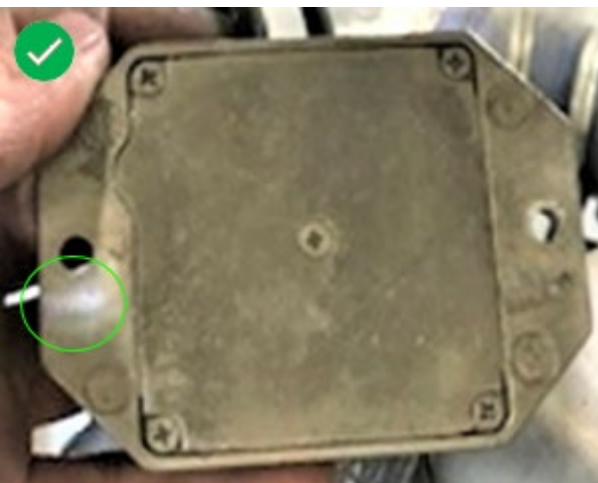
**SENSOR COVER DIRTY AND ROUGH BUT SMALL WHITE SPOT NOT TOUCHING THE EDGE - CLEAN & REINSTALL**

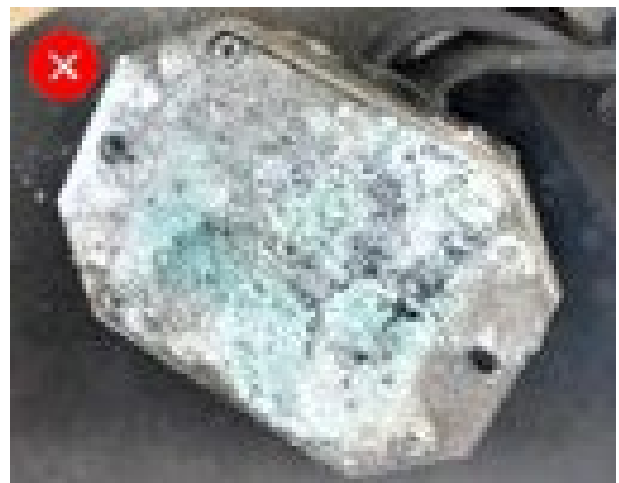
**BACK SIDE COVERED BY CORROSION - REPLACE**
