PREVOST

WB23-16A

DATE :	November 2023	SECTION :	06 ELECTRICAL
EXPIRATION:	November 2025		
SUBJECT :	SOLUTION FOR BATTERY DRAIN ON VEHICLE NOT EQUIPED WITH A PREHEATER

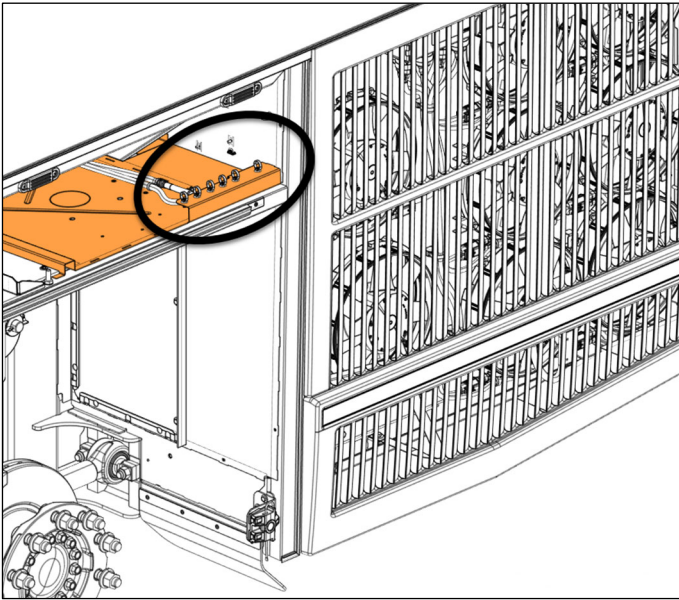
Figure 1: H3-45 Harness location

1. Locate the connector on the vehicle harness: refer to **figure 1** or **figure 2**

2. Unplug connector CSX1 and CSX3
