PREVOST

SAFETY RECALL

SR24-33

DATE :	September 2024	SECTION :	18 BODY
SUBJECT:	INSPECT THE PASSENGER SEAT BELTS

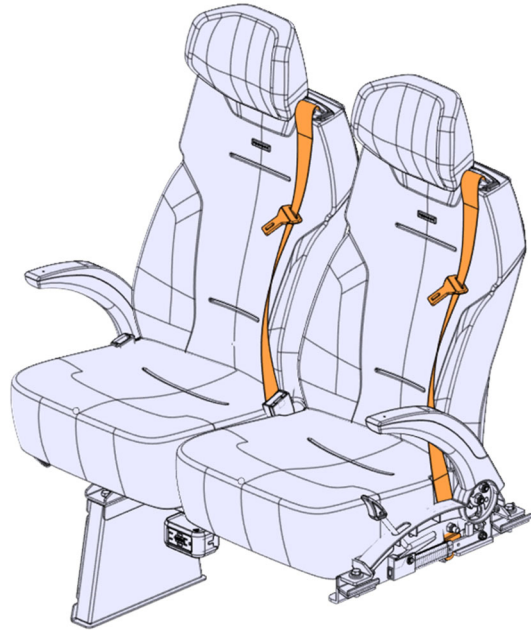
1. Inspect the automatic locking retractor of all passenger's seat belts.
 - If the seat belt does not disengage go to the next step and replace the seat belt.
 - If the seat belt disengages, the procedure is complete.
