PREVOST

MAINTENANCE INFORMATION Mi06-11

DATE : SEPTEMBER 2006	SECTION : 26 Slide-Out
SUBJECT : REAR SLIDE-OUT GEARBOX LEAKAGE

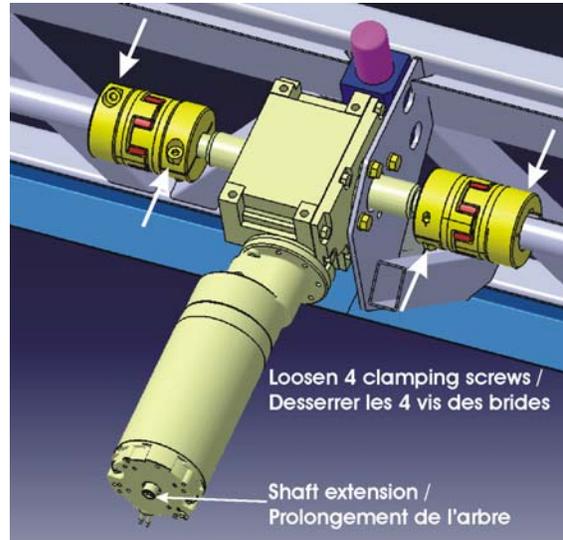
FIGURE 1

- a. Loosen the clamping screws on each clamping hubs (figure 1). If needed, rotate the motor shaft extension to gain access to the clamping screws.

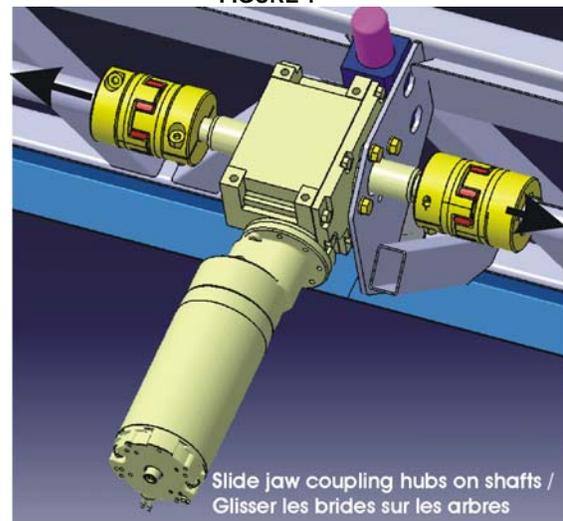
FIGURE 2

- b. Separate clamping hubs and slide onto the shafts, away from the gearbox (figure 2).

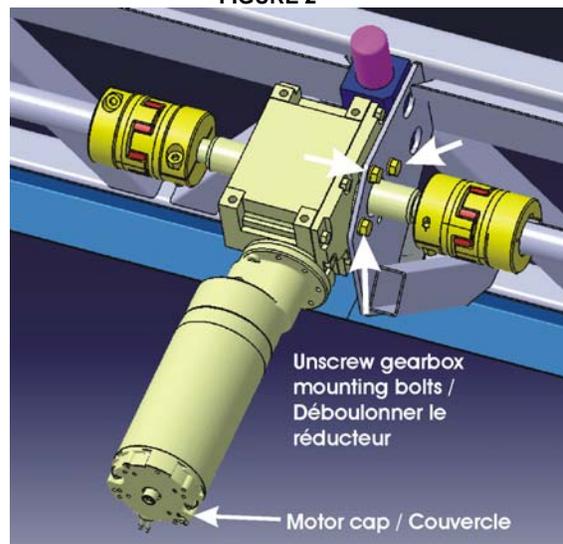
FIGURE 3

4. Unscrew the mounting bolts (3 or 4) securing the motor/gearbox assembly (figure 3).

6. Unscrew nuts and remove the motor cap (figure 3).
7. Remove the brush holder and the spring washer (figure 4).

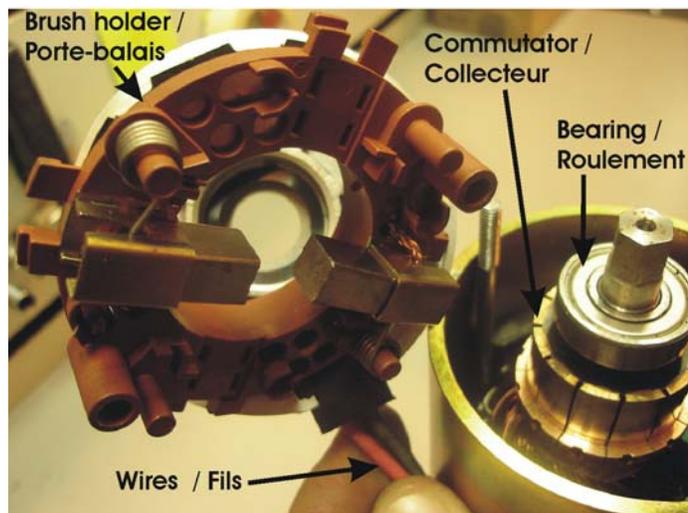
FIGURE 5

8. Read the note above. Reinstall the brush holder after a rotation of 180° from its original position (wires must exit from underneath once the motor reinstalled).
 - a. Pry the brushes gently with a small screwdriver to move them aside from the bearing and the commutator (figure 5 & 6).

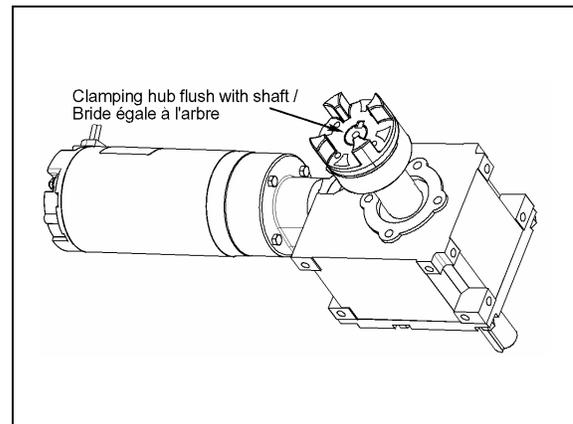
FIGURE 7

12. Reinstall the jaw couplings.
 - a. For both gearbox shafts, slide a clamping hub flush with the gearbox shaft extremity (figure 7).

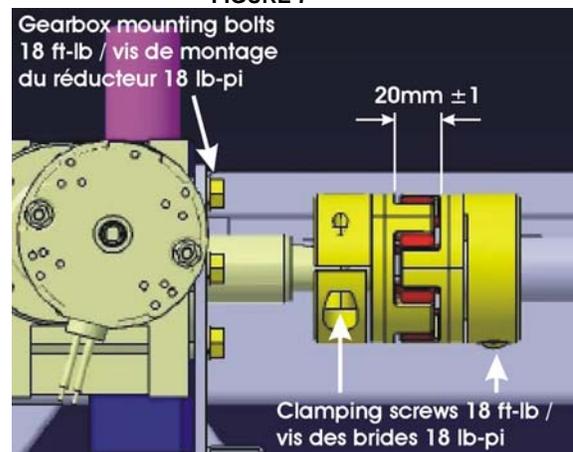
FIGURE 8

- b. Reconnect the clamping hubs. If necessary, rotate the motor shaft extension by hand to align the clamping hubs. Leave a gap of 20mm (13/16" approx) between each clamping hubs as shown on figure 8.
 - c. Tighten clamping screws to a torque of 18 lb-ft (figure 8).

10. Tighten nuts.
11. Reinstall the motor/gearbox assembly using the mounting holes opposite to the gearbox cover. Use 4 mounting bolts. Tighten mounting bolts to a torque of 18 ft-lb in a criss-cross pattern (figure 8).

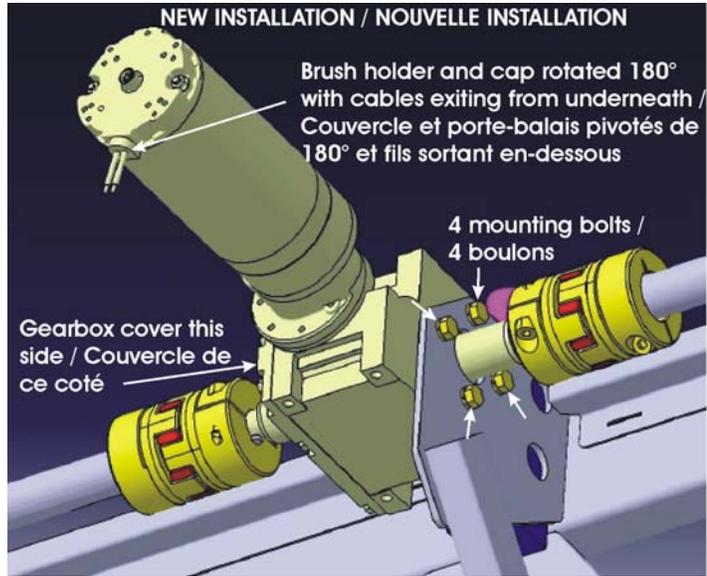
FIGURE 9

13. Connect the motor electrical cable connector. See new installation on figure 9.

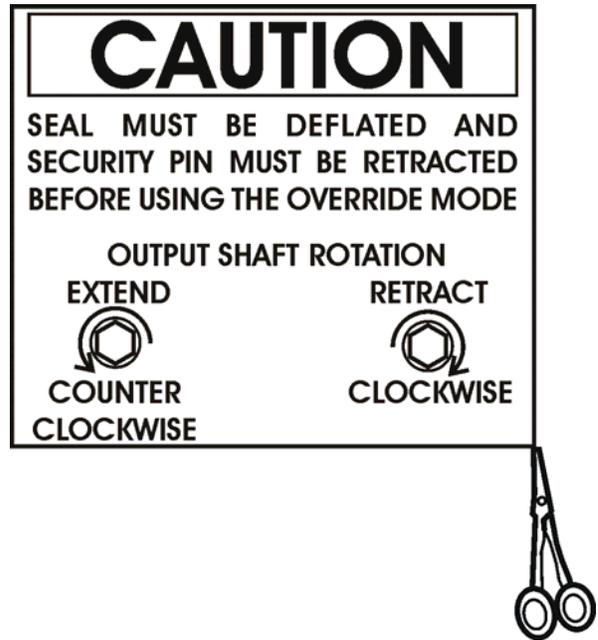
FIGURE 10

14. Place decal #478251 or figure 10 over the existing decal.
