SAFETY RECALL

Sr07-10

DATE : FEBRUARY 2008	SECTION : 07
SUBJECT : ZF-ASTRONIC AUTOMATIC TRANSMISSION GEAR SHIFTER PAD DEFECT

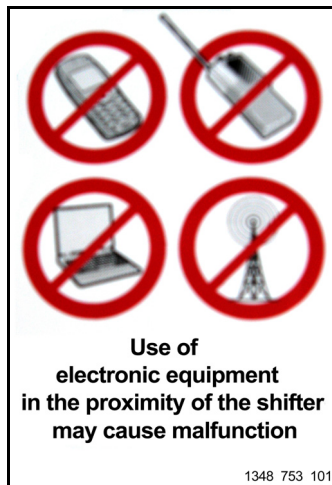
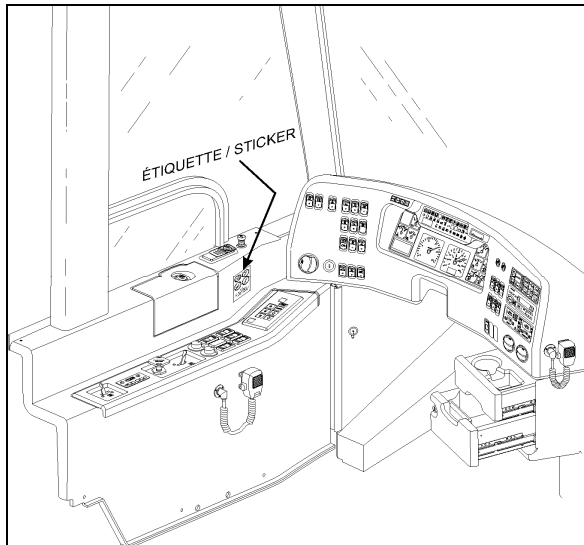
FIGURE 1: H3 COACHES

ZF has determined that a defect which relates to motor vehicle safety exists in the item of the motor vehicles listed above. A cell phone or a Blackberry placed in the proximity of the ZF Friedrichshafen Arens Astronic gear shifters, P/Nos.0501 214 599 and 0501 212 979, installed as original equipment on the above-mentioned coaches, could cause the display to change from "R" (reverse) to "2" (second gear) should the phone receive a call. The cause is the cell phone interference due to the combination of several reasons: Shifter layout and susceptibility to radiation and cell phone frequency.

1. Check and confirm that the radio installation is in accordance with the radio supplier's installation guidelines.
2. Affix the sticker (Part #572148) onto the L.H. side of the gear shifter pad as per figures 1 and 2.
