PREVOST

SAFETY RECALL

Sr09-04

DATE : FEBRUARY 2009	SECTION : 16-SUSPENSION
SUBJECT : REPLACING LOWER A-ARMS FIXING BOLTS

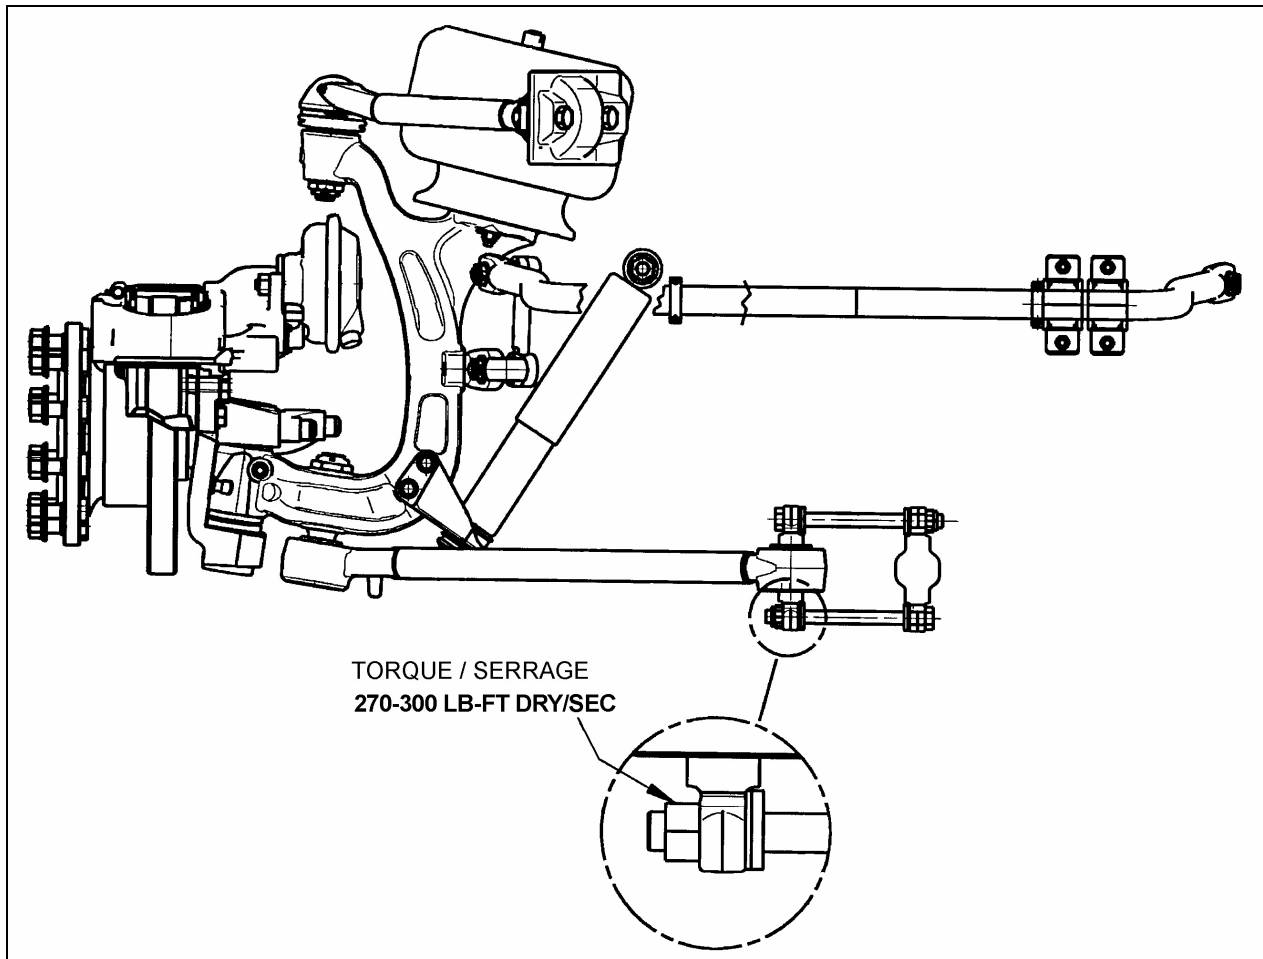
2. Verify what sign is present on the bolt heads fixing the lower a-arms.

3. If letters "CFS"

are engraved onto the head, the bolt(s) must be replaced with bolts having a triangular sign

4. Torque bolts to 270-300 LB-FT dry (366-407Nm).

Reinstall spacers in the same position to avoid modifying wheel alignment.

5. Also replace M20 Stover nuts.

Replace one bolt at a time to prevent parts movement.
