Safety Recall

SR12-69

WHEELCHAIR LIFT: SERIAL NUMBER AND MAINTENANCE SAFETY PIN INSPECTION 9700 (B13R)

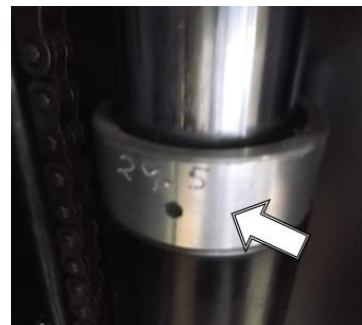
- 3) Check that both cylinders are marked with '29.5' **Note:** this marking could be on the "back side" of the cylinder, in which case an inspection mirror might be necessary.

If not, please contact your nearest Prevost Service Center or Service Manager to organize replacement of cylinders

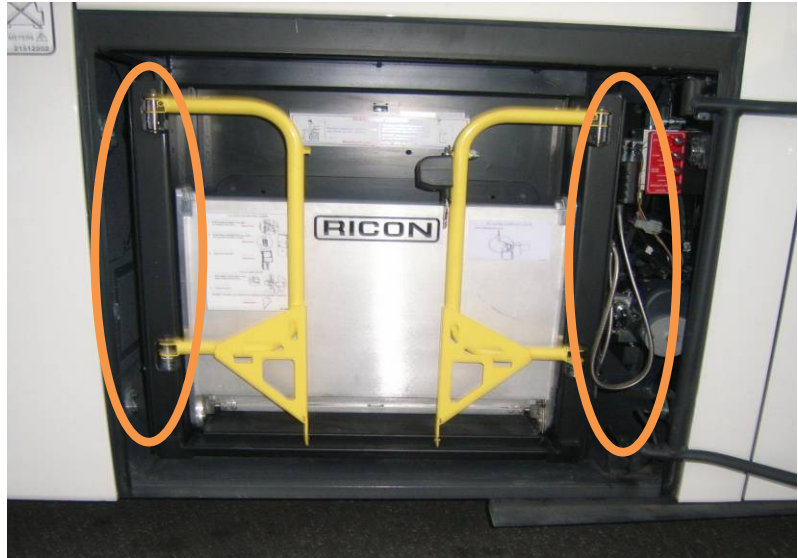
- 4) Open the Wheelchair lift door;
- 5) Make sure there are maintenance safety pins on each side of the wheelchair lift unit.

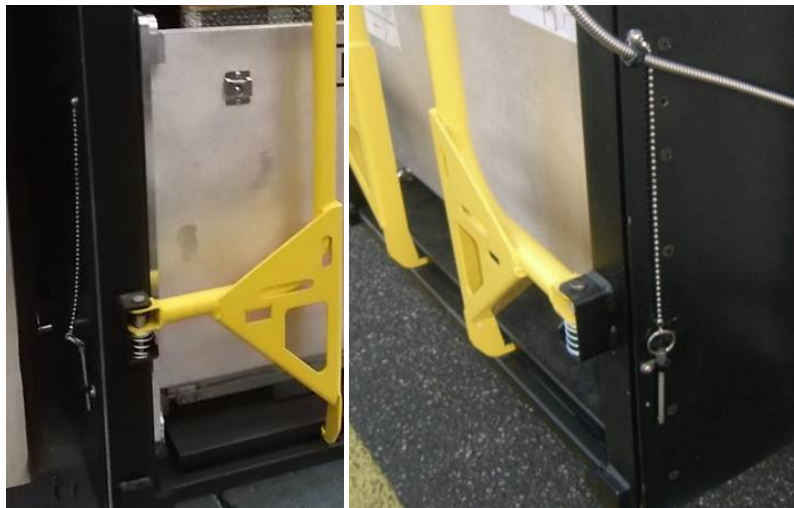
- 6) If maintenance safety pin or chain is missing, please install it.

At left side fix at the top with a screw 19718 and at the bottom with 3/8" long screw 865023 and 3/16" p-clamp 865021.

On the right side, fix together with the cable of the control pendant with a screw 19718 and the existing clamp, and at the bottom with 5/16" long screw N8892943 and 3/16" p-clamp 865021.
