PREVOST

**SAFETY
RECALL**

SR13-93

DATE :	JANUARY 2014	SECTION :	18 - Body
SUBJECT:	IMMI Seat Belt may be difficult to unlatch

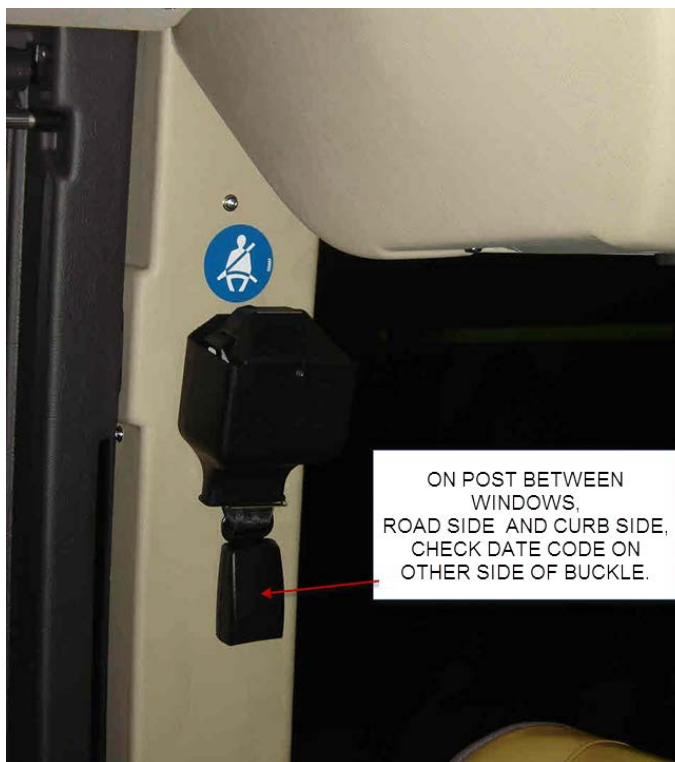
Locate the side-wall mounted retractable shoulder belts in the vehicle.
Check the date code on the other side of the buckle.

ON POST BETWEEN
WINDOWS,
ROAD SIDE AND CURB SIDE,
CHECK DATE CODE ON
OTHER SIDE OF BUCKLE.

Two suspect date code ranges are involved:

13220 through 13256

AND

214 13 through 256 13.

If the buckle date code is within either of the ranges above, replace the part.

Select the retractable shoulder belt in assembly #864813.

Install on wall.

Torque belt anchor to 27 lbf-ft
