**SAFETY
RECALL**

SR14-10

DATE :	APRIL 2014	SECTION :	06 - Electrical
SUBJECT:	12VI5 POWER CABLE CRIMPING [H Series]

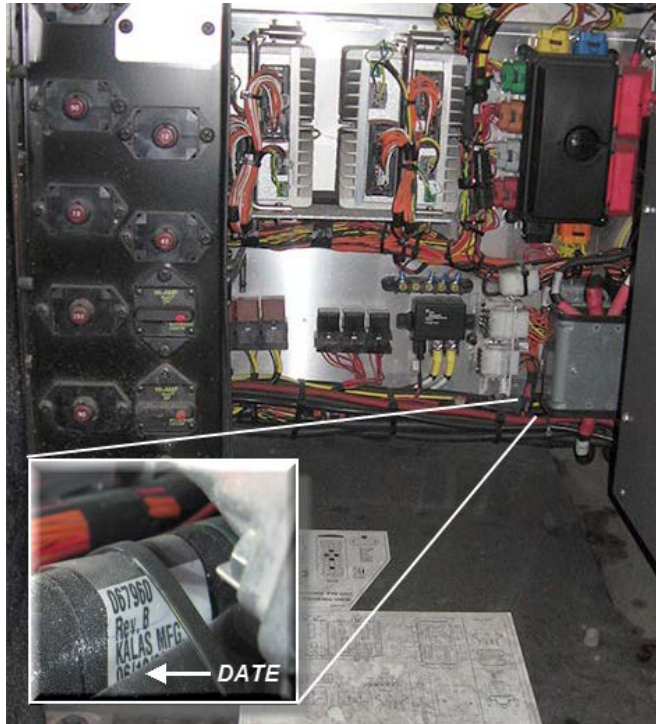
Figure 1 - Label

Locate the harness label (Fig. 1): you may need to cut a few cable ties.

- If date code on harness is **03/21/2013**, proceed with the safety recall.
- If any other date code is present, vehicle is not subjected to recall. Do not carry out any further work.

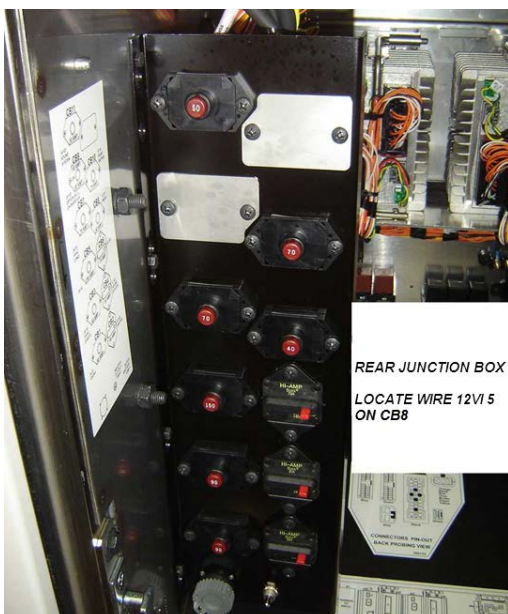
Figure 3 - CB8 end

2. Behind the circuit breaker junction panel (fig. 3), locate wire **12VI 5** connected to **CB8** (Fig. 2&6).

3. On circuit breaker end, cut cable 12VI5 just above the terminal.
4. Strip wire and install ring terminal #560086.
