**WARRANTY  
BULLETIN**

Wb02-18

DATE : January 2003	SECTION :	18 - Body
EXPIRATION: January 2003		
SUBJECT : MODIFICATIONS TO FRONT BUMPER LOWERING MECHANISM

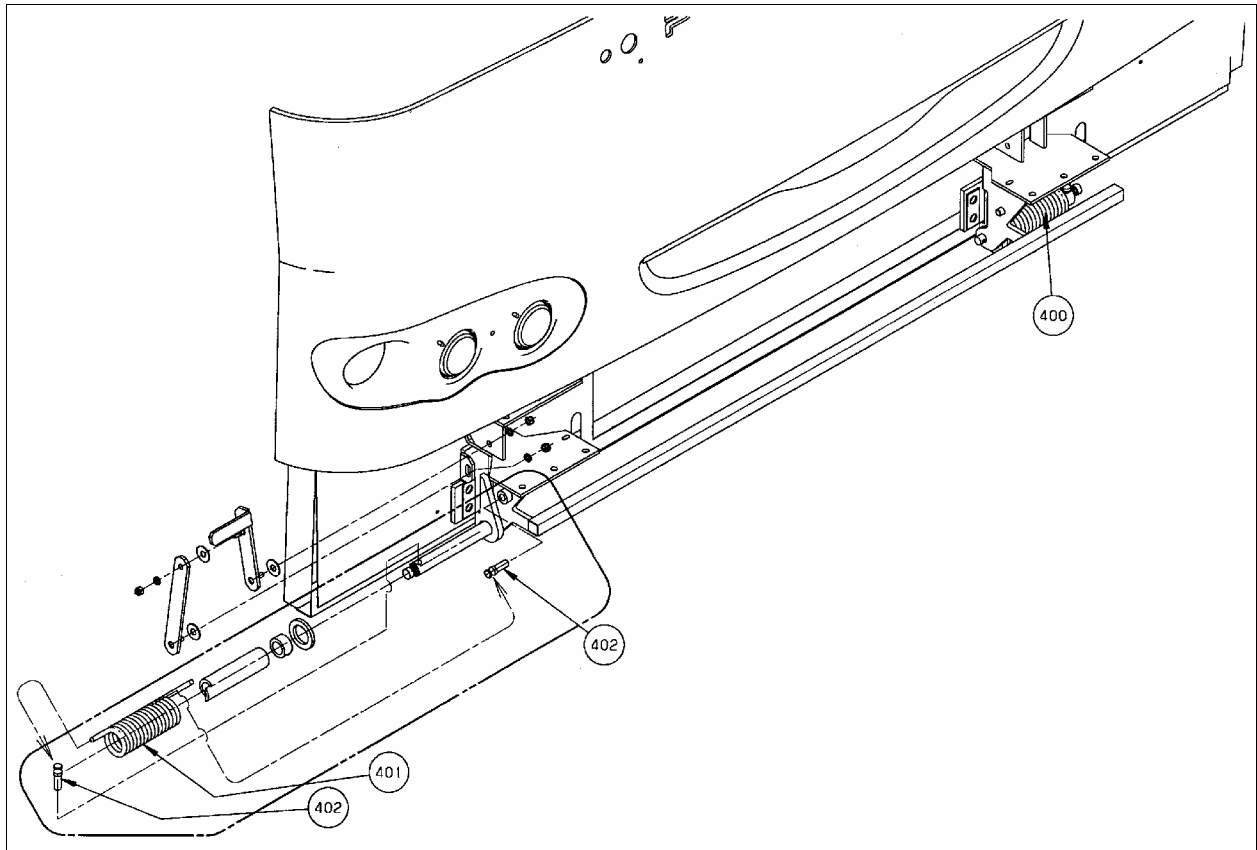
FIGURE 1

3. Remove L.H. side spring (400). Using proper tool, relieve spring tension on one locking pin (402) and remove it. Slowly release spring tension and remove the second locking pin. The spring is free (refer to figure 1).

4. Install new spring (410 984).
5. Repeat procedure for the other spring (410983).

**Note:** A special tool kit is available from Prévost Car Inc: Kit # 410671 including tool #410708.

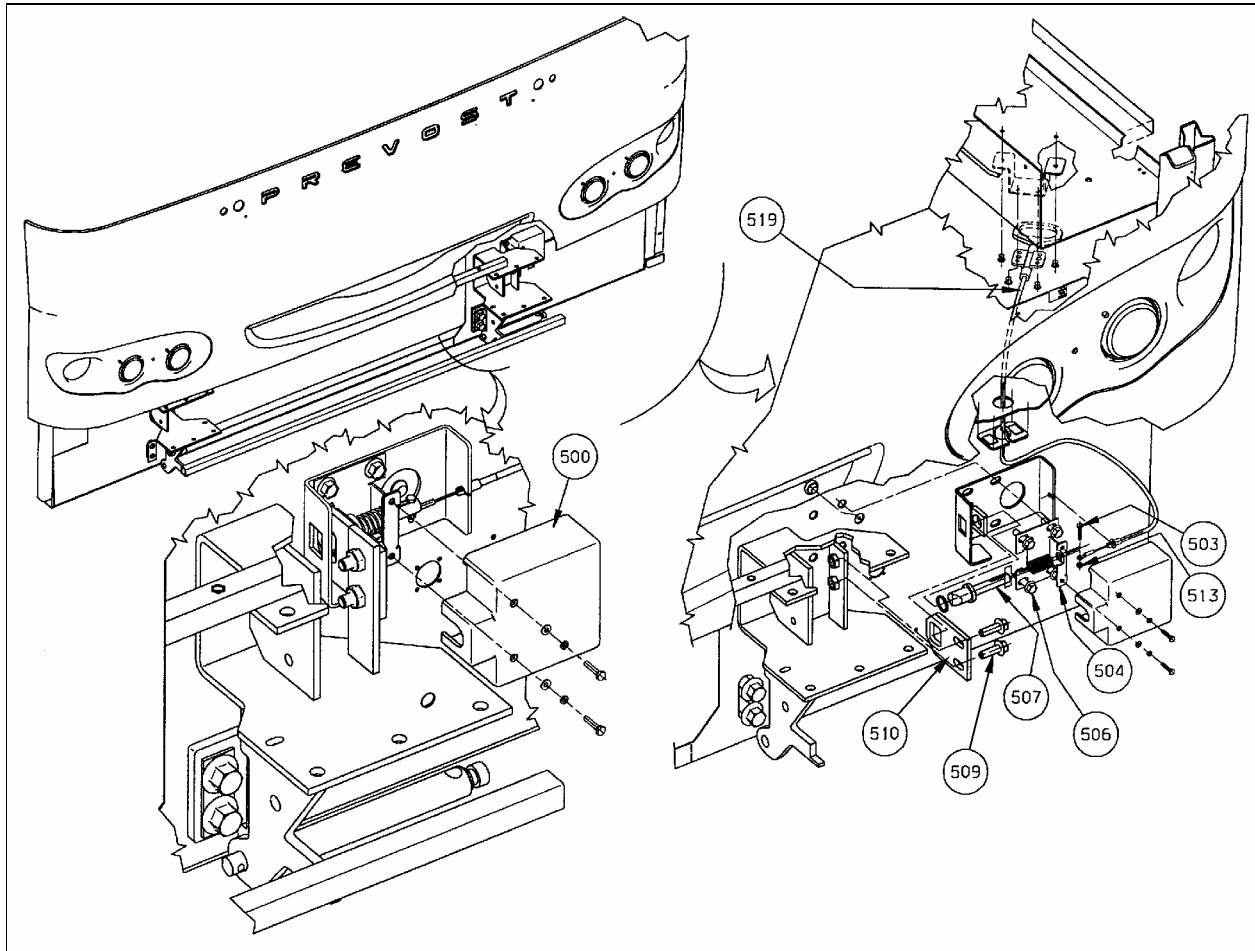
FIGURE 2

- Unfasten screw (503) and nut (513) to separate release cable (519) from latch-bolt (507) (refer to figure 2).

- Unfasten the four bolts (506) fixing the latch-bolt guide (504).
  - Install new guide (410927) and new latch-bolt (287391)
- Note:** Make sure bumper closes properly. If this is not the case, unfasten two bolts (509) and adjust plate (510).
- Reinstall lowering mechanism protective cover (500).
  - For coaches only, install decal (410982) inside front bumper as per figure 3.

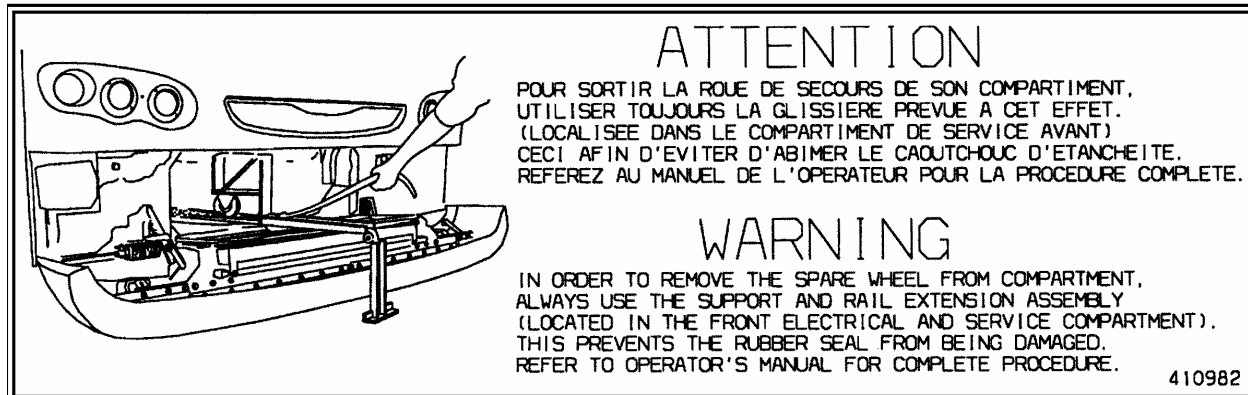
FIGURE 4

- When closing the compartment, be sure the bumper is firmly in place.
