Wb04-18

DATE: DECEMBER 2004	SECTION : 16 - Suspension	n
EXPIRATION: DECEMBER 2	006	
SUBJECT : INSPECTION OF	RADIUS ROD NUTS LOCK	NG
TAB PLATES

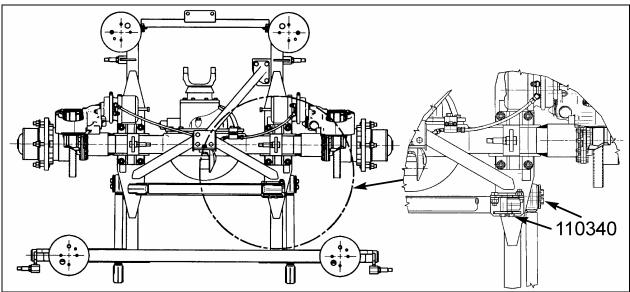
FIGURE 1 : FRONT SUSPENSION LOCKING TAB PLATES

It is possible that some of the above-mentioned vehicles were delivered with the radius rods locking tab plates unfolded. It is necessary to check all the locking tab plates identified in this bulletin and to fold the locking tabs up the bolt heads if necessary.

1. Identify drive axle subframe and rear suspension locking tab plates. Check if all the tabs are folded up against the nuts, fold up if required.
