PREVOST

**WARRANTY
BULLETIN**

Wb11-15A

DATE : MAY 2011	SECTION : 18 - Body
EXPIRATION: MAY 2013	
SUBJECT : DIESEL PARTICULATE FILTER (DPF) ACCESS DOOR AIR GRILLE BONDING VERIFICATION

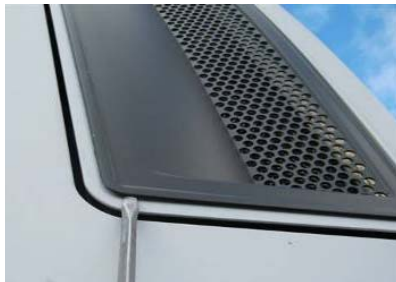
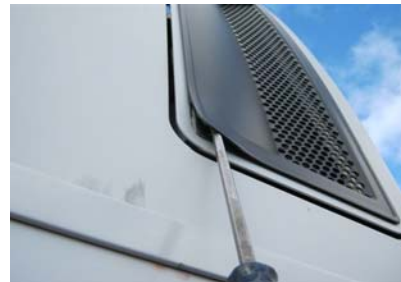
1. Open the DPF access door.
2. Look for the apparent adhesive bead on the back of the air grille. Use the following criteria to validate for proper bond strength:
 - Validate that the adhesive bead color is gray. If the adhesive bead is black, the bonding is not acceptable.
 - Validate that the adhesive has hardened or cured. A soft adhesive bead indicates a lack of activator at time of assembly or the wrong type of adhesive was used. In this case, the bonding is not acceptable.
 - Check that the bonding between the parts is hard, rigid and strong. If the adhesive bead is flexible, deformable and weak, the bonding is not acceptable.

ON THE PICTURES ABOVE, INSERTING A SCREWDRIVER SHOWS WEAK BONDING (protect surrounding painted surface)

3. If the bonding is not acceptable, make an appointment in one of Prevost Service Centers in order to have the air grille corrected. If the air grille can easily be separated from the door, please do so. Otherwise, remove the entire access door.

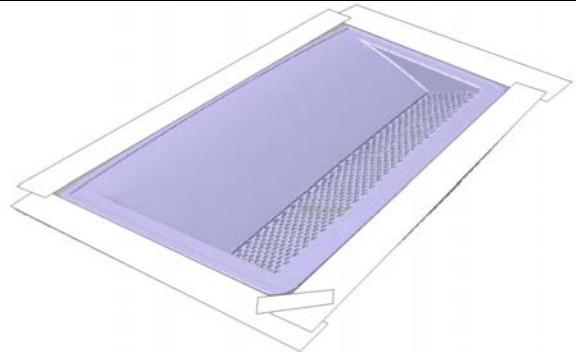
1. Before removal of the air grille, protect the surrounding painted area using masking tape. Place masking tape so it will help you, as a guide, to properly reposition the air grille at time of installation.

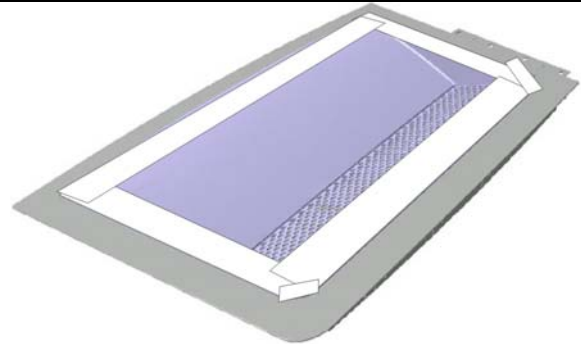
2. Using making tape, protect the painted surface of the air grille.

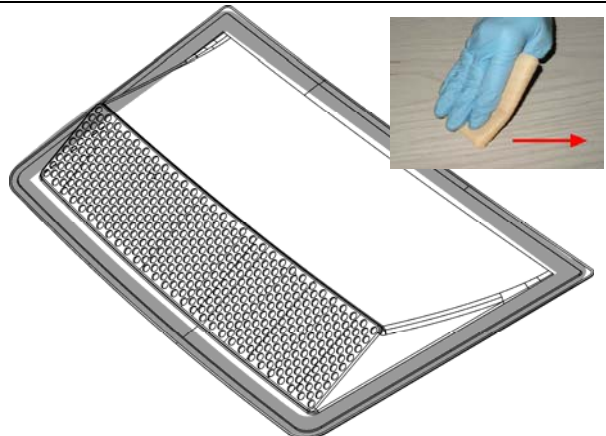
3. Carefully remove the air grille. Take care not to damage it as it will be reuse (suggested tools: air hammer chisel (zip), knife, wire saw).
4. Scrape old adhesive and remove all tape residue. For best results, prepare surface so the fiber glass will be exposed.
5. Clean off dirt, dust of grease from surface where adhesive will be applied using silicone remover (p/n 682989) or isopropyl alcohol. Do not clean with a back and forth movement. Allow enough time to dry.

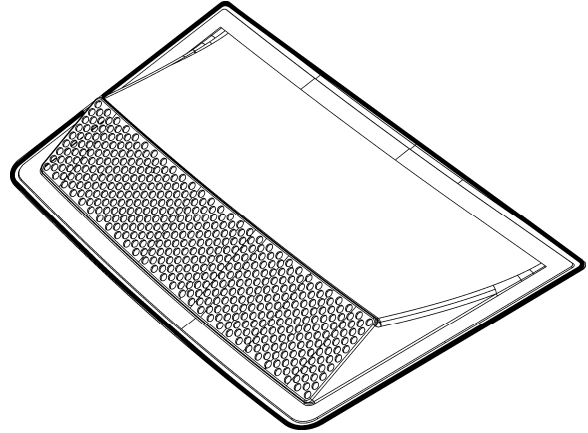
6. Apply 1/8X1/4 double-face adhesive tape around the air grille at about 1/8 inch from the edge.

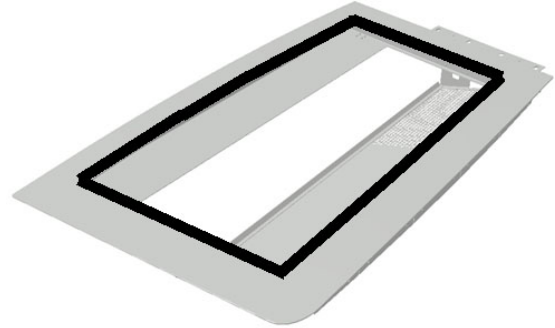
7. Remove all residue of old adhesive and tape on the door. Use sand paper if required.
8. Clean with silicone remover or isopropyl alcohol.
9. To assure best adhesion, rub door surface where adhesive will be applied using a gray Scotch-Brite pad (p/n 680226).
10. Clean with silicone remover or isopropyl alcohol once again
11. If the primer coat has peeled or chipped, apply Plexus PC120 (p/n 687955) primer locally.

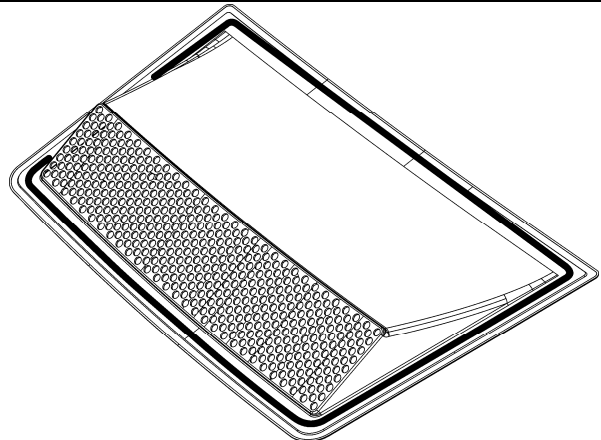
12. Use only methacrylate Plexus MA530 adhesive (p/n 687956). Plexus MA530 is a 1:1 ratio, i.e. one part of adhesive for one part of activator.
13. In order to assure proper adhesive curing, it is mandatory to use mixer nuzzle #683919. **Do not use any other type of mixer.**
14. Apply adhesive bead at 1/2 inch from the tape. The bead size must be about 1/4"-5/16" (cut mixer nuzzle at 2nd mark).
15. Remove the double-face adhesive tape protective paper.

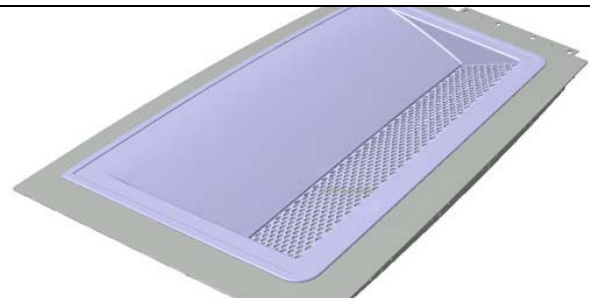
16. Place air grille on the door and press firmly. Allow at least one hour (1 hr) for curing time.
17. Reinstall DPF access door.
