# PREVOST

## WARRANTY BULLETIN

**WB14-32**

DATE :	SEPTEMBER 2014	SECTION: 06- Electrical
EXPIRATION:	SEPTEMBER 2016	
SUBJECT :	MASTER RELAY CORROSION

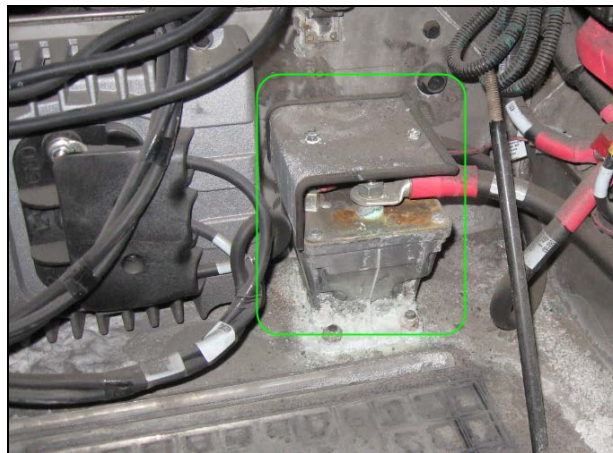
On the vehicles affected by this bulletin, it is possible to observe signs of corrosion at the base of the master relay installed in the vehicle battery box.

5. Locate the master relay fixed at the bottom of the rear corner in the battery box.

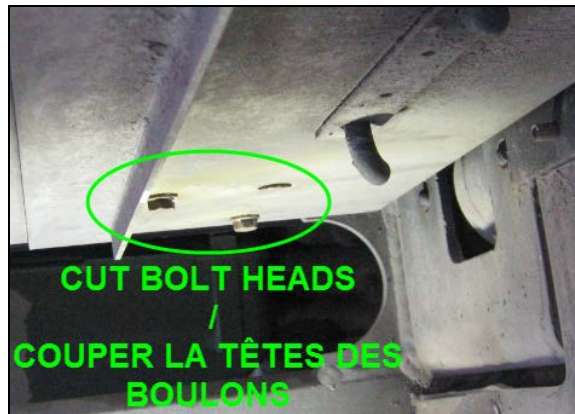
If the hex bolts and nuts are severely attacked by corrosion, it may be necessary to cut the bolts heads from under the vehicle with a rotary cutting tool and suitable eye protection equipment.
