**PREVOST**

**WARRANTY  
BULLETIN**

**WB14-39**

DATE :	SEPTEMBER 2014	SECTION :	22 - HVAC
EXPIRATION:	SEPTEMBER 2016		
SUBJECT :	POWER CABLE INSPECTION AND DECAL ADDITION

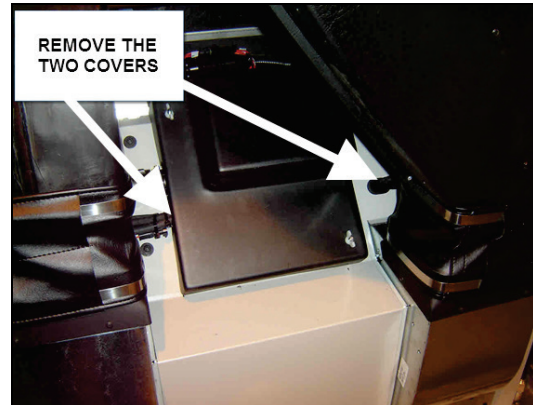
1. Open the evaporator compartment door (road side). Remove the control box cover and the fan housing cover.

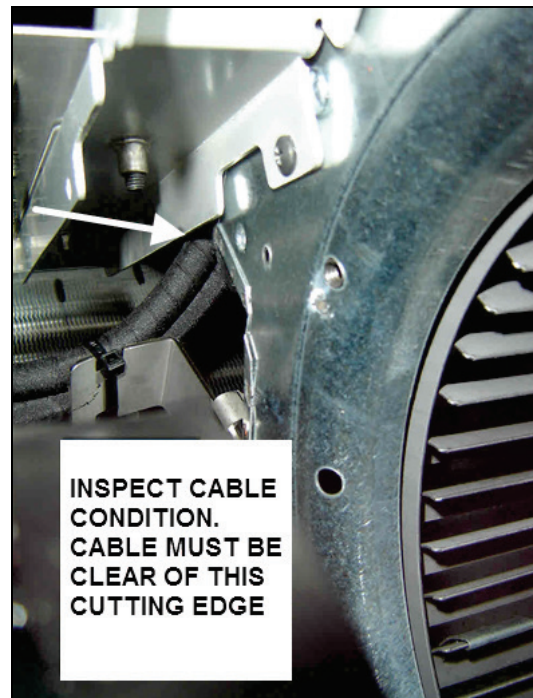
2. Inspect the power cable at location shown in picture.
