PREVOST

WARRANTY BULLETIN

WB16-02H

DATE :	MAY 2016	SECTION :	06 - Electrical
EXPIRATION:	MAY 2018		
SUBJECT :	CHARGING SYSTEM IMPROVEMENT

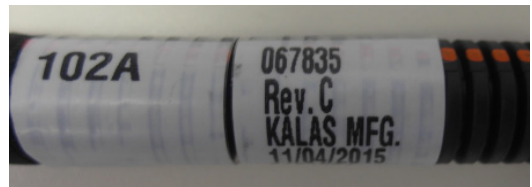
FIGURE 7

Rev.C lug terminal through hole dia.= 5/16" CORRECT

Rev.B lug terminal through hole dia.= 13/32" INCORRECT

7. Reinstall the jumper cable **#067835 revision C** included in kit #7770335 (FIGURE 7, FIGURE 8).

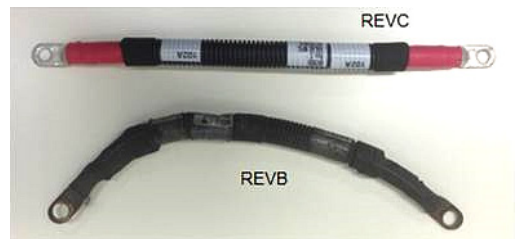
FIGURE 9

Rev.B diameter of the through hole is too large, reducing contact surface with the stud and the nut thus reducing electrical conductivity between the lug and the alternator stud (FIGURE 9).

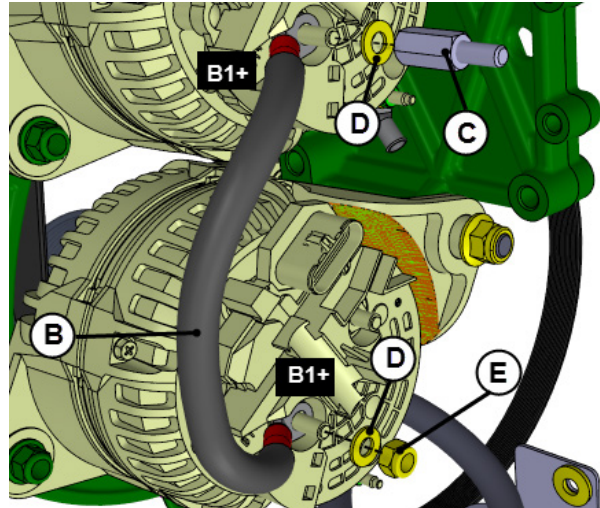
FIGURE 10

Note: M8 nut "E" formerly #5001787 is canceled. Use nut #5001983 instead.

- B : JUMPER CABLE #067835 revision C**
C : STUD ADAPTER #060297 torque: 10 lbf-ft
D: FLAT WASHER #5001341
E: NUT M8 #5001983 torque: 10 lbf-ft

-
8. Reinstall appropriate jumper cable **B** (i.e. rev.C) with appropriate stud adapter. Refer to **FIGURE 10**.

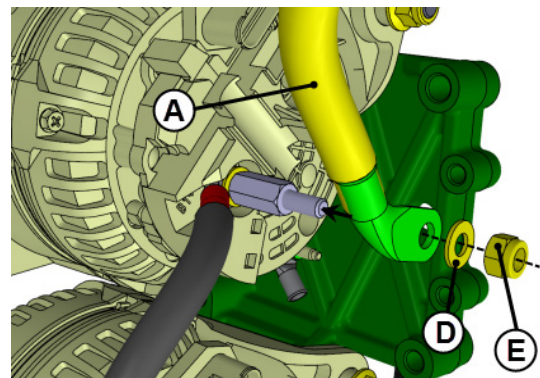
FIGURE 11

Note: M8 nut "E" formerly #5001787 is canceled. Use nut #5001983 instead.

- A : POWER CABLE**
D: FLAT WASHER #5001341
E: NUT M8 #5001983 torque: 10 lbf-ft

-
9. Reinstall power cable **A**. To do so, connect power cable **A** to the upper alternator **B1+** stud terminal. Refer to **FIGURE 11**.

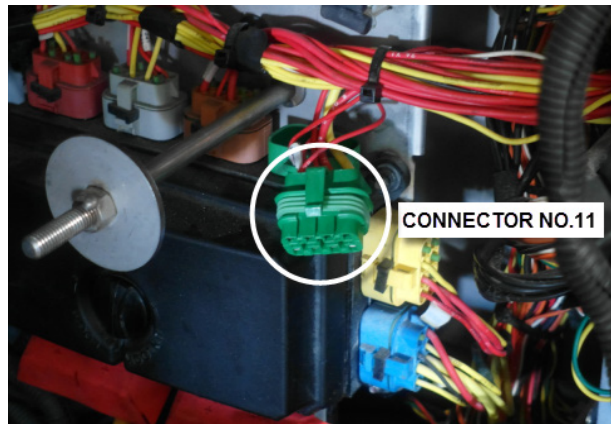
FIGURE 13

3. Using an extractor tool or a small flat blade screwdriver, remove wire 24VDALT from cavity H of connector no.11 (FIGURE 13 to FIGURE 16).

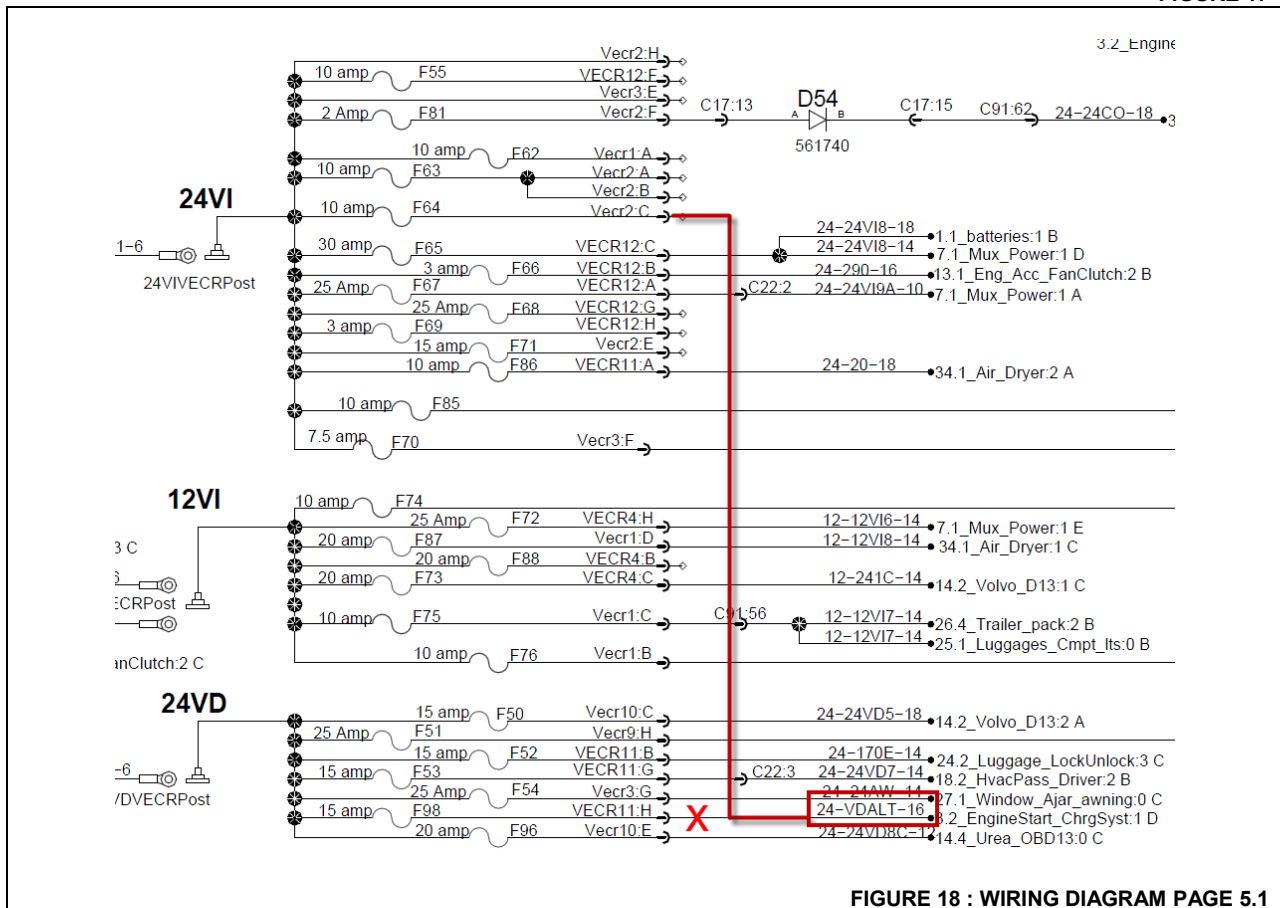
FIGURE 18 : WIRING DIAGRAM PAGE 5.1

Cavity **C** of connector no.2 should be available. This branch of the circuit will be protected by 10A fuse F64 (see FIGURE 18 below).

Should cavity C not be available, refer to your vehicle wiring diagram page 5.1 to select another free cavity protected by a 10A or 15A fuse (see FIGURE 18 for reference).

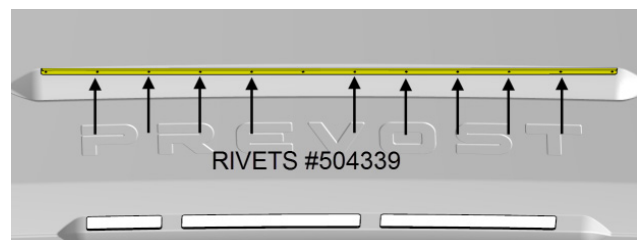
FIGURE 31

- Fasten drip edge using nine (9) rivets #504339 as shown on FIGURE 31. Use a 9/64" drill bit.

IMPORTANT NOTE: The drip edges must not be stuck on the vehicle body

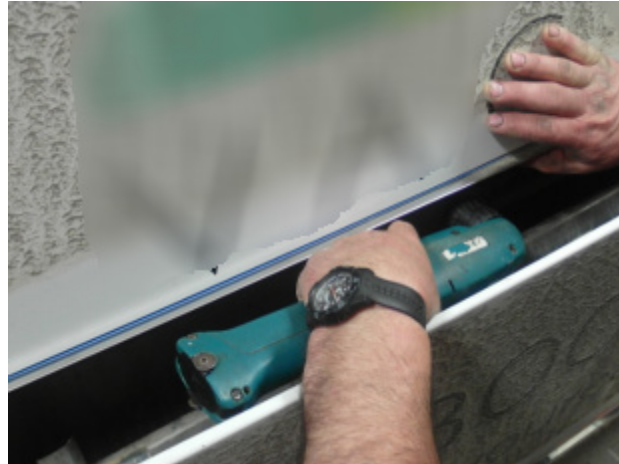
Drill using a 9/64 bit. FIGURE 36 shows how to drill holes with the access hatch in place using a right angle drill.

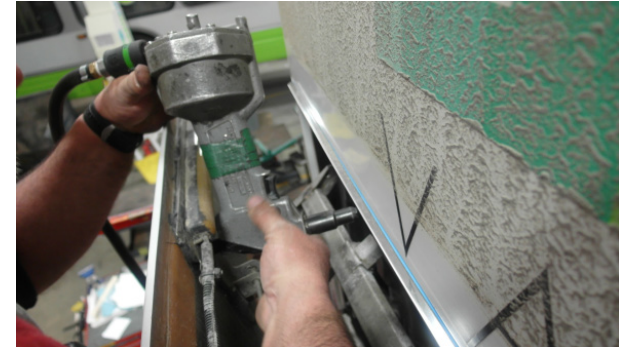
FIGURE 38

14. Remove the five (5) screws previously installed and replace with rivets.

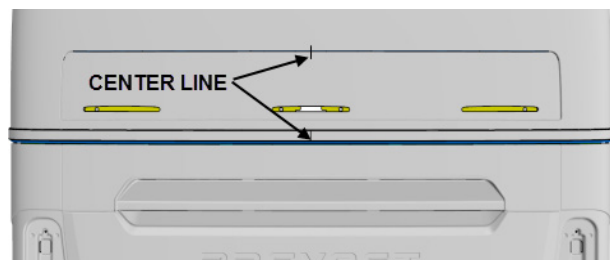
FIGURE 43

3. To ease installation of the drip edges, draw a reference lines on the vehicle body indicating the center of the rear end so that the drip edges will be installed perfectly centered (FIGURE 43). You may use the center high mounted stop light and the SS molding as reference to find the center of the rear end.

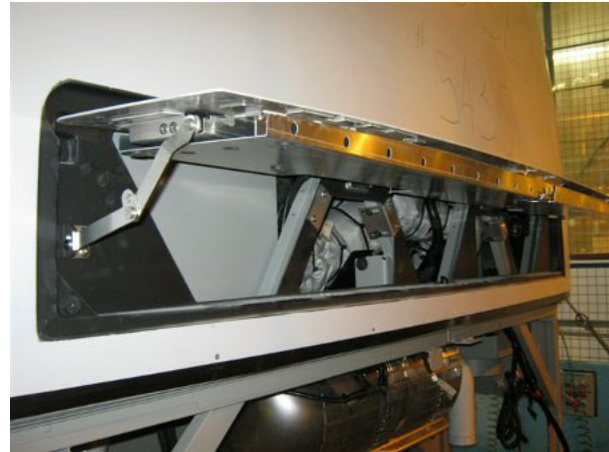
FIGURE 44

4. Remove the **exhaust aftertreatment system (ATS) access hatch**.

Prior to removing the access hatch, protect the surrounding surfaces using wide paper masking tape.

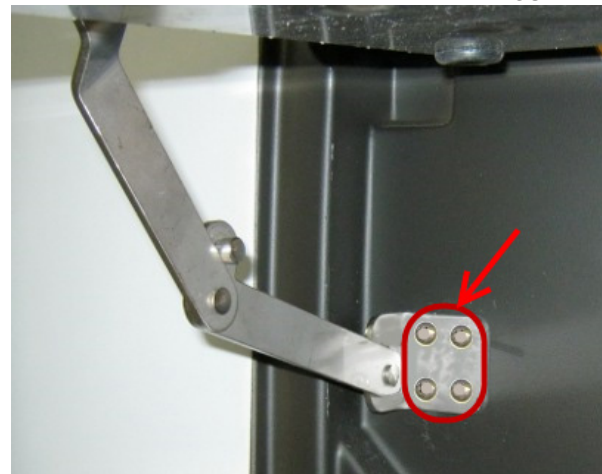
- a) To do so, drill through the folding arm rivets (4 rivets) shown on FIGURE 45
- b) Disconnect the “high mounted stop lights” cable harness.
- c) Unscrew the hinges mounting bolts (2 bolts per hinge). Spacers may be found behind the hinges. Make sure you identify the spacers in order to reinstall the access hatch using the proper spacer at the correct location (FIGURE 46).

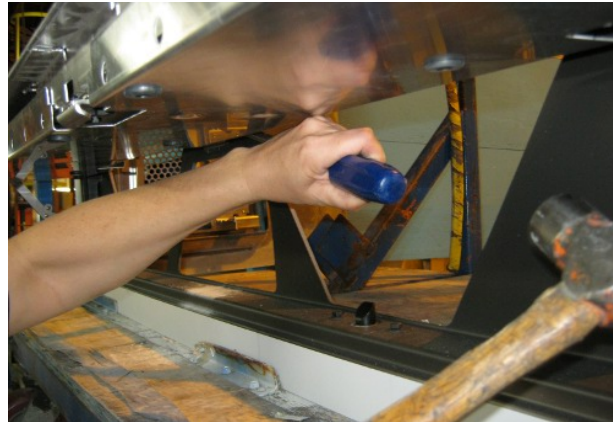
FIGURE 58

-
19. Check the upper part of the access hatch for rubbings against the rivets when opening and closing the hatch. If this is the case, the hatch has to be moved downward.
20. Loosen the hinge mounting bolts (4 bolts) slightly.
21. Use a screwdriver and hammer, tap slightly on the hinges to move the door for proper fit (FIGURE 58).
