FUSEBOX DECAL REPLACEMENT 9700 (B13R)

NOTICE TO SERVICE CENTERS	
Verify vehicle eligibility by checking warranty bulletin status with SAP or via ONLINE WARRANTY SYSTEM available on Service / Warranty tab of PrevoSt website.	
Model	VIN
Volvo 9700 us/can Model Year : 2014 - 2016	From 3CET2V22X <u>E5164935</u> up to 3CET2V42X <u>G5176275</u> incl.
This bulletin does not necessarily apply to all the above-mentioned vehicles, some vehicles may have been modified before delivery. The owners of the vehicles affected by this bulletin will be advised by a letter indicating the Vehicle Identification Number (VIN) of each vehicle concerned.

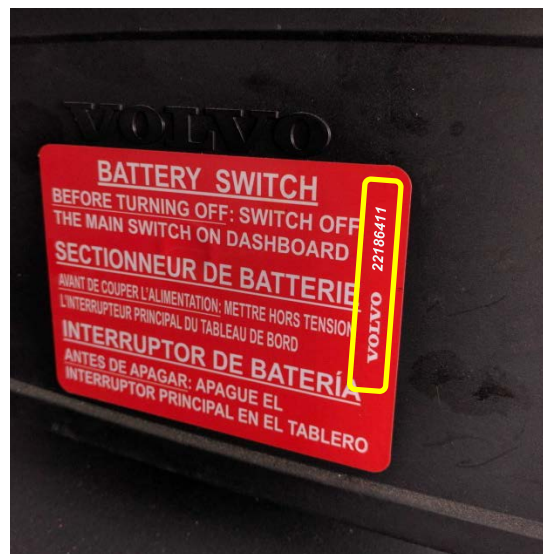
FIG. 1 LOCATING FUSE BOX PART NUMBER

Look for the fuse box located inside the front electrical compartment on the driver's side. Only specific fuse boxes are required to have this corrective measure done. Concerned fuse boxes have **PN 22186411** indicated on the cover, as shown on the image below:

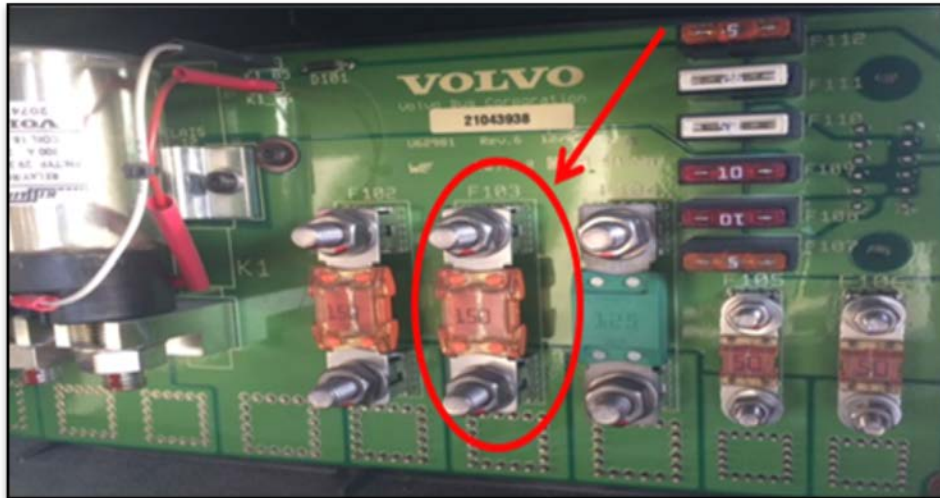
FIG. 2 POSITION OF "F103" FUSE

On vehicles affected by this bulletin, the fuse decal at position "F103", inside the front fuse box, indicates incorrect information. **80A** should be read instead of the actual value of 150A.

A specific decal must be placed in order to indicate the correct ampere information at position "F103".
