SAFETY RECALL

SR17-85

X905 FUSE BOX INSPECTION
9700 (B13R)

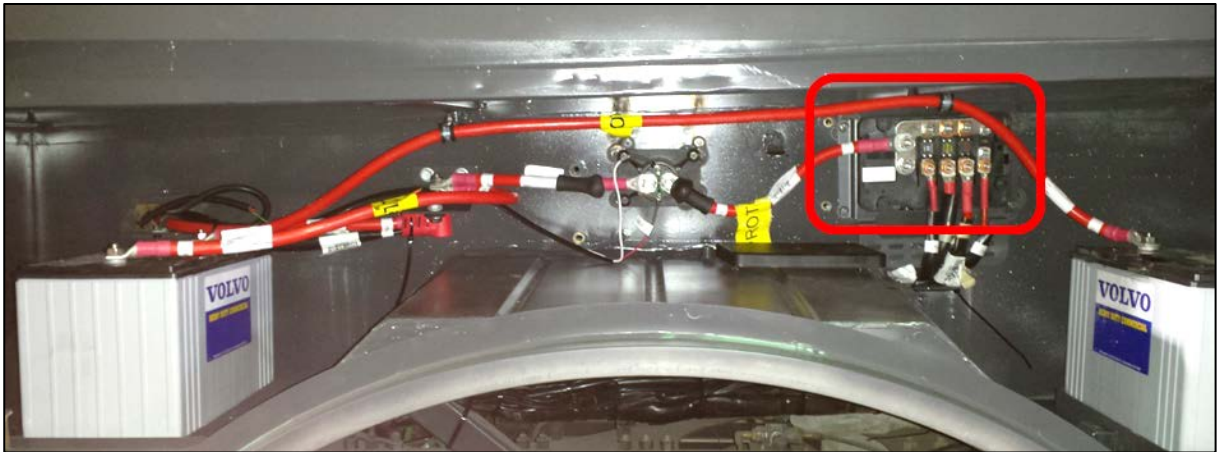
Figure 2: Consumer I-Start compartment

- Remove the fuse box cover

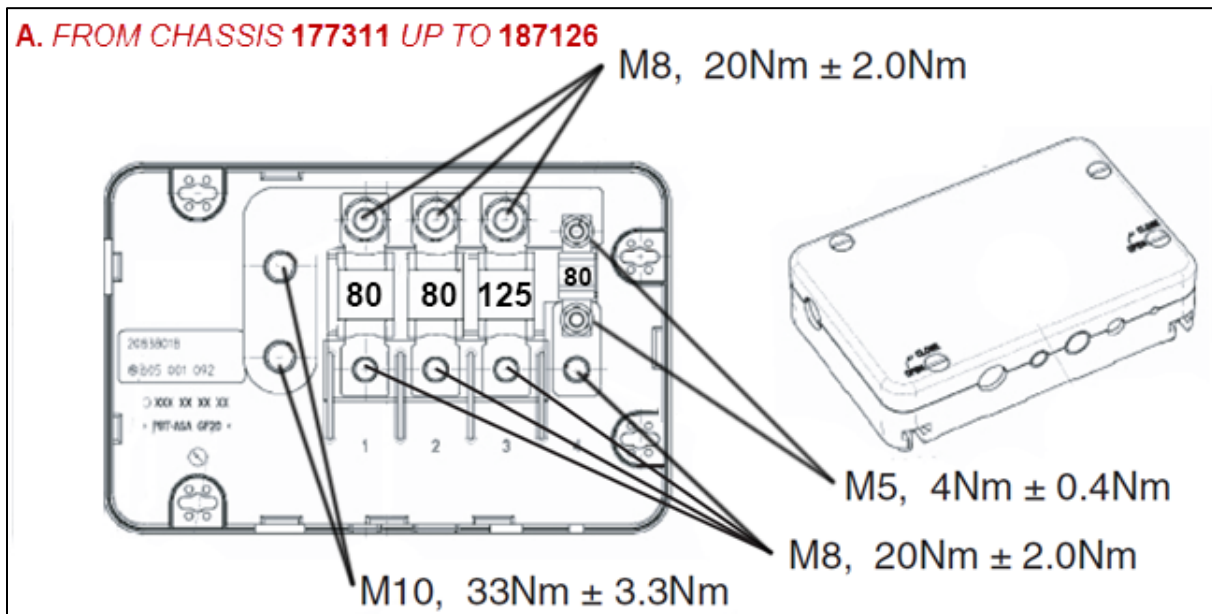
Figure 3: Stud Torques, Fuse arrangement. From Chassis 177311 up to 187126.

STEP A. From chassis **177311 up to 187126**: Inspect the fuse amp rating values in the fuse box. Value should be, from left to right:

80 | 80 | 125 | 80*

Refer to **Figure 3** below.

*Note that the last **80** position may be empty. It is used only if the vehicle has a wheelchair lift.

4. Replace any fuse showing heat damage.
5. Confirm the fuses have the proper rating for each position.
6. Replace as required with the following parts.
 - 994913 **80A** fuse
 - 982617 **125A** fuse
7. Tighten the connection studs to the indicated torque values shown in Figure 3 and Figure 4.
8. Apply color guard corrosion protection 684013 on all connections in the fuse box. (Figure 5)
9. Let coating dry.
10. Apply torque seal mark across nut and stud.
